Initial Health and Safety Audit

**Conducted for South Derbyshire County Council
Cultural and Community Services**

**The Greenbank Leisure Centre
Etwell Leisure Centre**

**Carried out by Top Lodge Leisure Ltd
January 2022**

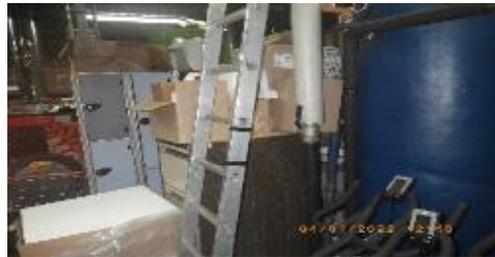
Examples of the some of the areas that are to be cleared in the plant room at Greenbank

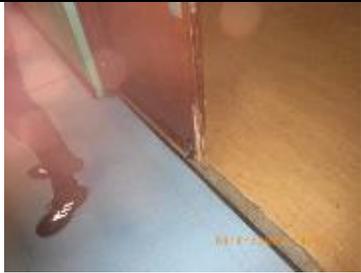
Damaged sports hall doors

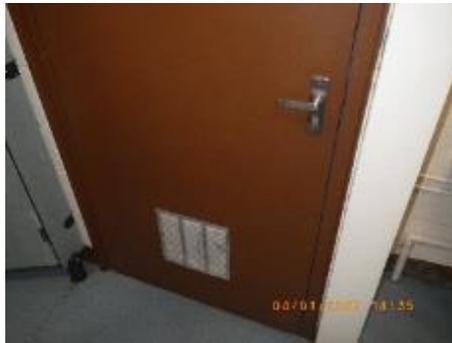
Fire safety	<p>The original fire risk assessment was not available and the review of the assessment that was available showed that none of the actions raised had been closed out. It was not possible to demonstrate closure indicating that the sites have not been brought up to a satisfactory conditions as far as fire safety risk is concerned.</p> <p>There is a fire log book in place at both centres however this is not used to its full potential and only used to record areas including fire extinguisher checks, fire drills and emergency lighting. Issues that have been identified are noted and recorded as being reported to TFM however closure of the issues cannot be demonstrated with some of the same faults being constantly reported.</p> <p>A fire door register is in place however many of the fire doors are inadequate in both buildings and require updating. Some doors are in poor condition and some have had air panels cut into them. The fire door adjacent to the sports hall at Greenbank had had ventilation holes put in that stops the doors from being classed as fire doors.</p>

Fire door with vents cut in. The properties of the fire doors have been defeated.

<p>The fire doors to the studio in the APEX Centre did not close properly.</p> <ul style="list-style-type: none">• An inspection of all fire doors to take place to identify where replacement/remedial actions are required. This could prioritise those that are in the poorest condition and programmed as part of the ongoing maintenance plan. <p>Evacuation drills take place with the Academy at Etwell however although the drills are recorded there is very little information as to how the drill went and whether additional training is required. Similar comments also apply to evacuations carried out at Greenbank.</p> <ul style="list-style-type: none">• Additional information could be added to the Fire Log book identifying any specific issues that may have arisen.• Drills could be made more realistic with scenarios put in place such as blocking a normal evacuation route or placing an object in the zone areas (rooms etc).• Evacuation drills to be carried out to ensure that people with disabilities are able to leave the building safely particularly at the Greenbank Centre. The emergency action plan to be updated to reflect this procedure. <p>A certificate of fire conformity for the fire extinguishers at Etwell was issued by CLK Fire and Safety Compliance Ltd on 24th May 2021.</p> <p>Servicing of extinguishers at Greenbank had been carried out by TFM. Records were not able to be accessed. Certification had been granted by TFM despite two extinguishers being recorded as not being passed.</p> <p>The lift doors at the top and bottom of the stairs at the Greenbank Centre did not have any warning notices on them regarding the use of lifts during fire.</p> <ul style="list-style-type: none">• Evacuation procedures to be reviewed to ensure that the safe evacuation of people with disabilities is identified and procedures put in place and documented.

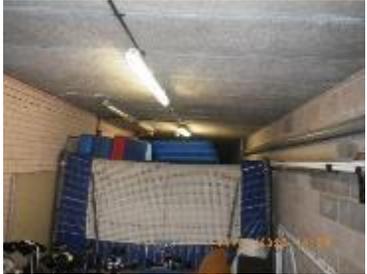
<p>Unchained/locked trampolines</p>

- Additional information could be added to the Fire Log book identifying any specific issues that may have arisen during inspection checks and to follow up the progress of any actions.
- Check that trampolines are locked to prevent unauthorised use as recommended by the Association for Physical Education and Coachwise in their guidance documents and that access to the gym only store is secured.
- Regular checks for the rooms Climbing Centre to be put in place particularly during holiday periods to maintain standards.
- Keeping users up to date with maintenance issues could help to maintain good relationships and demonstrate to users that customer standards are in place.
- A review of the provision of facilities for disabled users of the sites to be carried out together with emergency evacuation procedures.

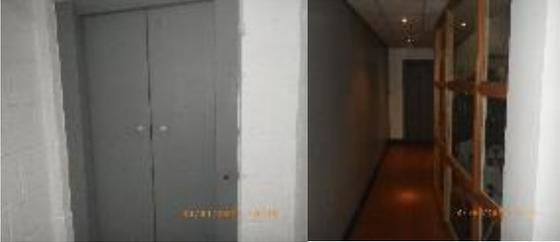
<p>Lift doors without signage top or bottom</p>

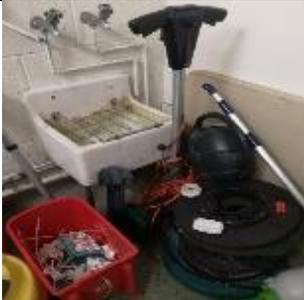
<p>Disabled toilets are being used as cleaning stores in both centres. Equipment was not stored correctly and was generally untidy. Other cleaning chemicals appeared to be stored in different staff areas. PPE was not obvious.</p> <ul style="list-style-type: none">• A review of all substances used on the site to be carried out and COSHH sheets and the hazardous substances updated. Any chemicals that are not currently used to be disposed of and removed off the sheets.• COSHH training to be recorded for all staff together with the correct use of PPE.• A dermatological assessment carried with staff who use cleaning chemicals. This can be simply asking whether there are any existing allergies or sensitivities and recording in personal files together with actions taken to protect them.• All cleaning stores to be tidied with equipment stored correctly, sinks cleaned, mops hung up and coloured coded equipment identified. Electrical equipment to be stored tidily and correctly i.e. not thrown in a spare corner.

Disabled toilet used as a cleaning store

- All cleaning stores to be tidied with equipment stored correctly, sinks cleaned, mops hung up and coloured coded equipment identified. Electrical equipment to be stored tidily and correctly i.e. not thrown in a spare corner.

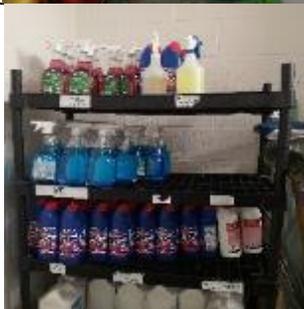
Another cleaning store
