Milton
Conservation Area
Character Statement

2010
CONSULTATION DRAFT

**SOUTH DERBYSHIRE
DISTRICT COUNCIL**

Milton *Conservation Area*

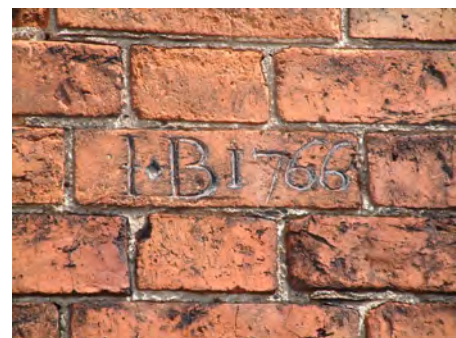
Initialled and dated brick at Brook Farm, built by the Brown family in 1766

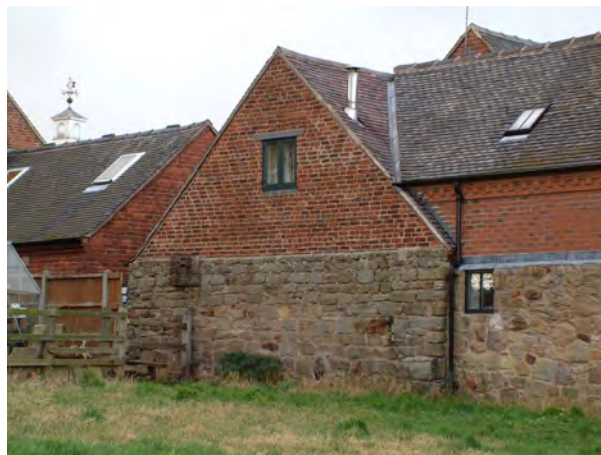
Stone and brick at The Farm

There is physical evidence for earlier buildings having been built in coursed and squared stone, or simply rubblestone, but the examples of this are scarce, most having been replaced during the 19th century with brick buildings. The range of 2½ storey cottages on Main Street (11-15) incorporates a stone plinth, which appears to be original to the late 18th century construction. The same detail appears at Brook Farmhouse and the boundary wall that served its former farmyard. Other buildings that incorporate a stone plinth are generally related to earlier footings of buildings that fronted the road. Lilac Cottage (10 Main Street) is an 18th century brick reconstruction. It has a 17th century plan form and incorporates a stone plinth and section of gable wall, also belonging to its earlier history. Ivy Cottage has footings from an earlier building that was probably set gable-end onto the road and 5 Main Street also incorporates a section of coursed stonework, revealing an earlier building on this site.

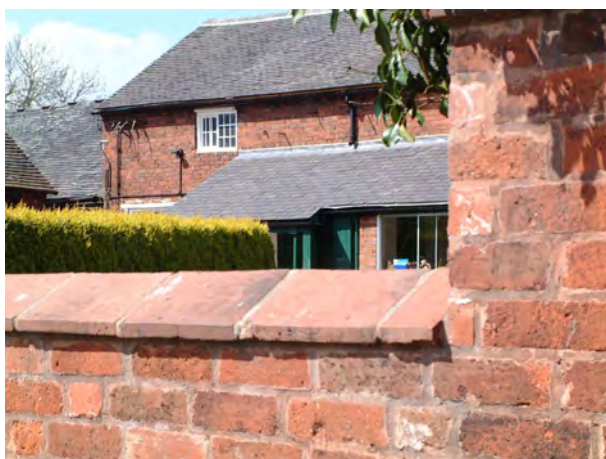
Boundary wall at Common Farm

Although the buildings are largely brick, boundary walls are built from local sandstone or red brick. There are only two instances of the use of railings (The Farm frontage and Kirby Holt).

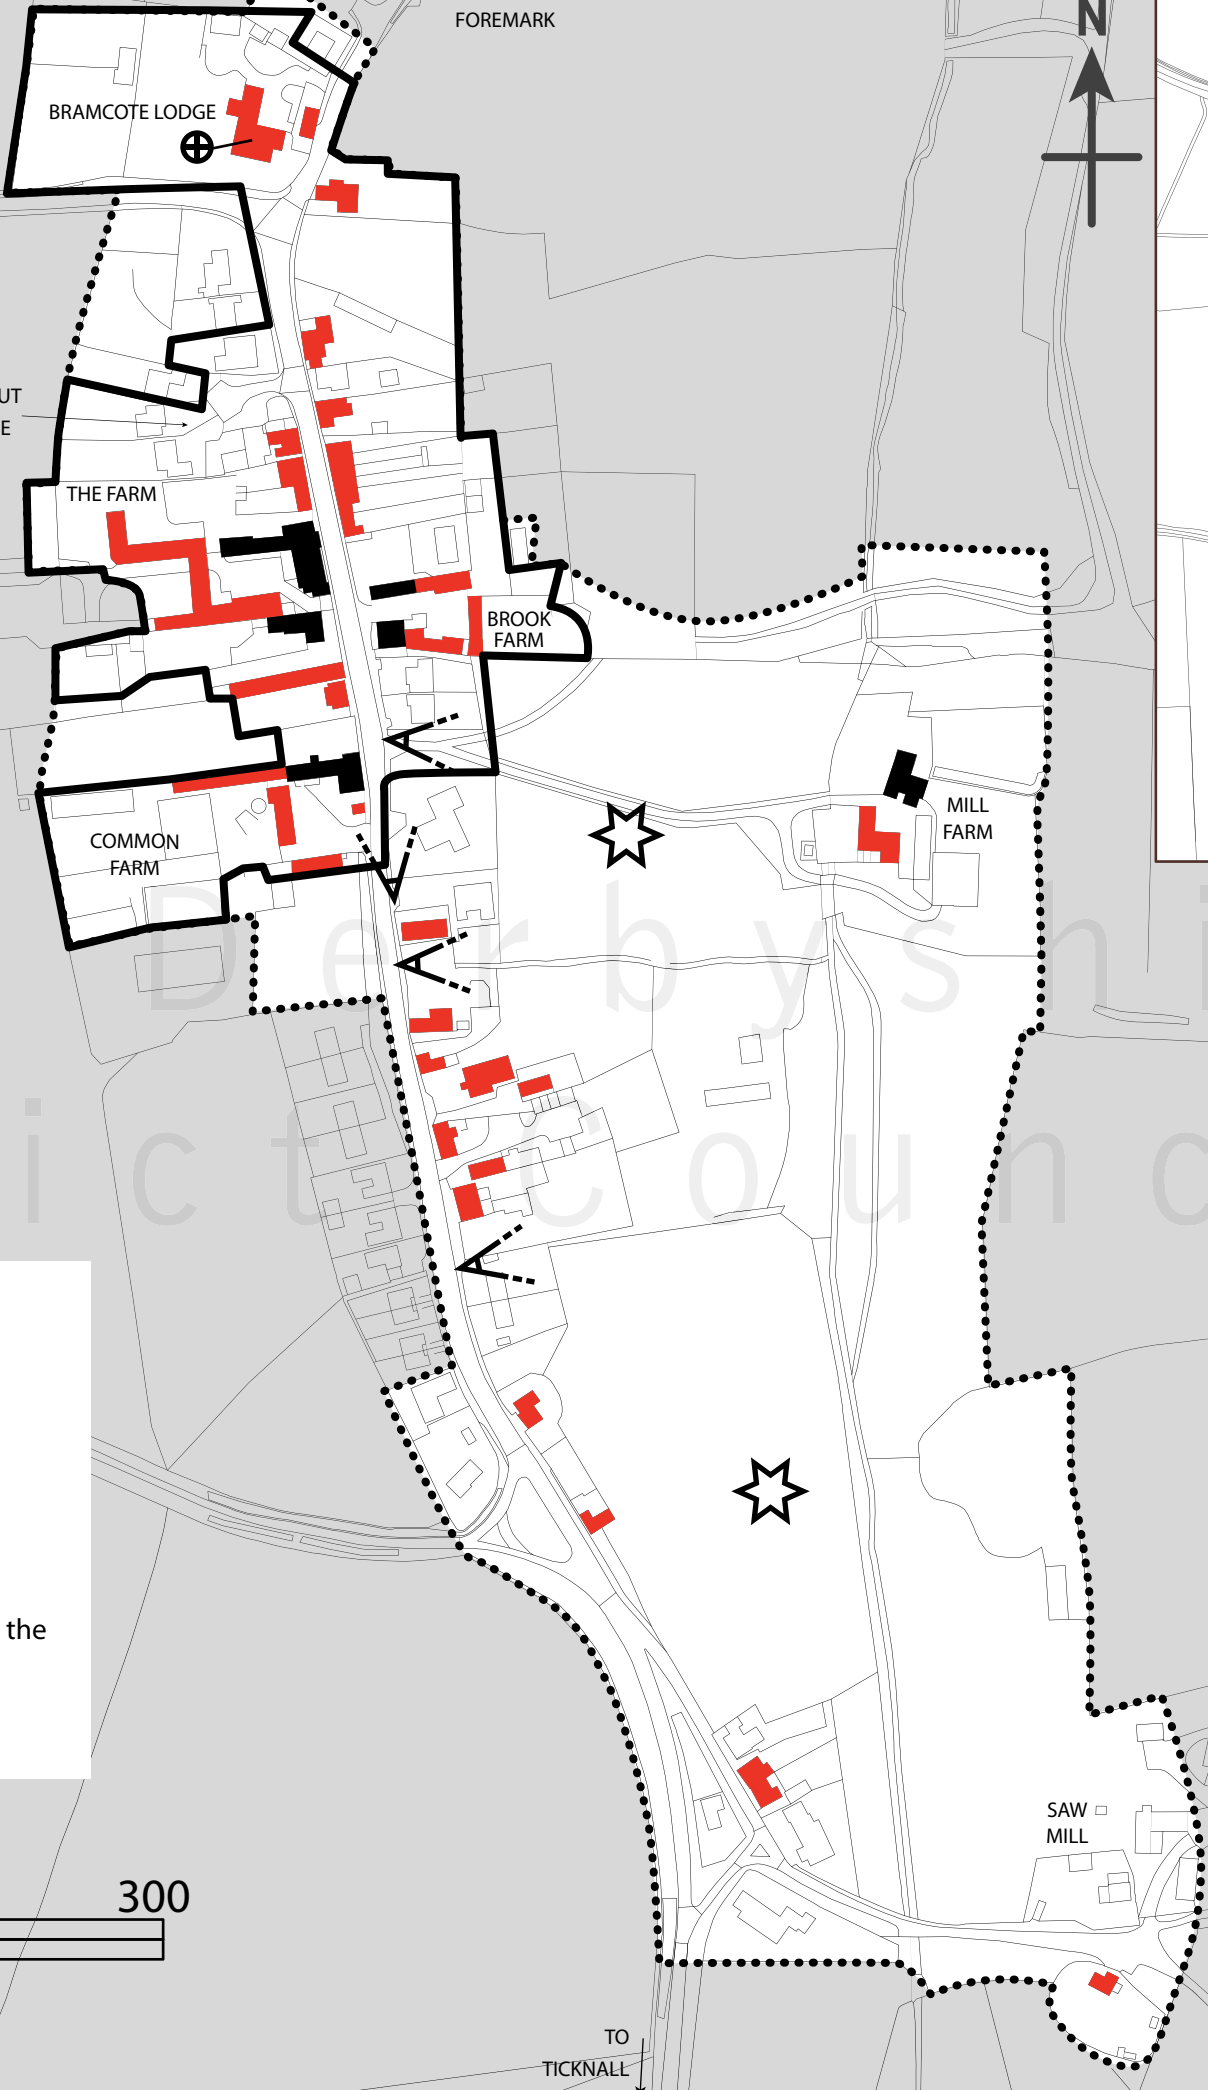
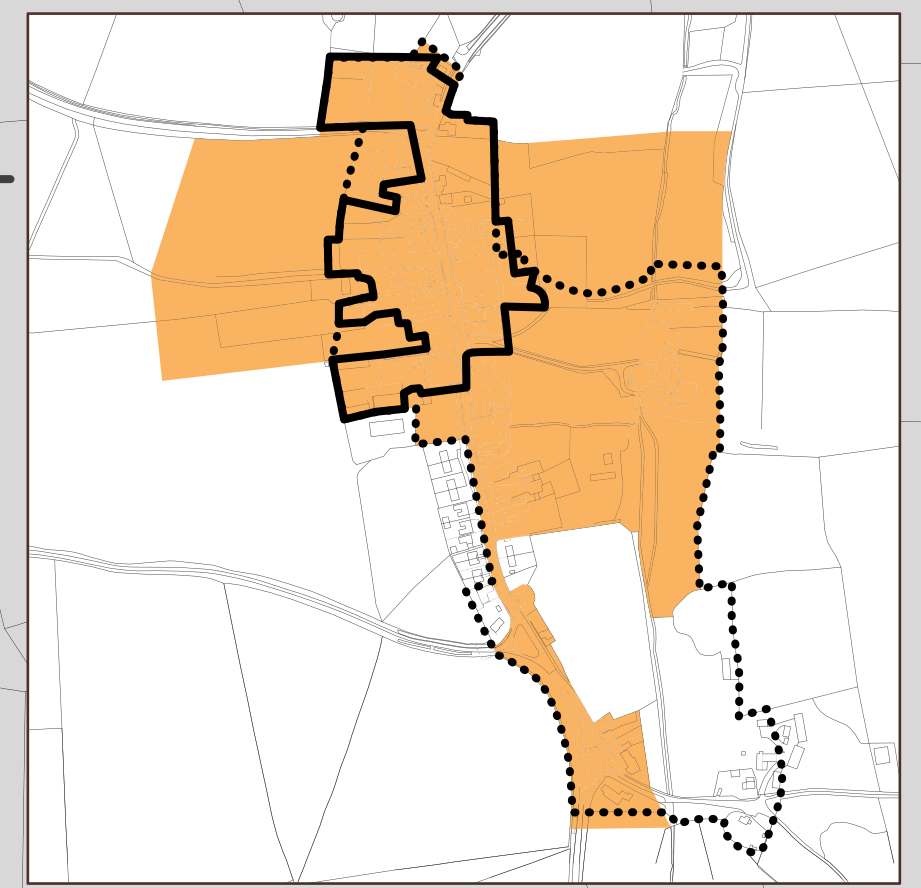
Milton Conservation Area
Designated : 15th July 1971

- Conservation Area boundary
- ⋯ Proposed extended boundary
- ☆ Open spaces
- 👤 Principal views
- ⊕ Architectural landmarks & focal points
- Listed buildings
- Other buildings which contribute positively to the special architectural or historic character
- Areas of high archaeological potential

At Milton, it is suggested that the conservation area boundary be extended to include the less densely built-up part of the village south of Common Farm, and the open spaces between the Main Street and the brook. Beyond the brook the extension would include Mill Farm, the former Saw Mills and the woodland that formerly contained the fishery.

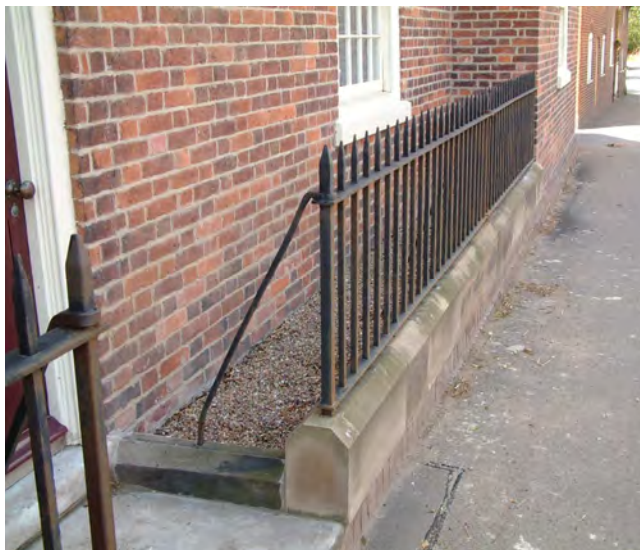
BOUNDARY TREATMENTS

Within Milton boundary walls are predominantly local sandstone, with dressed stone copings, triangular or half-round, more rustic than genteel in character. There are a few instances of brick boundary walls, finished in red clay copings but only two surviving examples of wrought-iron railings set into a stone plinth, of which the example at The Farm (below) has recently been restored.

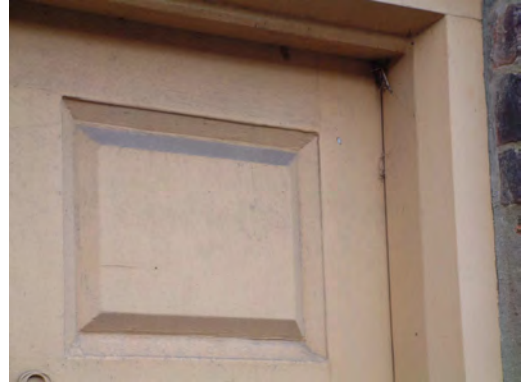
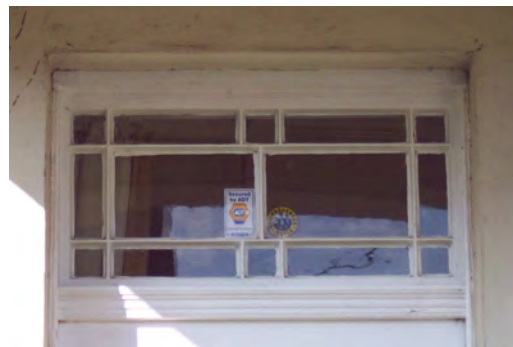
DOORS

Of the few surviving historic doors in Milton, the “double chamfer” 6-panel door is the most common (left, bottom left and detail above). For the smaller cottages, door frames were kept simple with a chamfered and timber pegged construction. Many doors may have been constructed with vertical boards. They usually incorporated a stone threshold. In the early 19th century fanlights were reserved for the better houses (below and bottom left).

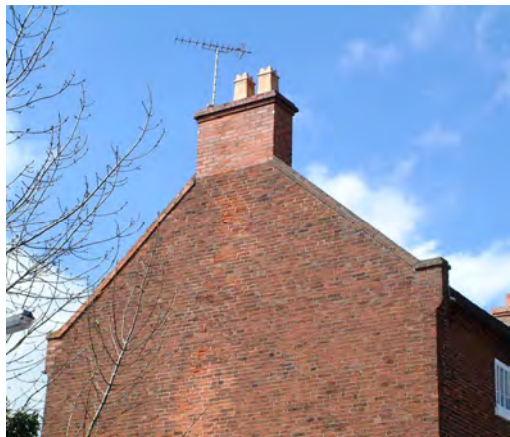
Pitched roof with a plain close verge and corbelled eaves (right), the simplest and most common type of construction.

There is occasionally a corbelled verge, designed to throw rainwater away from the brickwork (below right - No.1 The Hollies).

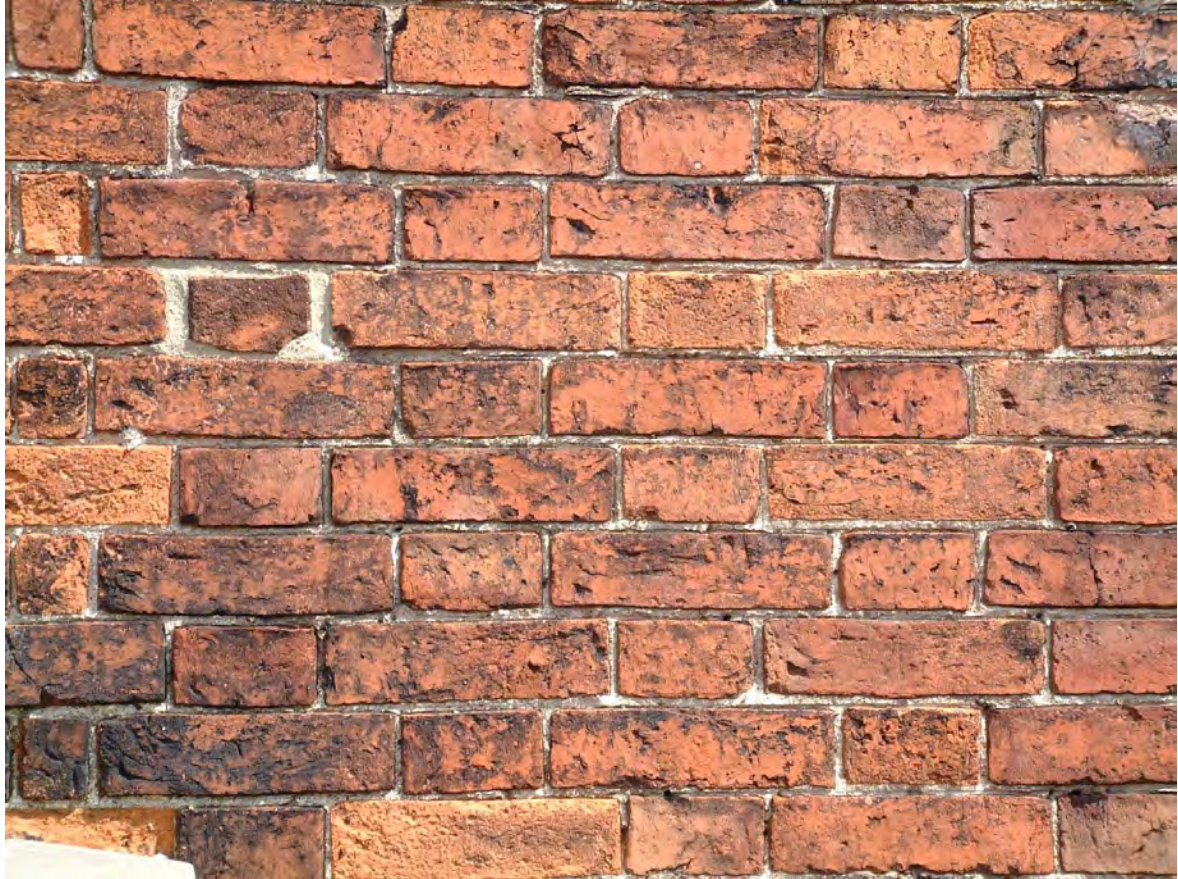
Flemish bond brickwork with penny-struck joint (above) can be found on both the farmhouses and smaller cottages.

The rounded, moulded bricks used to protect corners of buildings from physical damage (The Farm - right) are a local feature of several villages in South Derbyshire.

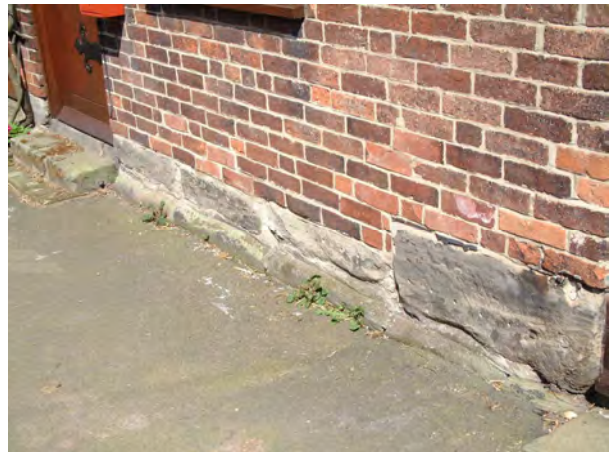
WALLS - Plinths

Milton has a number of brick buildings with a shallow stone plinth. In some cases this represents the rubblestone footings of an earlier building on the same site, but it was also adopted as a base for new walls (roughly coursed examples - right).

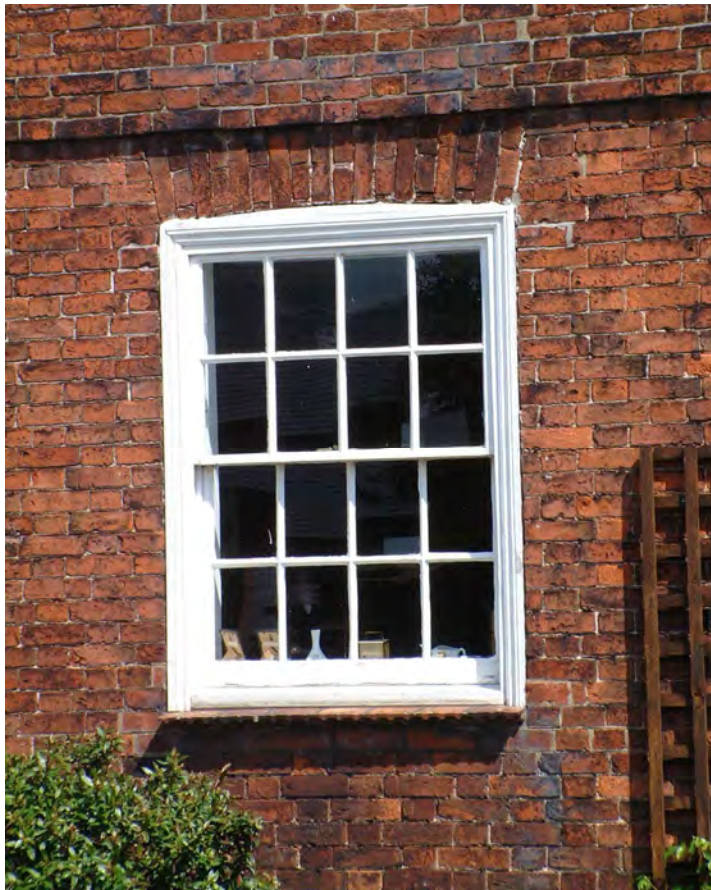
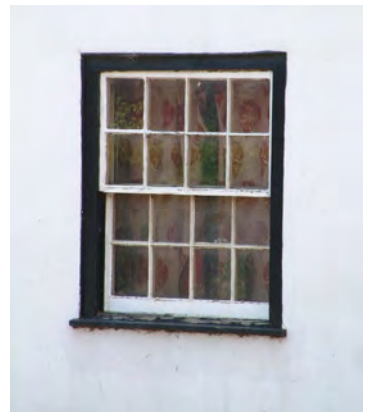
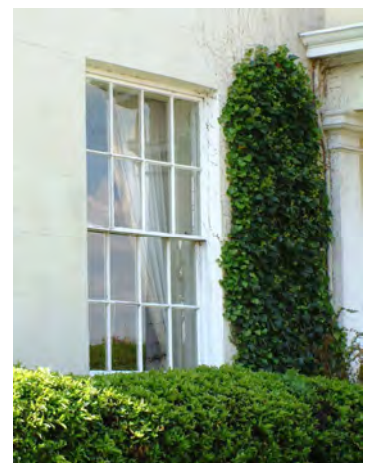
WINDOWS

Within Milton the main historic window types were vertically sliding sashes (below and below right) and timber casement windows, set within chamfered timber frames. There were also occasionally horizontally-sliding sashes, also known as Yorkshire sashes (above and bottom right). There are now few examples left of the once common casements. The example from The Farm (top right) is a recent copy of a traditional style.

Above - horizontally-sliding multi-paned Yorkshire sash

Below - vertically-sliding sash windows (8 over 8 panes)

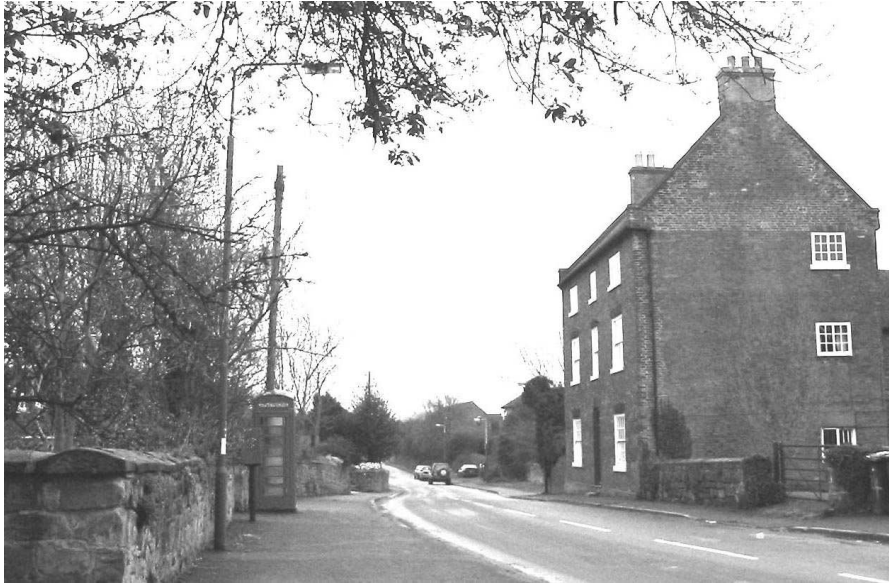
(grid ref. N 432, 059 / E 326, 471)

Below - Listed Grade II K6 red telephone box (Sir Giles Gilbert Scott Design) at the north side of entrance to Mill Farm.
