Lullington *Conservation Area* Character Statement

2010
CONSULTATION DRAFT

**SOUTH DERBYSHIRE
DISTRICT COUNCIL**

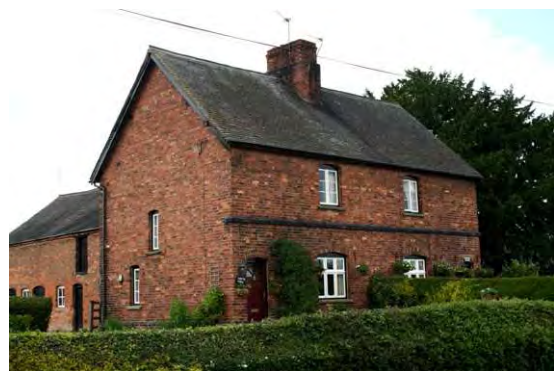
Creamery Cottage & South View, Dag Lane

New cottages were built between 1824 and 1880, such as the semi-detached pair on the north side of Dag Lane (Creamery Cottage and South View). Another example, Aubretia Cottage, Rose Cottage and Victoria Cottage, is a row of three dwellings built in 1831 by the Gresley Estate. They are built in a typical "cottage orné" style, where the identity of the three was disguised to look like one large cottage.

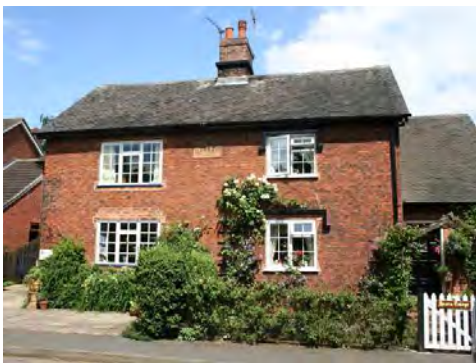
Haven Cottage & Cottage Two, 1847

In 1847 the semi-detached pair of estate cottages now known as Haven Cottage and Cottage Two were built. Another semi-detached pair, now called Ash Ley and The Hollies, was built around the same time.

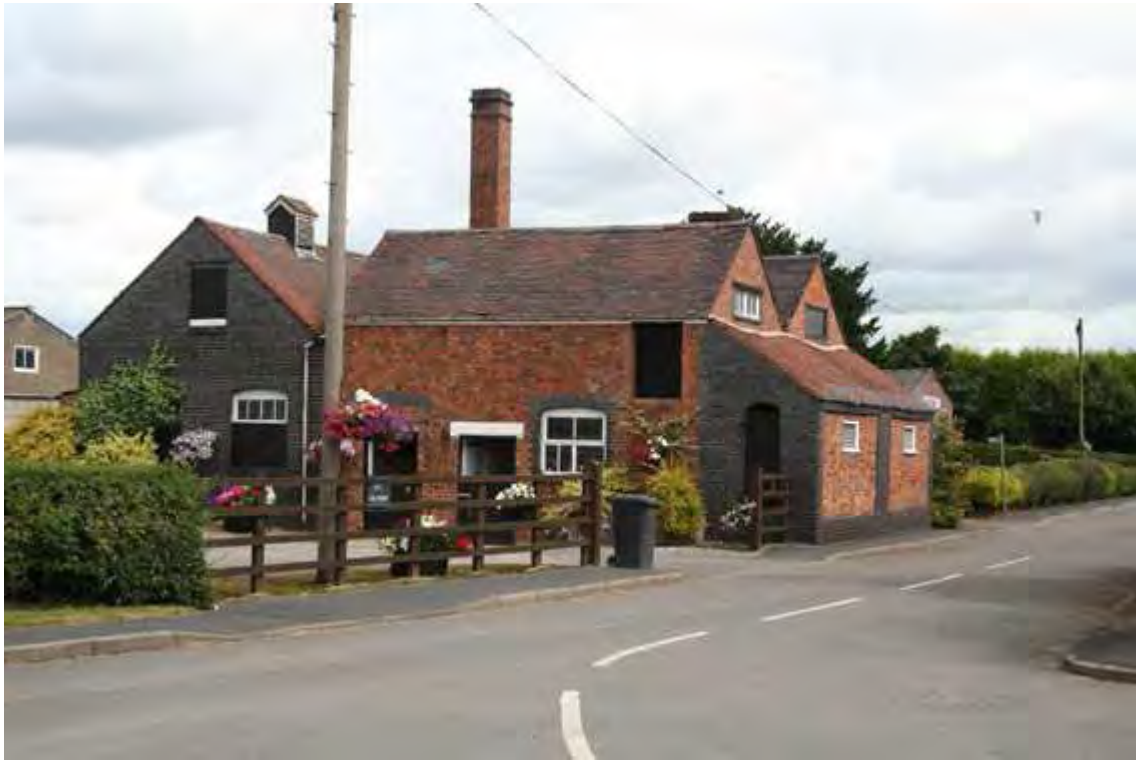
The Creamery, formerly the village gas works, Dag Lane

by a gas works (now The Creamery) and another row of allotments further south had been halved with the frontage occupied by Gable Cottage. The gas works installed by the Colvile family were one of several new innovations that they introduced. The gas works served both the Hall and the village. The Colvile family also built a water tower to the north of Lullington Hall, which enabled a gravity-fed supply of piped water to the house and a plumbed system for baths and water closets.

The gas works suffered a terminal breakdown in 1903 and was replaced by a Creamery, utilising most of the same buildings. This opened c1906 and capitalised on the local cheese industry, which was very well established in this part of Derbyshire.

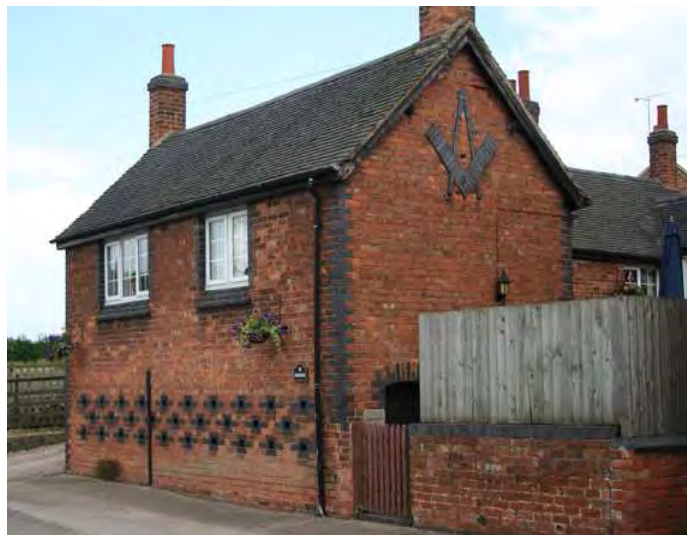
Opposite the Creamery, the Colviles were responsible for building the Wheelwright's shop (pictured below) and the Smithy which still bear the distinctive emblems of a square and compass and an upturned horseshoe laid in blue bricks in the gable ends.

Blue brick was used extensively by the Colville family on their estate buildings in combination with red brick, to great decorative effect. The most obvious examples are the Gas Works building, the Wheelwright's shop and the Smithy, all situated at the west end of Dag Lane. Together they form an important group of purpose-built utilitarian estate buildings. In addition to the motifs of the carpenter's square and compass and the horseshoe, blue bricks were laid to create ventilation patterns and as a plinth.

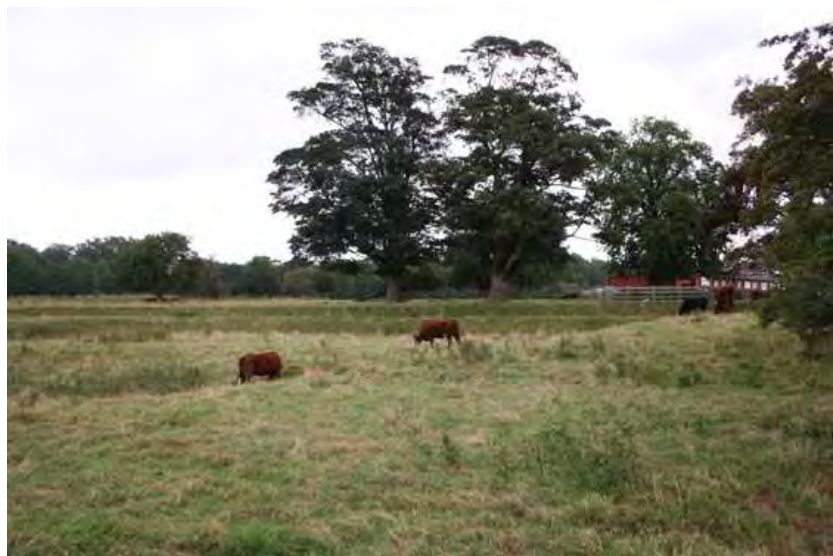
Terraces and earthworks within Lullington Park

A series of terraces exist to the west of the cricket pavilion, with a coursed stone wall separating them from the open countryside and parkland beyond. The structure of these terraces indicates an ambitious scheme for a terraced garden, designed to sit beyond the building platform for a new house, which would overlook the panoramic views to the south-west.

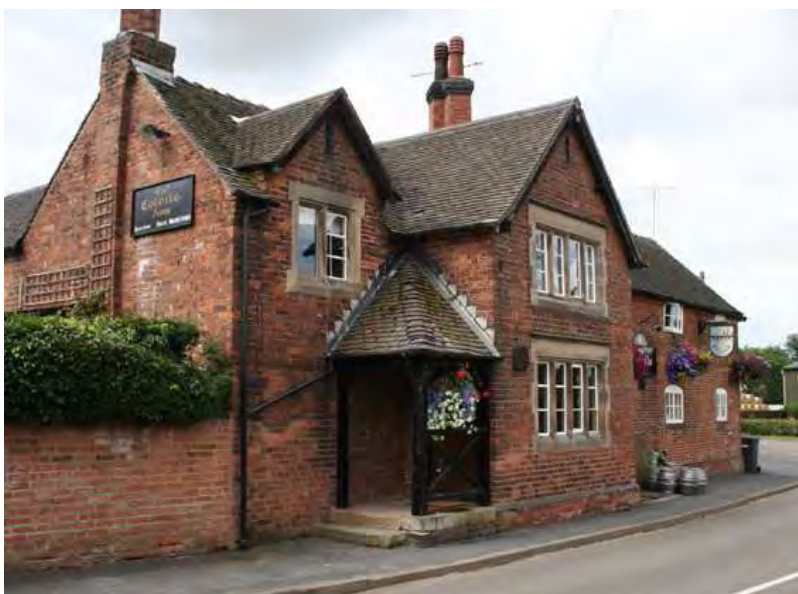
The Colville Arms - picturesque Victorian Gothic extension with stone mullioned windows

Doors would often be placed on the side walls so that the immediate impression was of one large cottage, rather than two, and so that the locals would not be seen at first glance going about their business. The later fashion for an asymmetrical appearance can be seen in the extension to the Colville Arms.

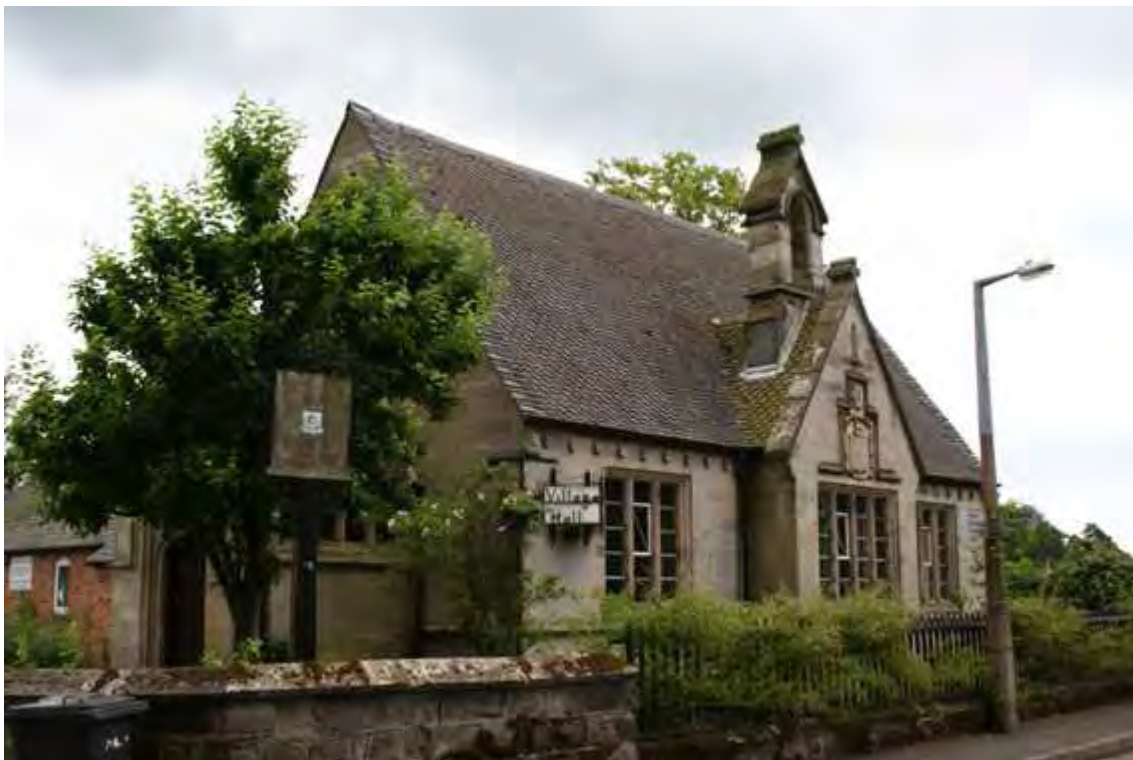
The cottages built by the Colvile estate were quite simple, compared with other estate cottages in local villages, and avoided the use of many expensive embellishments, such as rustic porches and ornate timberwork. The Village Hall (pictured below) is exceptional and beautifully detailed with carved stonework and was probably designed by an architect.

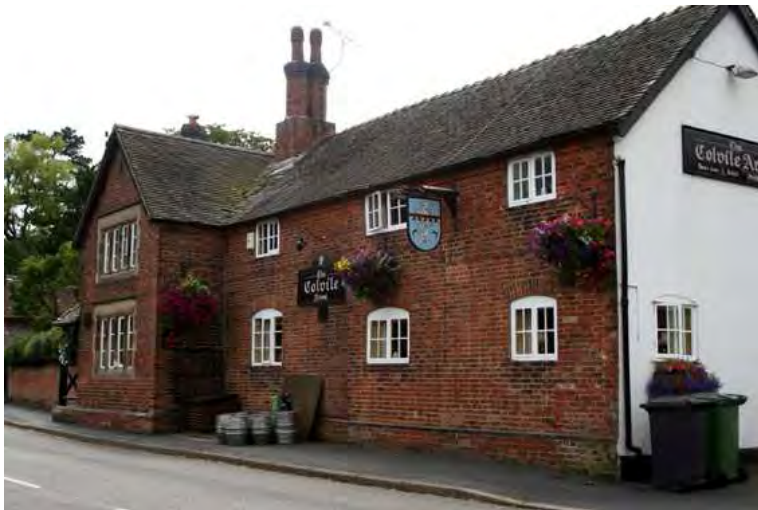
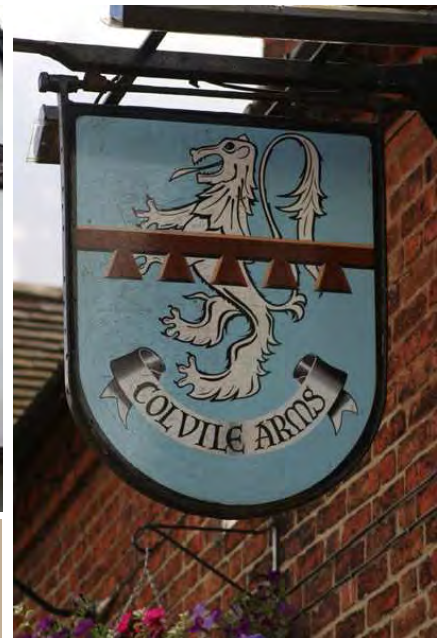
The Colvile Arms (above and right) - 18th century brickwork incorporating dentilled eaves

Brickwork was used in the 18th and early 19th century for structural details such as corbelled eaves, some plain with several courses of brick projecting one above the other or “dentilled” brickwork, where each alternate header brick projects to create a decorative effect. An example of dentilled brick eaves can be seen at The Colvile Arms. At Lullington Hall the bricks at eaves level were corbelled out and laid diagonally to produce a “sawtooth” pattern, a pattern also repeated on one of the outbuildings. The same outbuilding incorporates a decorative stepped brick verge on the gable end.

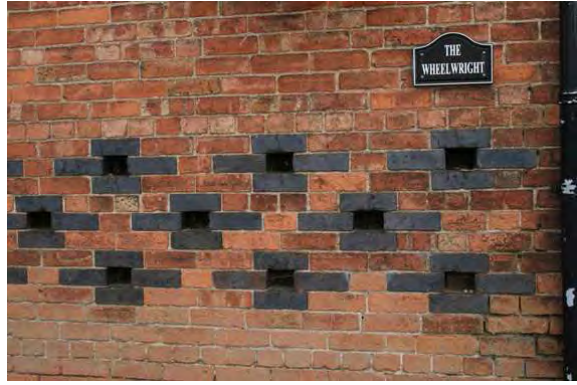
Blue bricks were laid to form a “string course”, a decorative horizontal band on the front of the contemporary pair of cottages on Dag Lane and were incorporated as oversailing courses on many of the chimneys within the village and occasionally as a coping, as at the kitchen garden walls.

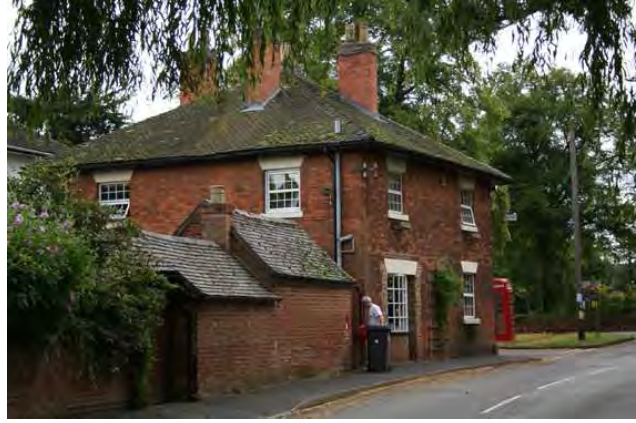
A number of roofs in Lullington are hipped and tiled with bonnet tiles, as at The Grange and The Old Post Office (pictured right). Another hipped roof at Lullington House was finished in Welsh slate, the only example of its use.

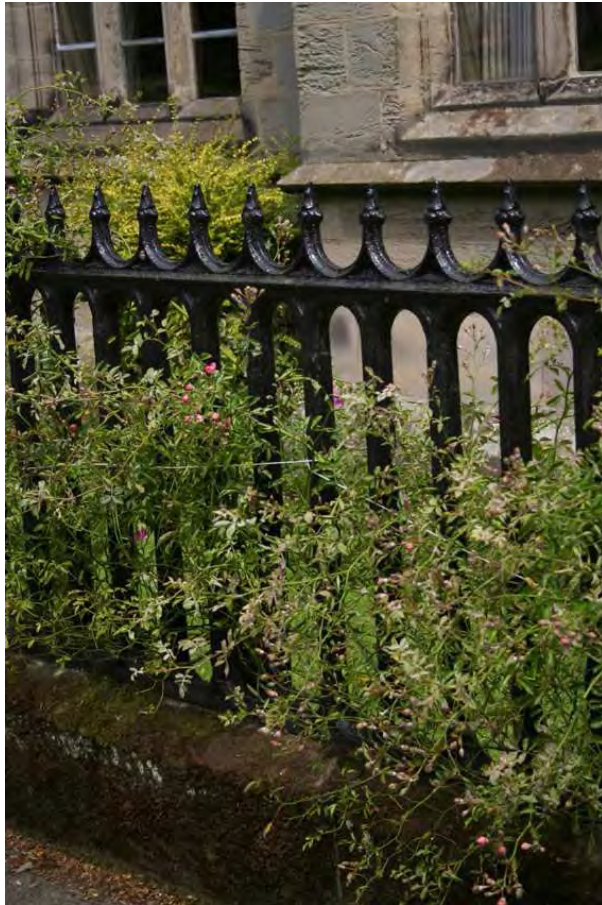
Right - estate railings of five-bar horizontal rails with simple posts, in wrought iron or steel, can be found surrounding sections of the old Colvile parkland estate.

The introduction of cast-iron enabled railings to be produced more cheaply in panels and the amount of ornamentation increased. By 1830 cast-iron had largely replaced wrought-iron because it lent itself to mass production.

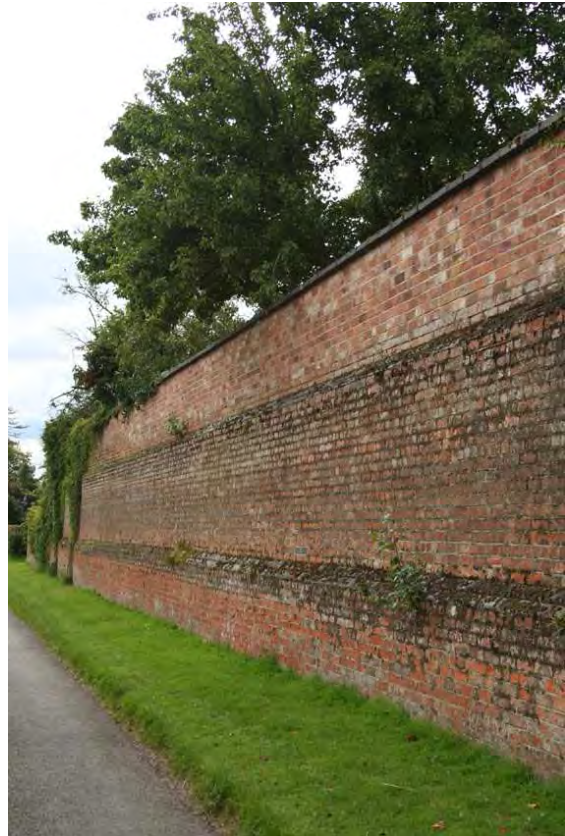
Tall, brick wall with chamfered moulded blue brick copings and weatherings at the kitchen garden (above), Clifton Road.

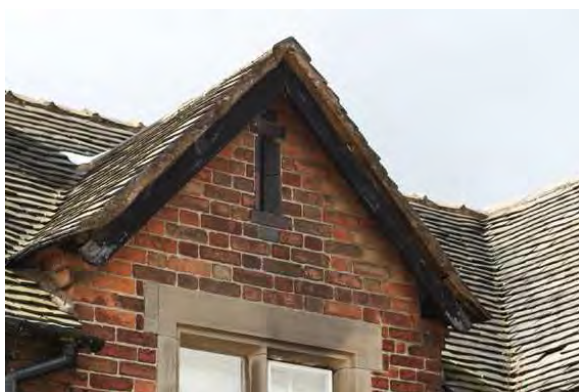
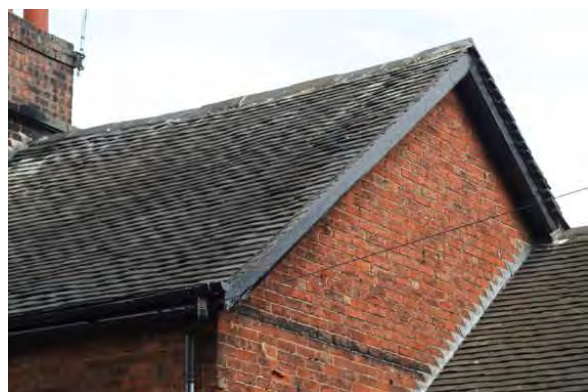
Below left and right - steep pitched roofs with overhanging verges and plain bargeboards, at Colvile Arms (left) and Haven Cottage (right).

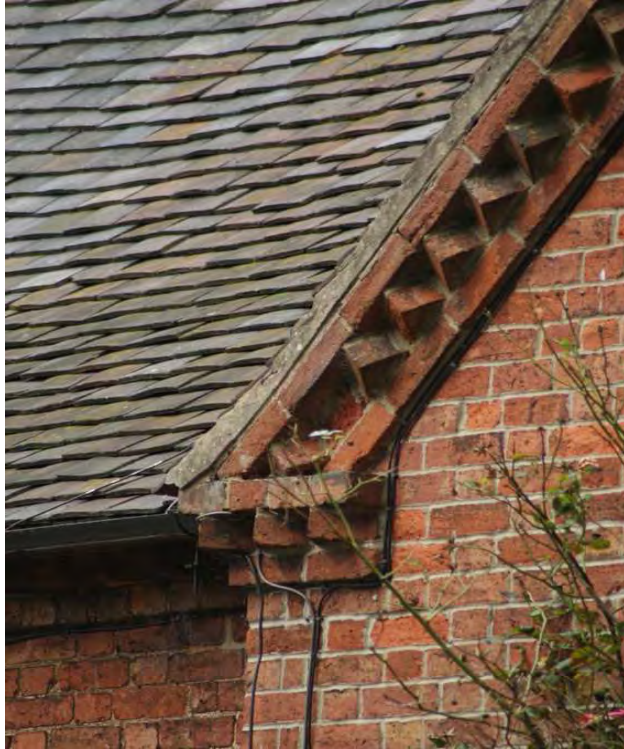
Above - sawtooth and corbelled brick eaves and verge creates a dramatic, detailed profile at Rose Cottage.

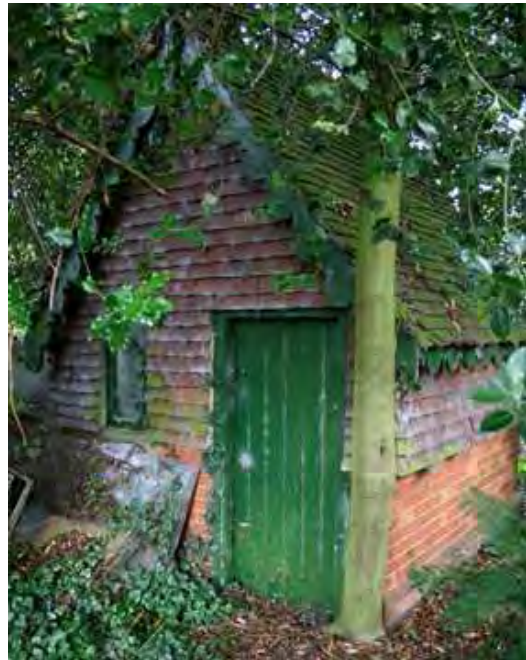
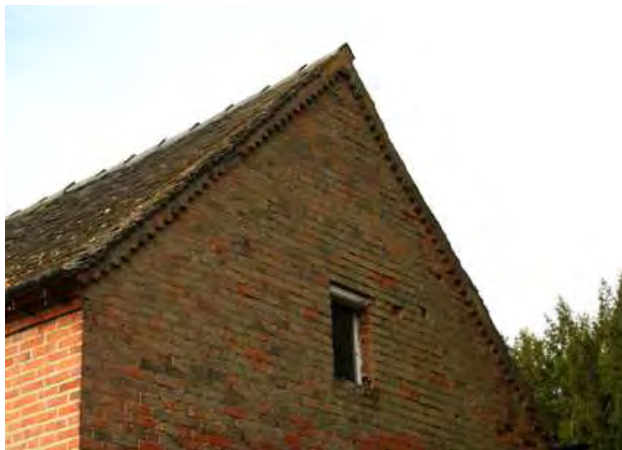
Below - decorative scrolled bargeboards and tile-hung walls at the late 19th century well-house at Lullington Hall.

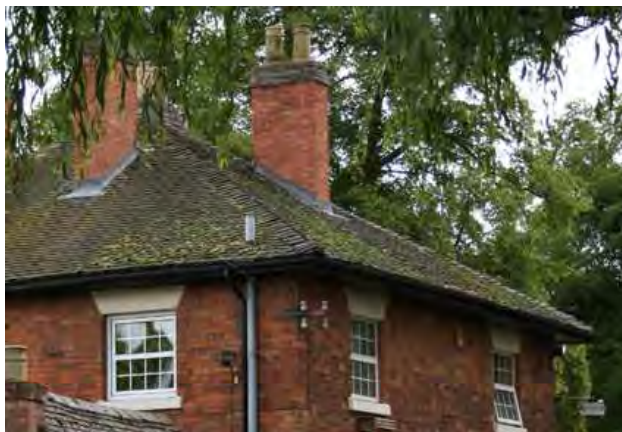
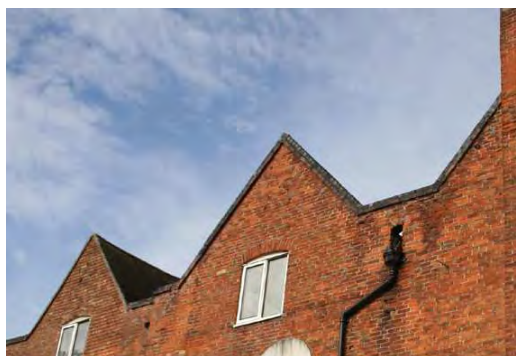
Left - one of the oldest surviving roof types is the pitched roof with stepped brick verge, at Lullington Hall, a detail that is also found in nearby villages.

Above - another old roof type is the raised coped brick gable, also found at Lullington Hall.

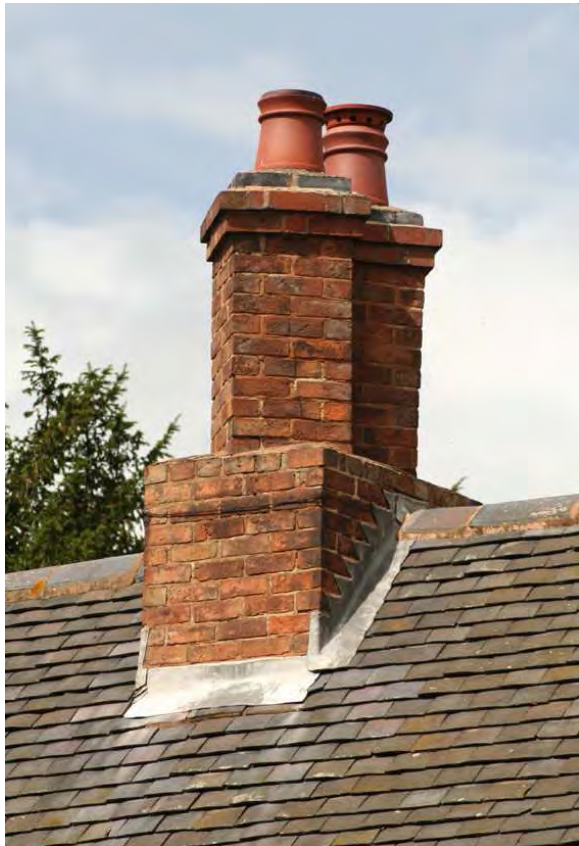
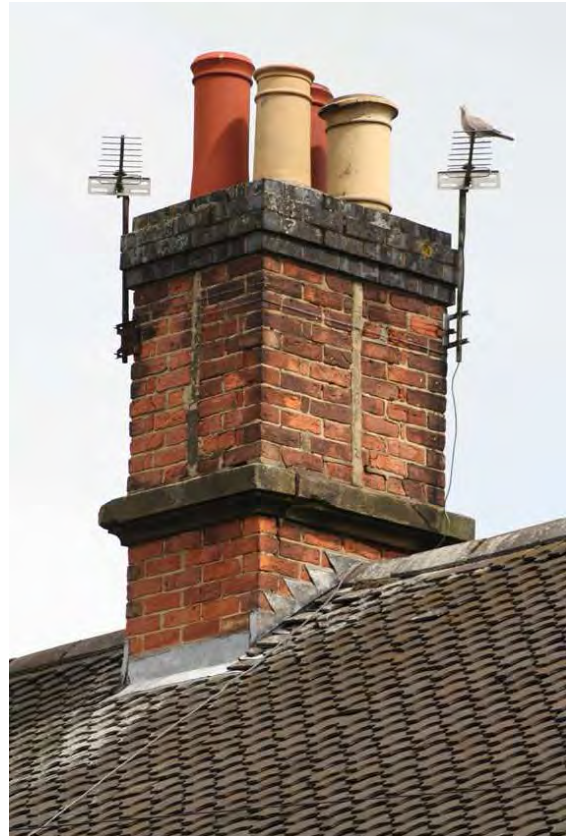
Chimney stacks set on a diagonal (top left) and engaged stacks with individual flues (top right) are amongst the oldest surviving styles of chimney, used on the “estate” cottages.

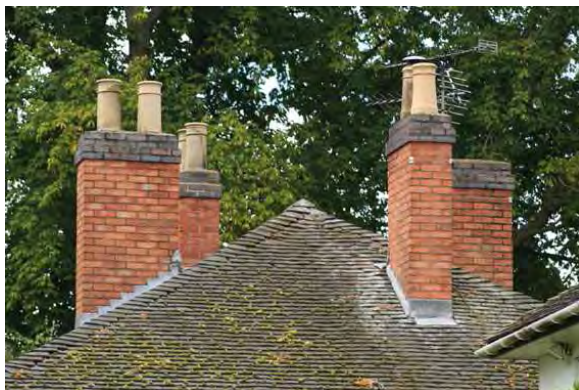
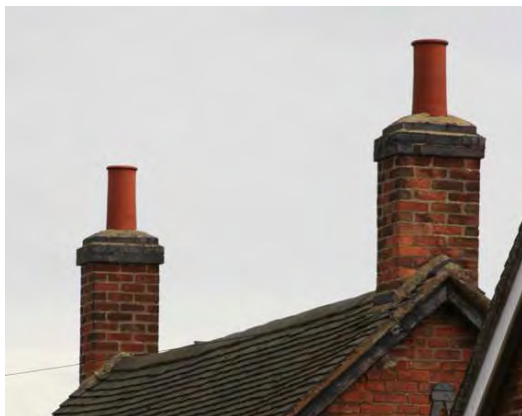
Later chimney stacks also adopted the same pattern of diagonal set flues (Colvile Arms - bottom right) and many incorporate blue brick oversailing courses (left, bottom left and right).

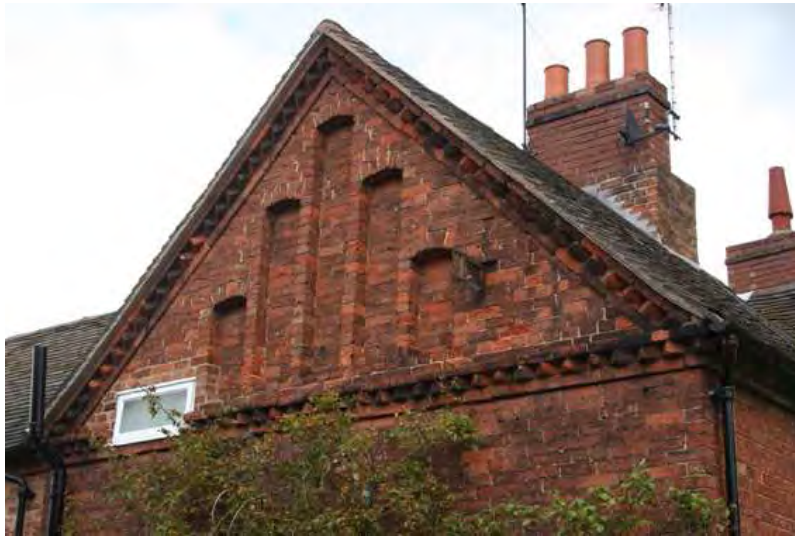
Left - decorative recessed panels of brickwork, with corbelled, "sawtooth" verges and eaves (Aubretia Cottage of 1831).

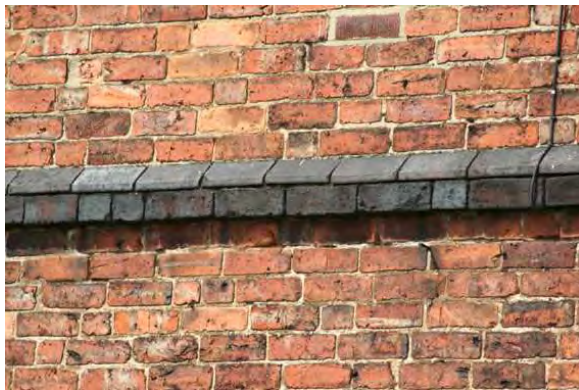
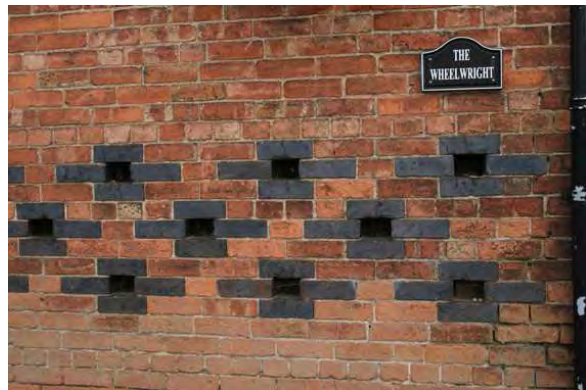
Below - blue bricks were used to emphasise ventilation holes at The Wheelwright.

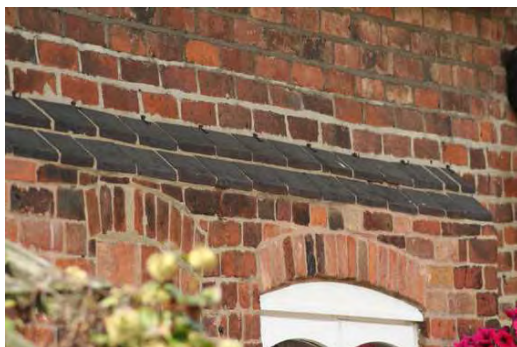
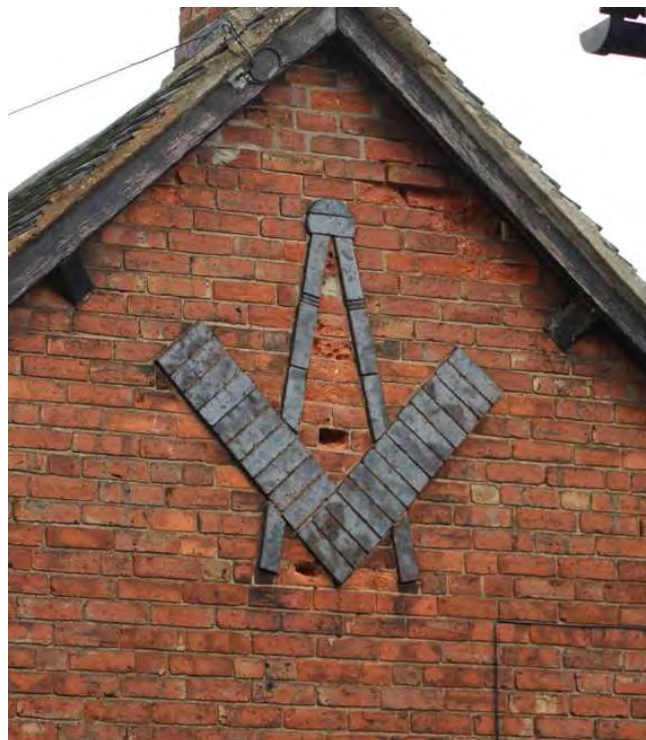
Right - blue bricks create a "square and compass" at The Wheelwright .

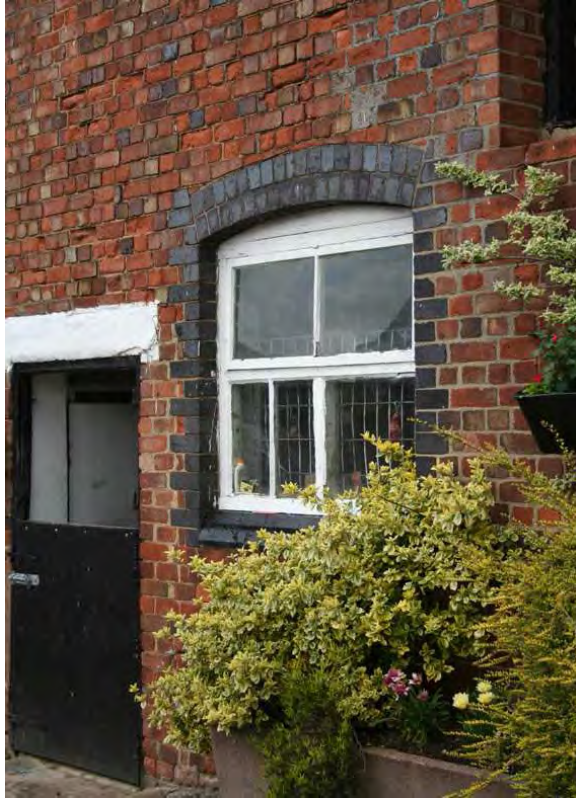
Above left - segmental blue brick arch, with blue brick reveals and moulded brick cill at The Creamery.

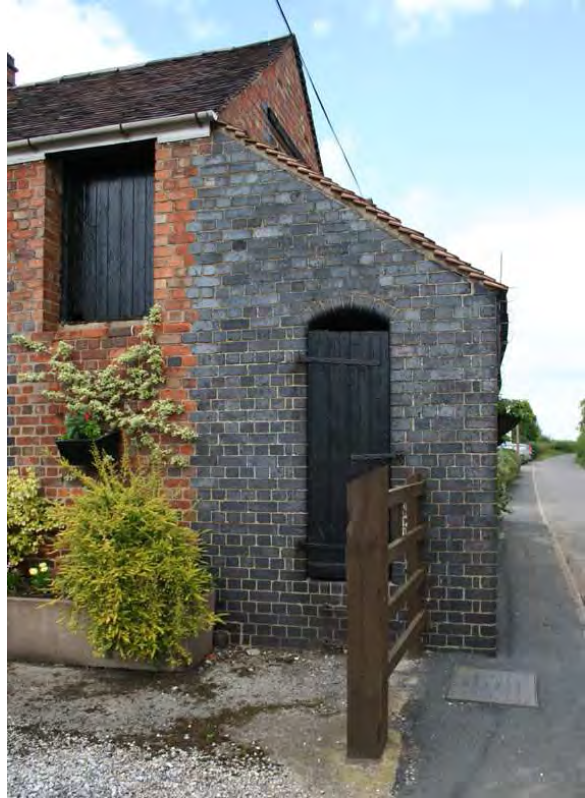
Above right - blue bricks with rounded moulded bricks adopted for the corners, where there was greatest potential for wear, at The Creamery.

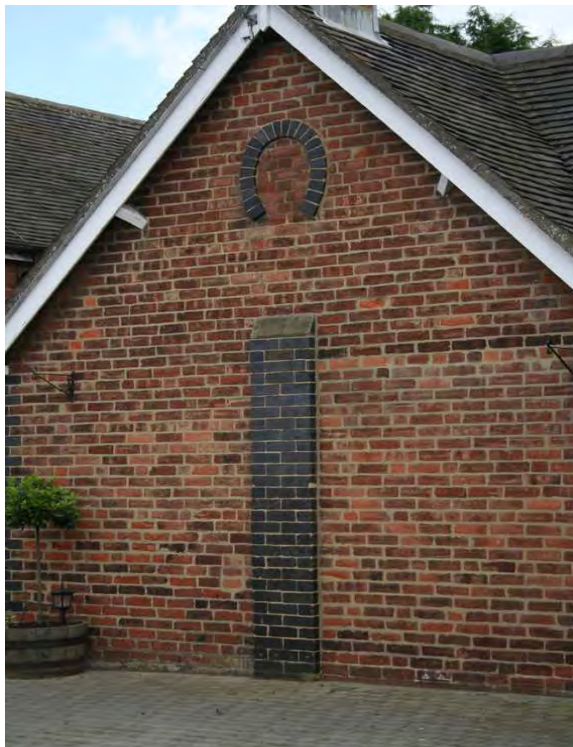
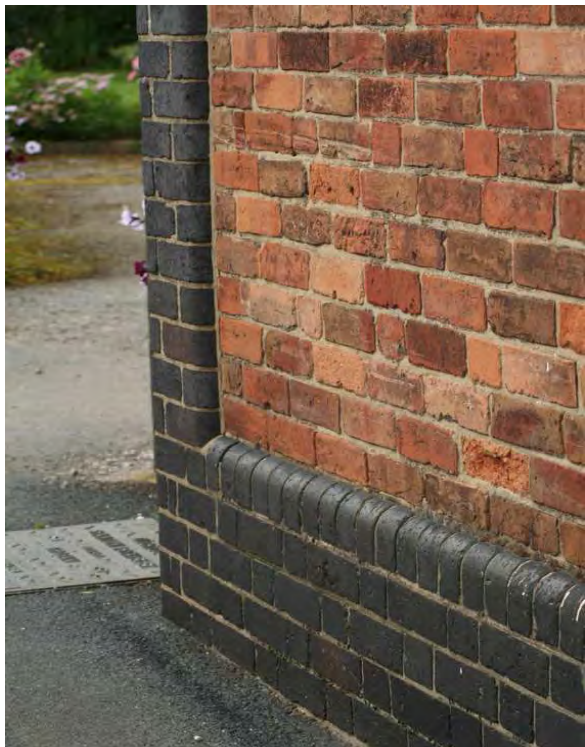
Below left - horseshoe and buttress in blue bricks at the former forge and below right - moulded blue bricks were used for the plinth and pier at The Creamery.

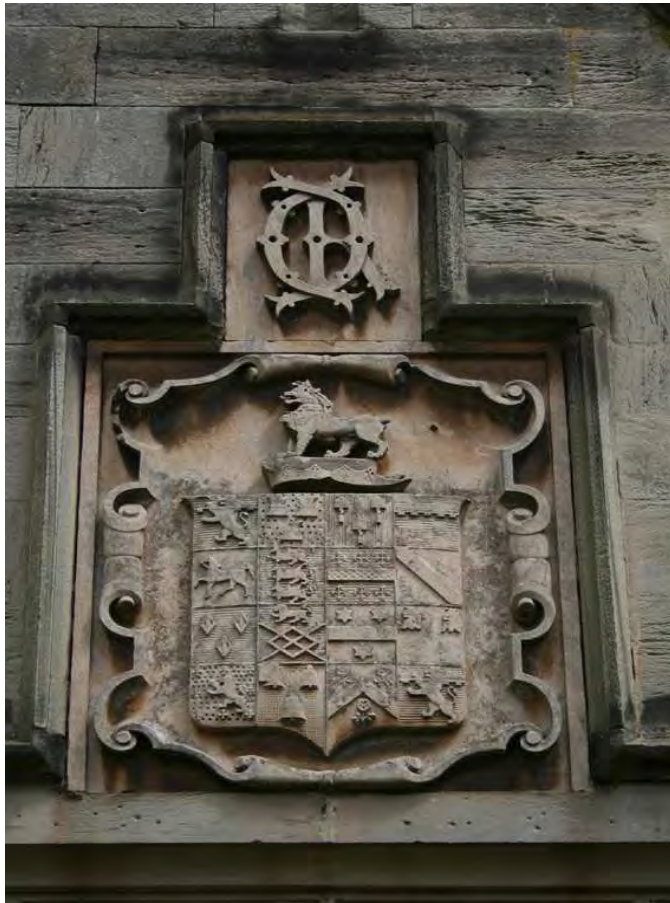
Above - coat of Arms and monogram of C R Colvile at the former village school.

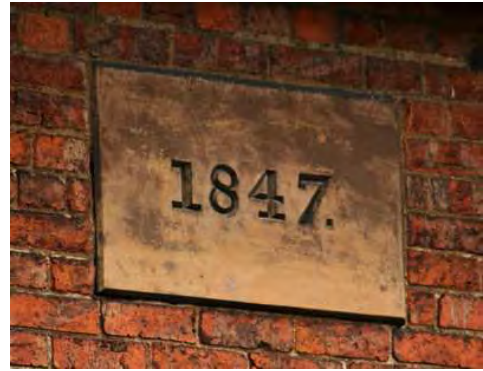
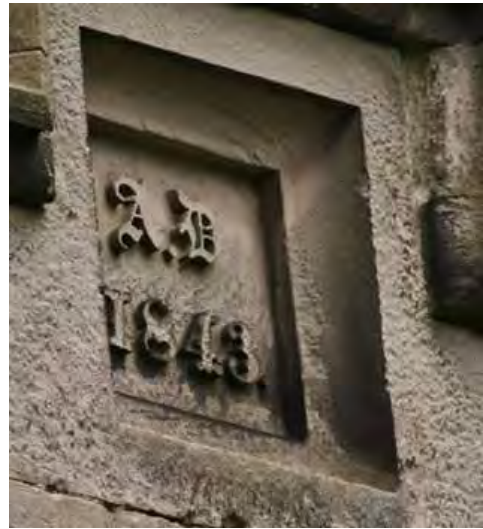
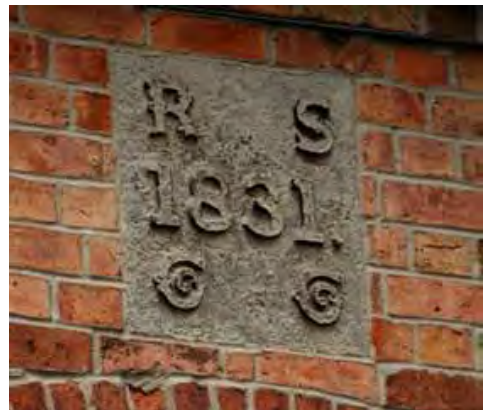
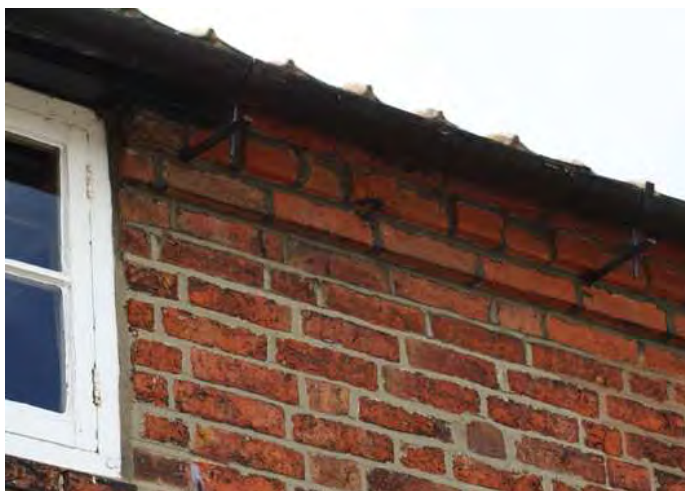
Right - 19th century datestones on buildings erected by the Gresley and Colvile families.

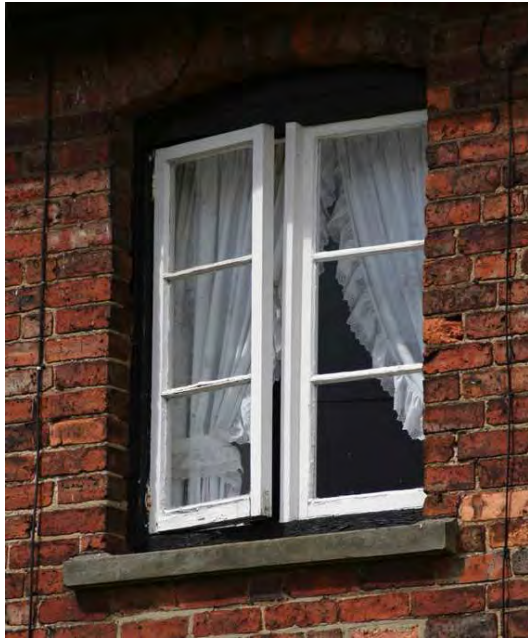
Above - side-hinged timber casements recessed within chamfered frames at Creamery Cottage.

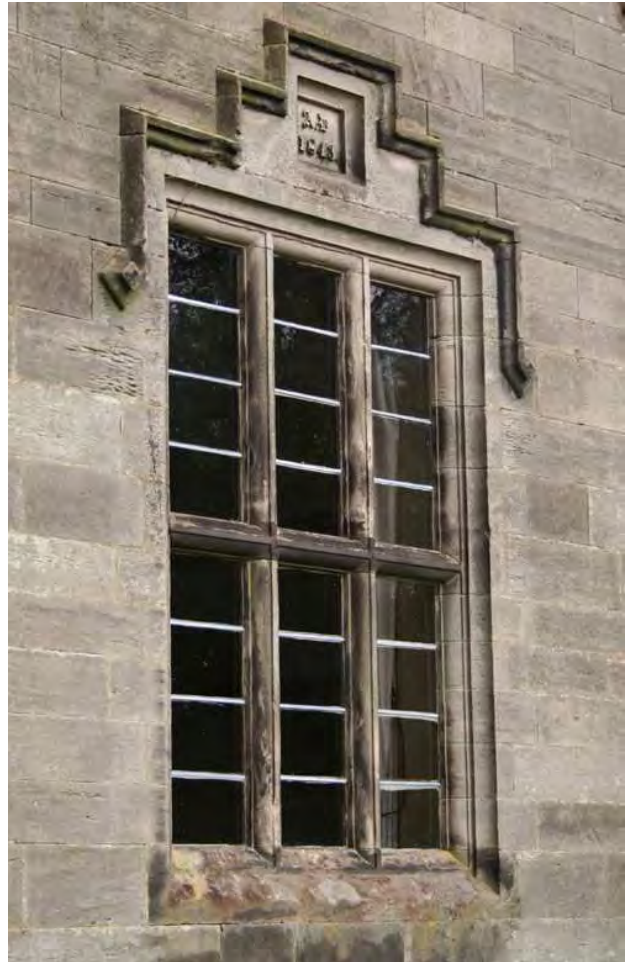
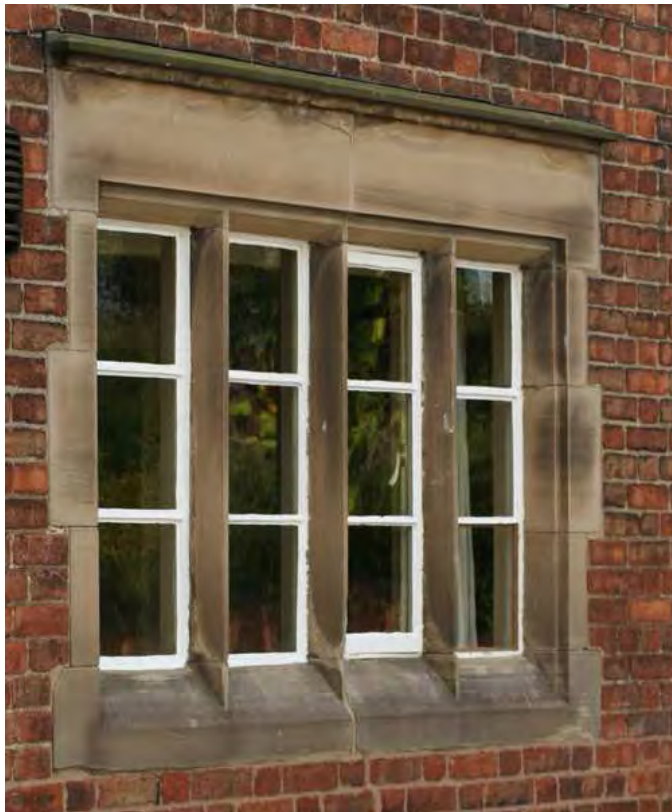
Metal casements at the Village Hall (right) and Colvile Arms (below).

During the 19th century metal casements were often used as they could be made with narrow frames and sat neatly within stone mullioned windows.

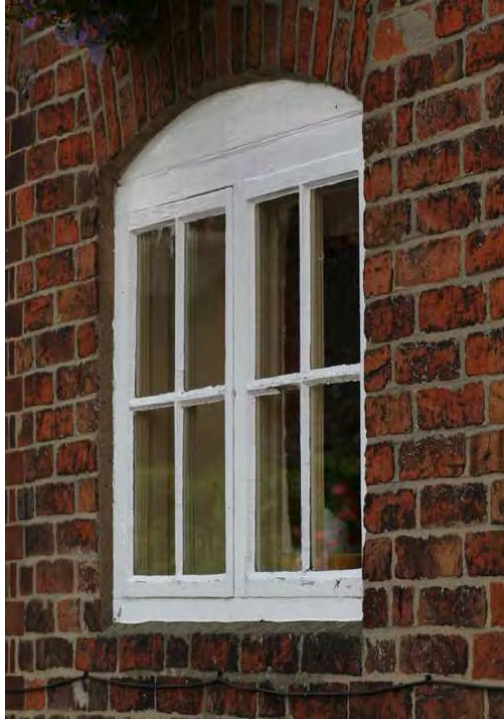
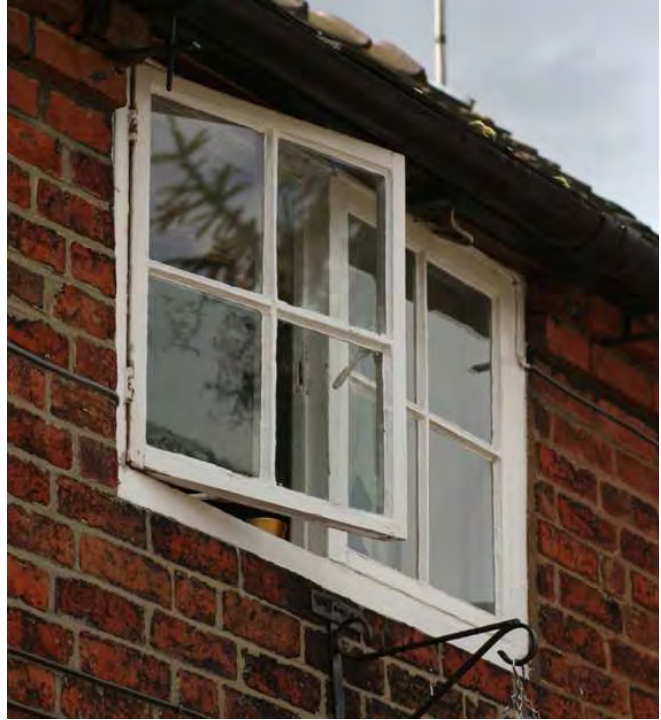
Above - multi paned timber casements at the Colvile Arms. Casements are fitted flush with the frame, which is fixed about 30mm from the face of the brickwork. There are no cills, relying instead on the weathering properties of the brickwork.

Large panes of glass were a desirable commodity, as the production of cylinder glass improved. The examples illustrated on this page are typical of their mid 19th century period. It was only much later in the 19th century that small-paned leaded-lights had a revival.

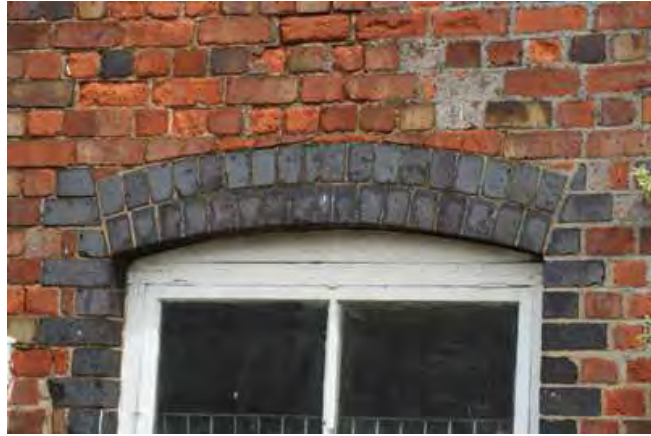
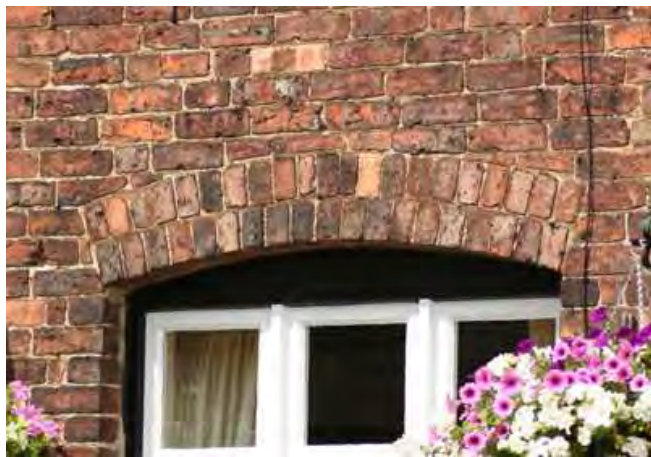
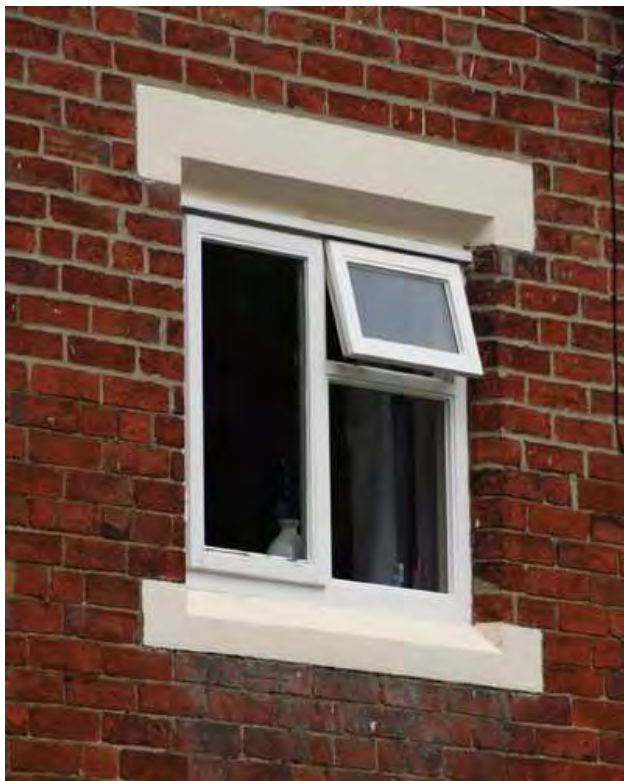
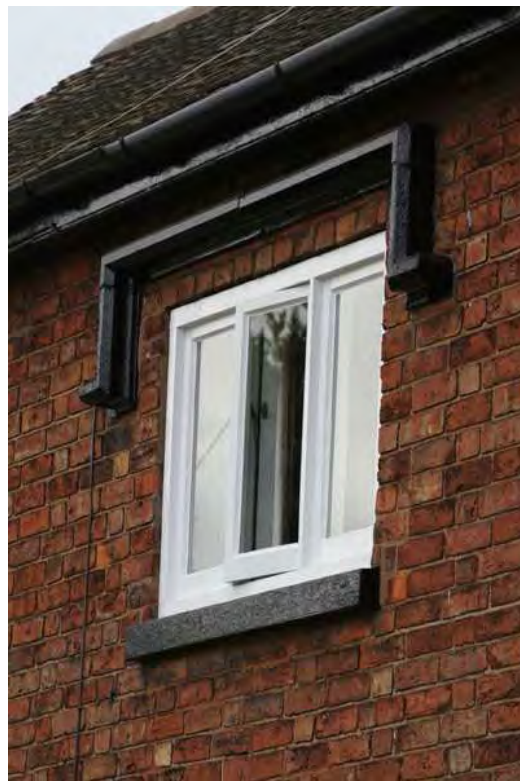
Where economy was important, lintels were simple in form. A segmental brick arch was commonly used, particularly for utilitarian buildings. The segmental arches at The Creamery (top right) and Creamery Cottage (bottom right) were formed from two courses of “header” bricks.

During the 19th century, imported stone was commonly used for lintels and cills. Stone was moulded with chamfers (above left - Gable Cottage) and hood moulds (above right - The Hollies).

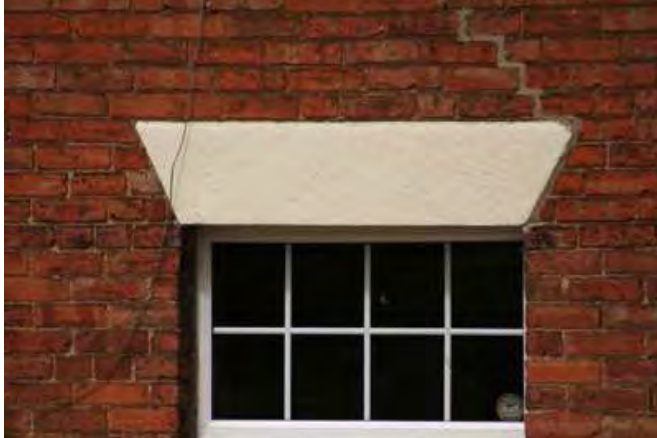
Wedge-shaped stone lintels started to appear in the first half of the 19th century, as at The Old Post Office (left) but by 1860 wedge lintels had largely disappeared from general use.

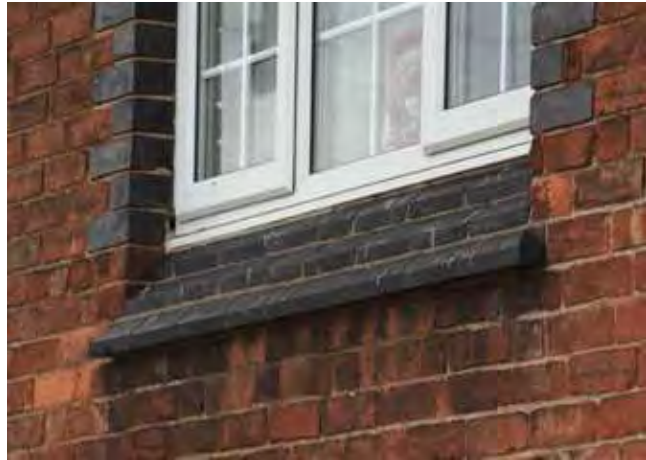
Many of the smaller cottages had no cill but later in the 19th century moulded blue clay bricks were used to create a more weatherproof detail (right).

Many of the buildings that incorporate moulded stone lintels also have stone cills (see examples above).

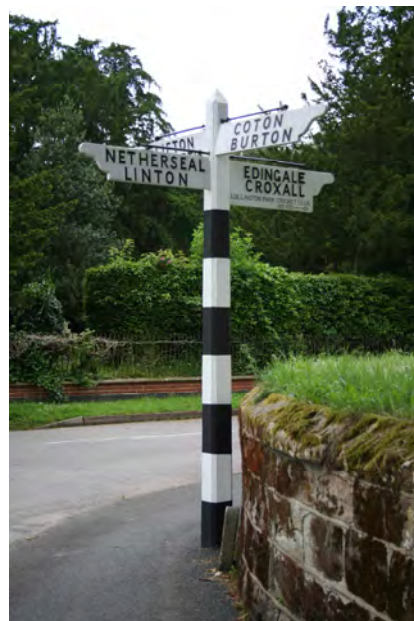
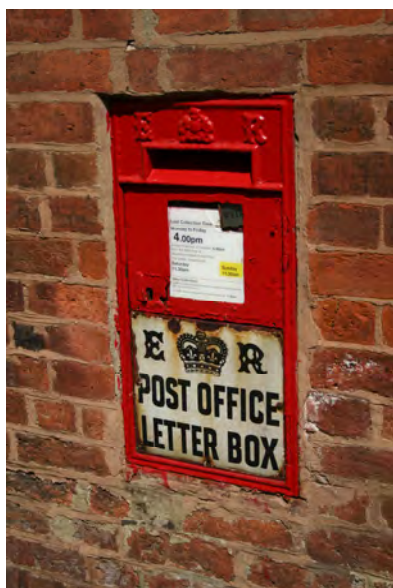
(grid ref. N 425, 018 E 312, 999)

Left - Rare Edward VII Ludlow type timber and cast iron wall-mounted letter box with enamelled lettered plate located on side wall of The Old Post Office.

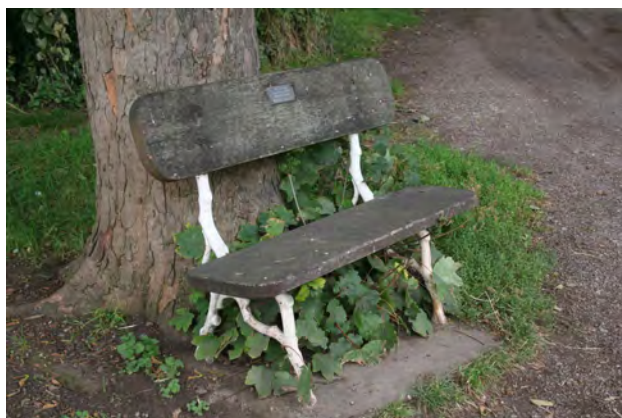
(grid ref. N 425, 129 / E 313, 018)

Above - cast iron and timber rustic bench, commissioned and erected by R Cooper (20th century) at entrance to Limes Farm.

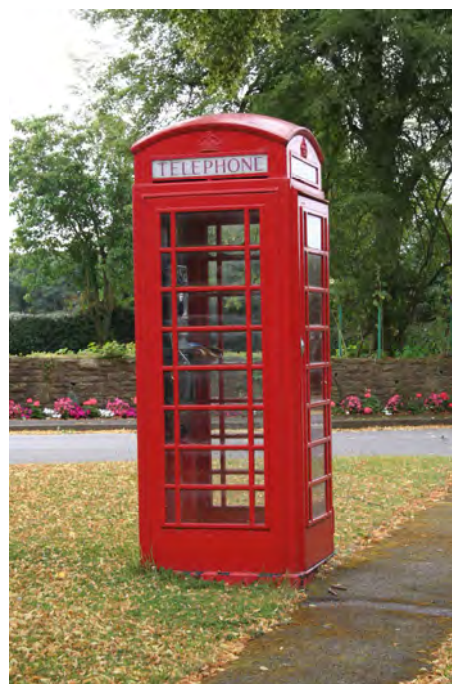
Above - K6 telephone box (unlisted), original design by Sir Giles Gilbert Scott on village green opposite The Grange.
