# Woodhouses *Conservation Area* Character Statement

**2013**  
***CONSULTATION DRAFT***

**SOUTH DERBYSHIRE  
DISTRICT COUNCIL**

## Introduction

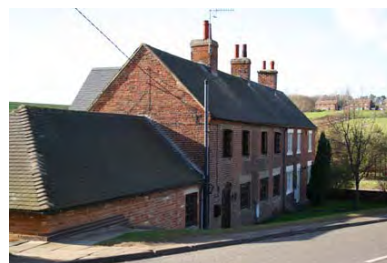
Woodhouse Farm (pictured left) marks the site of another of the original three encroachments. In 1789 the Melbourne Estate acquired the property, then divided into three cottages, and turned it into a small new farm. In 1884 the house and farm buildings were rebuilt. The farmhouse was built to front the new road and the range of L-shaped farm

buildings at its rear incorporated an earlier stable and loft of 1859.

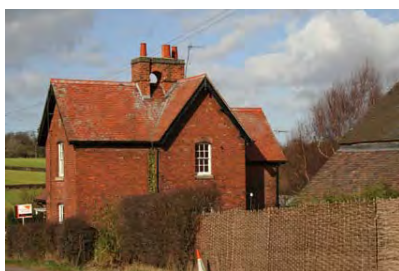
There were three dwellings at first. The terrace of two cottages (formerly three) at the bottom of the hill, to the west of the main road, are situated on the site of one of the three original dwellings and was built circa 1780 by Richard Webster of Calke. The terrace predates the road by a few years, explaining the awkward non-parallel alignment (pictured right).

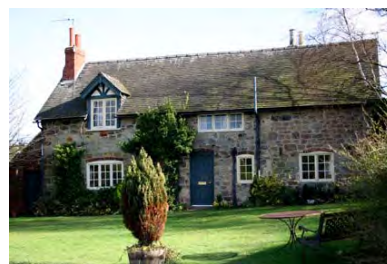
Woodhouse Farm Cottage (pictured right) marks the site of the third original encroachment. By the 18<sup>th</sup> century it had become part of the freehold estate of the Earl of Huntingdon. It was substantially rebuilt in the 19<sup>th</sup> century.

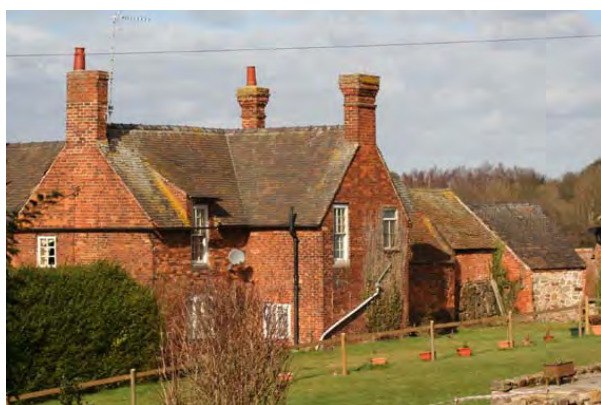
*Tutholme*

The hamlet expanded up the hill during the 17<sup>th</sup> and 18<sup>th</sup> centuries. The remains of a timber-frame structure exist inside Tutholme, probably early 17<sup>th</sup> century in origin. The section of coursed stone at The Malthouse, which incorporates a stone band and plinth, also indicates 17<sup>th</sup> century origins.

Raised raking dormer windows were added to Tutholme (pictured right) and The Malthouse in conjunction with tall sash windows. This is a quirky, late 19<sup>th</sup> century detail seen elsewhere on the Melbourne estate. More common in the area around Melbourne is the use of a gabled dormer, as seen at Common Farm Cottage and Woodhouse Farm Cottage. These were added in the late 19<sup>th</sup> century. The same half-timbered detail seen at Woodhouse Farm Cottage can be seen on several estate properties in Melbourne, where the estate architects Messrs. Evans and Jolley of Nottingham updated many of the estate buildings at around this time.

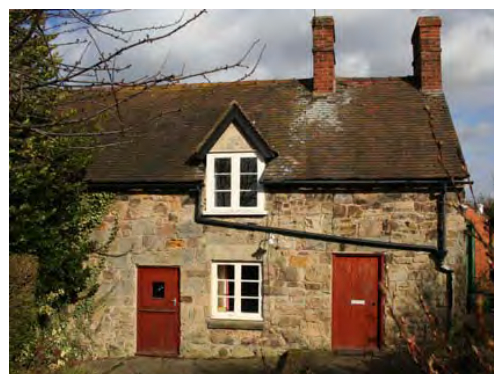
Only two properties relate directly to the main road; the semi-detached pair known as Pool Farm Cottage and Common Farm Cottage (pictured right) and Woodhouse Farm. The pair of cottages at the top of the hill was built before the 1789 road, and probably faced the track that linked Woodhouses with the Melbourne to Ashby road.

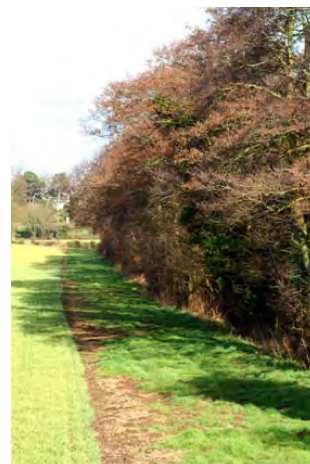
The land dips down to the New Brook (previously Melbourne Brook) at the bottom of the valley. This now follows a straight, man-made alignment although its previous meandering course can be seen on the parish plan of 1790 and other plans. It was straightened in the 1840s when the Melbourne estate carried out an ambitious landscaping scheme to remodel Melbourne Pool. In association with the straightening of the brook, the meadows alongside were irrigated to create the fields we now see alongside the brook. The brook defines the edge of the conservation area and its course is now emphasised by a tall, linear row of alder, lining its banks (pictured right) and running all the way from just below Woodhouses bridge, as far as Melbourne Pool.

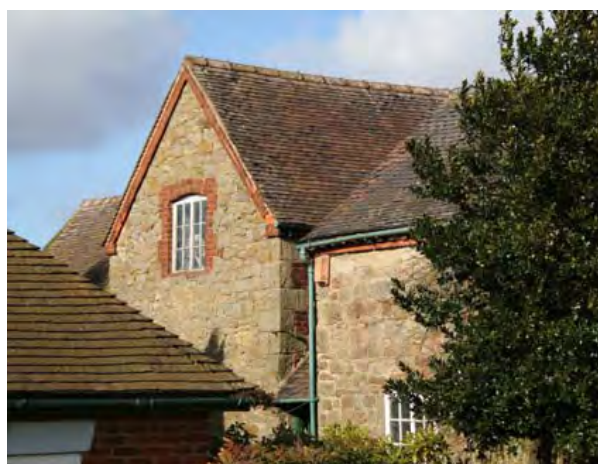
*Pool Farm - mellow tones of local stone, finished in brickwork to form straight eaves and verges*

The buildings within the hamlet are built from a mixture of soft, orange-red brick and mellow rubble sandstone. There are places where multiple phases of building evolution survive represented by both stone and brickwork. Good examples of this fragmented building form are The Malthouse and Woodhouse Barn, where for practical economy the earlier stone buildings were adapted and absorbed into later phases of brickwork, creating a rich surface texture and pattern.

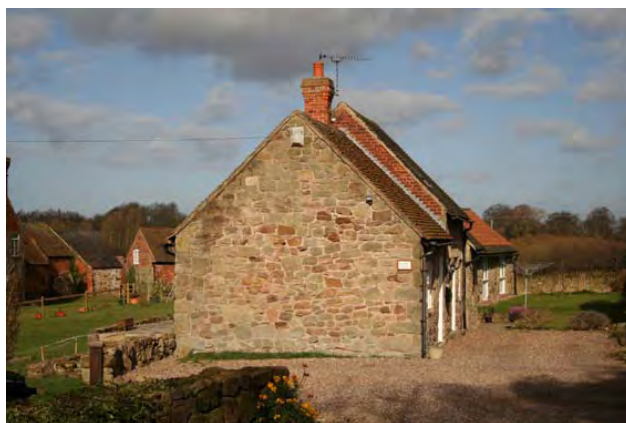
The vast majority of roofs are tiled with plain clay tiles. These are divided between early, red, hand-made clay tiles, of which there are a number of examples, and later replacement Staffordshire blue clay tiles. The hand-made red clay tiles incorporate subtle curves and undulations and add a subtle texture to the roofs. From the late 18<sup>th</sup> century hand-made Staffordshire blue clay tiles were imported into the area along the Trent and Mersey Canal from

the Potteries. These are extremely durable tiles and survive where the red clay tiles have failed. Bands of geometric fish-scale tiles can be found on the old farmhouse at Pool Farm. In the last quarter of the 19<sup>th</sup> century plain clay tiled roofs were in fashion again, for their “vernacular” associations, although most were machine-made. Red clay “Rosemaries” can be found at Woodhouse Farm, from J. C. Edwards' Ruabon brick and tile works.

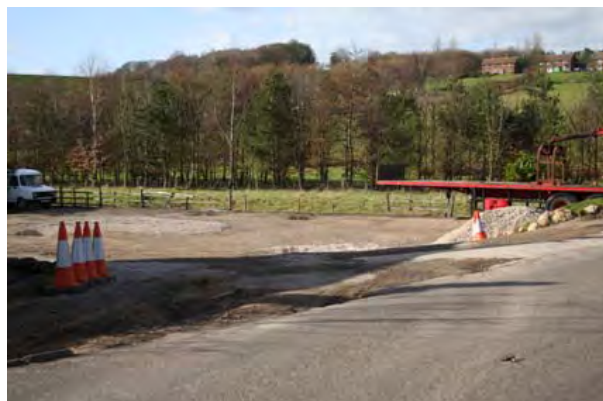
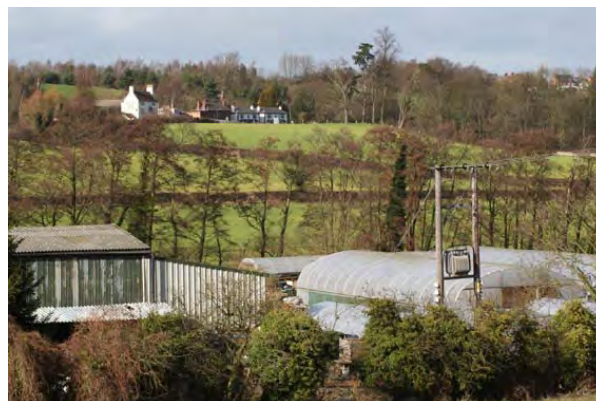
The hamlet has had a working character all of its life and it is still dominated by agricultural and horticultural practices. Modern methods of farming and market gardening come with an assortment of buildings and equipment, most transportable and temporary by nature – e.g. polytunnels, machinery, mounds of used tyres. The lorry park and its ancillary structures, sheds, hardstanding and vehicles at the foot of the hill is prominent in views at the entrance to the conservation area and the large quantity of hardstanding is detrimental to its agricultural character.

*Left - the lorry park at The Cottage*

*Right - view of The Melbourne Arms on the B587 over the polytunnels at Woodhouse Farm Nurseries*

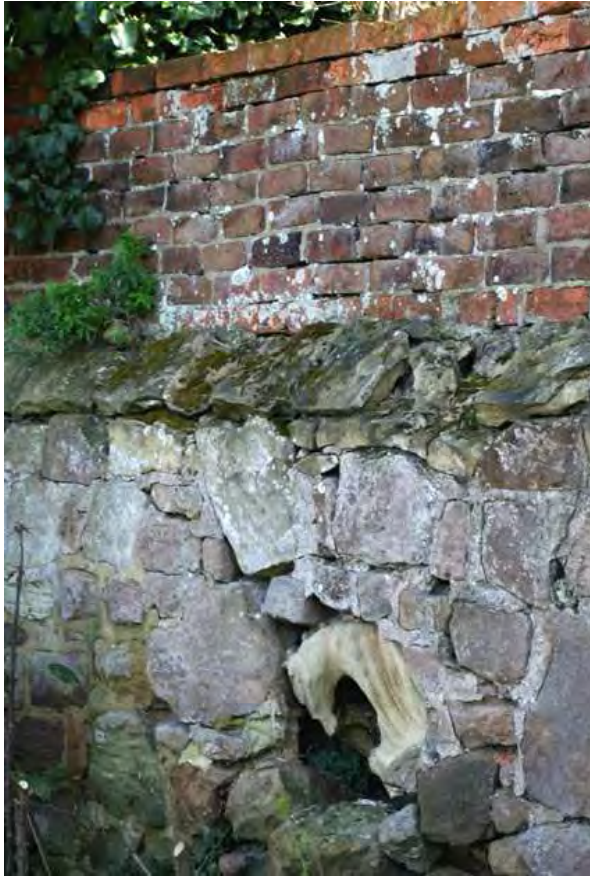
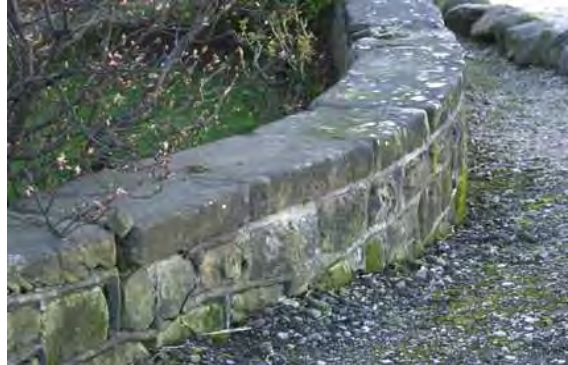
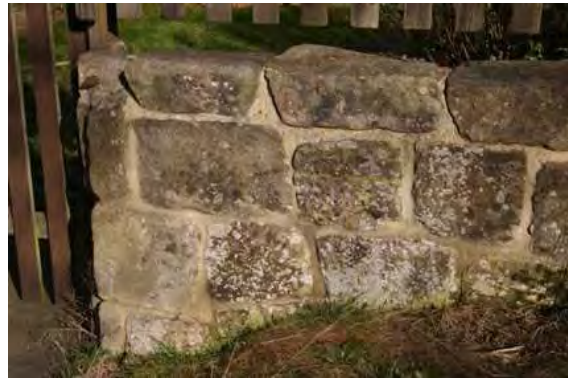
### **Boundary walls**

Above left - rubble gritstone with triangular coping, later raised in brick (Tutholme).

Bottom right - coursed gritstone wall with flat stone coping (Common Farm Cottage).

- Stone walls of rubble gritstone with triangular or squared flat copings
- Hedges of 20th century shrubs, e.g. privet and copper beech

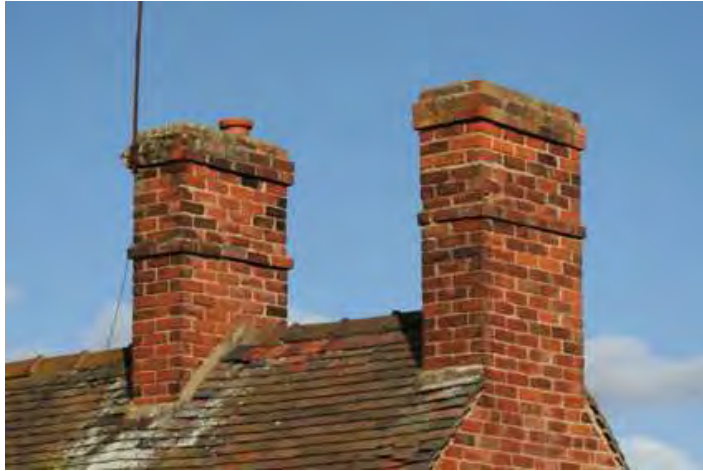
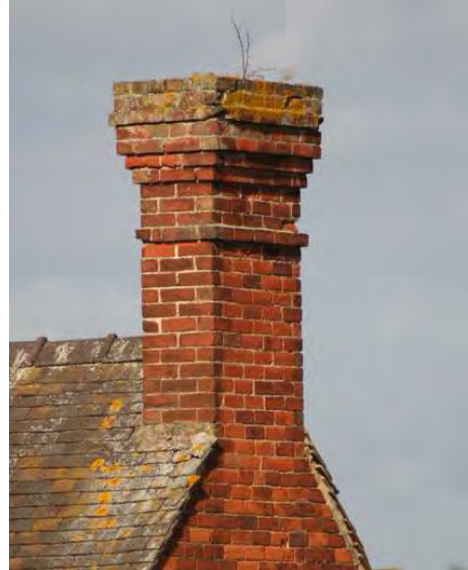
Above left - brick stacks with single horizontal band and two oversailing courses (Common Farm Cottage). Above right - multiple corbelled brick stack with single brick band at Tutholme. This was once a common estate detail in Woodhouses, shared with Common Farm Cottage, amongst others.

The corbelled chimneys are late 19<sup>th</sup> century in origin, but the practice was still adopted for the bungalow at Pool Farm in the 1920s. Chimneys are tall, with a single brick oversailing course and then a further tiered and corbelled stack of typically seven courses of brickwork. The resulting chimneys stand out with a common identity. They can be found at Tutholme, Plumtree Cottage, The Malthouse and Pool Farm. Chimneys at Common Farm Cottage, Pool Farm Cottage and Woodhouse Farm Cottage once had the same detail, but the upper courses have been rebuilt in recent times.

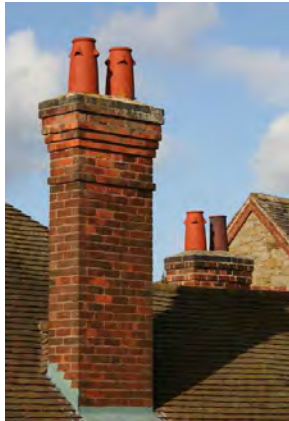
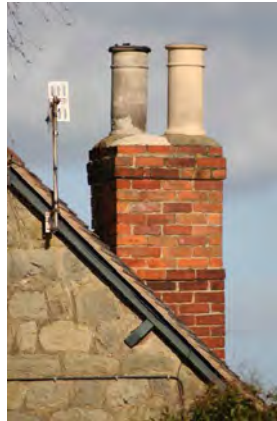
## CHIMNEY STACKS AND POTS

Below - The Cottages. Plain brick stacks with two oversailing courses to the foreground chimneys and original stone coping to the rear chimney.

Below - arched, vaulted stack at Woodhouse Farm. The original red brick oversailing courses have been replaced with blue bricks.

- Tall brick chimneys with multiple corbelled brick oversailing courses

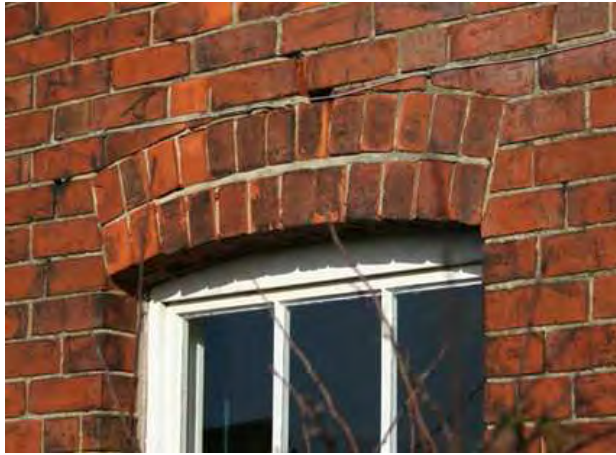
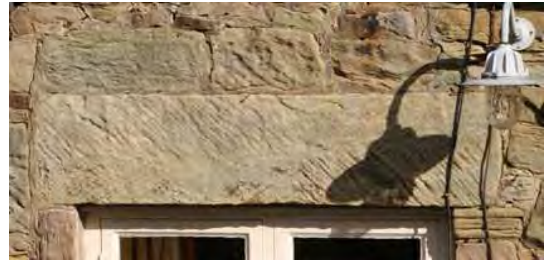
Left - where economy was important, lintels were simple in form. A segmental arch formed by two rows of "header" bricks at Woodhouse Farm. There are very occasionally plain gritstone lintels, as at Common Farm Cottage (above), Plumtree Cottage and The Cottages.

Most of the smallest domestic buildings in Woodhouses incorporate segmental brick arches. These were commonplace during the 18<sup>th</sup> and early 19<sup>th</sup> centuries. This was the simplest and easiest lintel to construct as the taper was accommodated wholly in the mortar joints, without the need to cut the brick. Many of the segmental arches were built quite cheaply with header bricks, either a single or double course. There are examples of double-courses of brick headers at Tutholme and single-courses of brick headers within stonework at Woodhouse Farm Cottage.

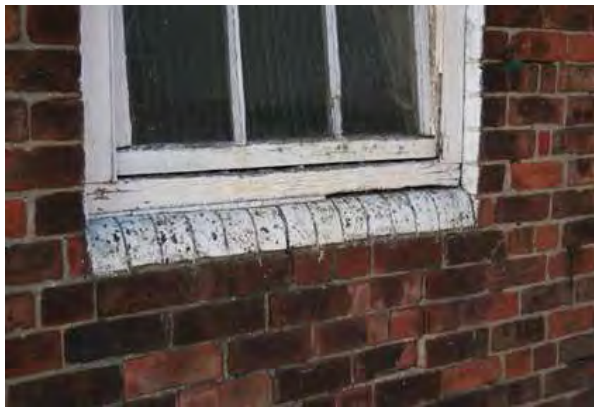
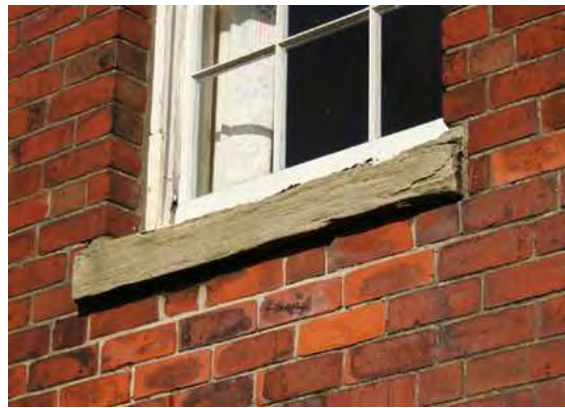
Stone cills are found in association with sash windows at Woodhouse Farm (above right) and at The Cottages and on occasion elsewhere. Many windows have no cill at all, relying instead on the weathering properties of the masonry beneath the joinery. The examples at The Malthouse (right) illustrate the use of a simple lead flashing, added in recent times, to protect the masonry from the worst of the weather.

Many of the buildings that were refurbished at the end of the 19th century were given a moulded red brick cill or a bull-nosed, moulded blue brick cill, as at Pool Farm, which has been painted at a later date (above left).

In combination with the segmental brick arches, stone cills were not normally used, relying on the simple weathering properties of the brickwork. There are a number of examples where moulded blue bricks were incorporated during the late years of the 19<sup>th</sup> century to enhance the performance of the cill, as at Tutholme, where chamfered blue bricks were used and at Pool Farm, where rounded blue bricks were used.

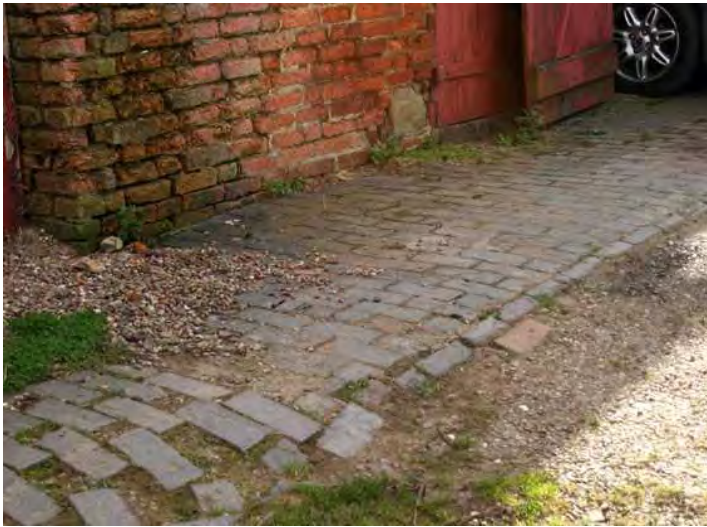
### Brick paving

Left - reddish blue brick paving laid in a brick bond, as an apron, in front of Tutholme. The original paving was laid as illustrated here, at 90 degrees to the building.

Red and blue bricks were also used as a paving material and can be found in several instances used as an apron, in front of the working farm buildings and houses.

- Red and blue bricks laid in even courses as an apron

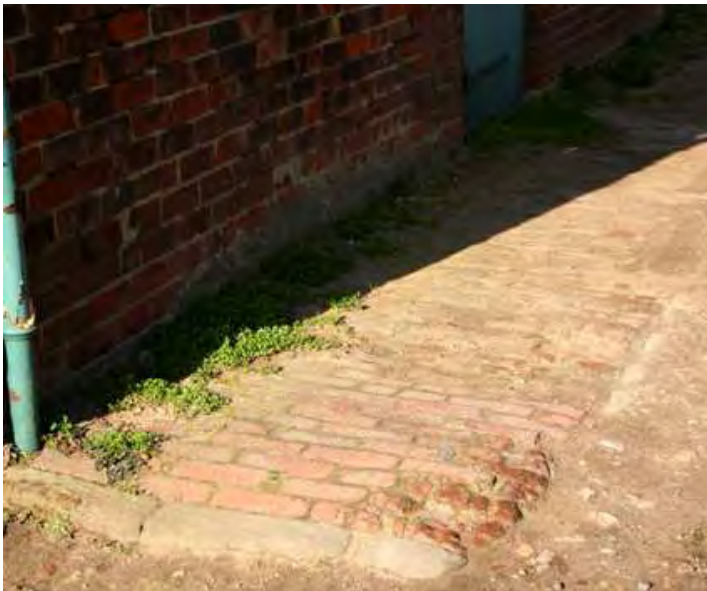
Below left - red brick paving laid in even courses as an apron at Pool Farm.

Below right - blue brick paving, restored and laid as an apron, in even courses parallel with the front wall, at The Malthouse.

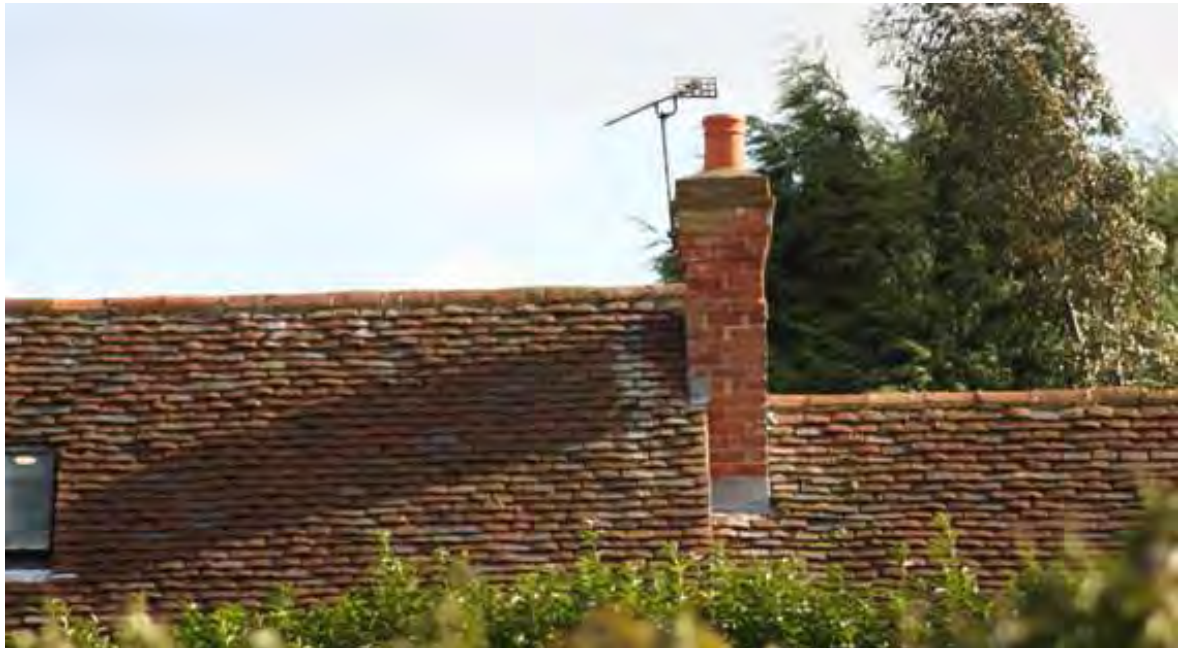
Above - the oldest roofing materials are hand-made red, plain clay tiles, which survive on a number of properties (Plumtree Cottage - above). Staffordshire blue clay tiles started to appear in the 1770s after the Trent & Mersey Canal opened. These can be seen at Tutholme (below left), along with a fragment of a raised, brick-coped gable and hand-made red clay tiled roof.

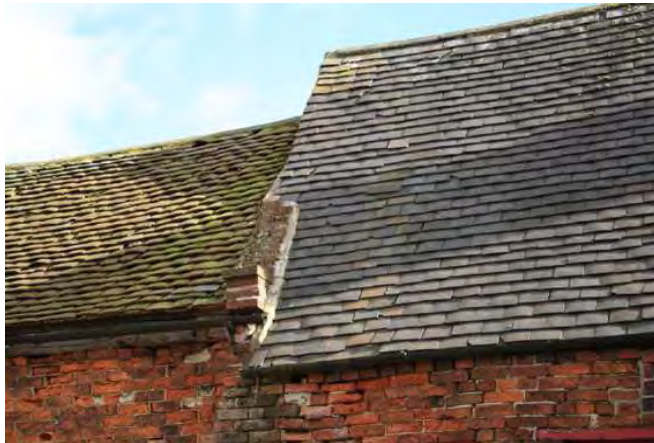
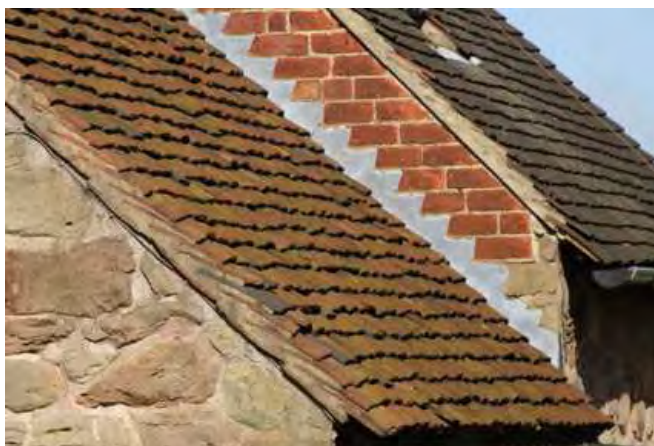
Above - machine-made red clay tiles of 1884 at Woodhouse Farm. Red clay tiles were very popular towards the end of the C19. The building also has a deep overhanging eaves and bargeboards.

The smooth, red brickwork of Woodhouse Farm (supplied by the Whitwick Colliery Company), built in 1884, is complemented by striking, red, machine-made roof tiles. This combination of materials and its unusual arched chimney stack makes it stand out amidst the surrounding mellow, hand-made brickwork.

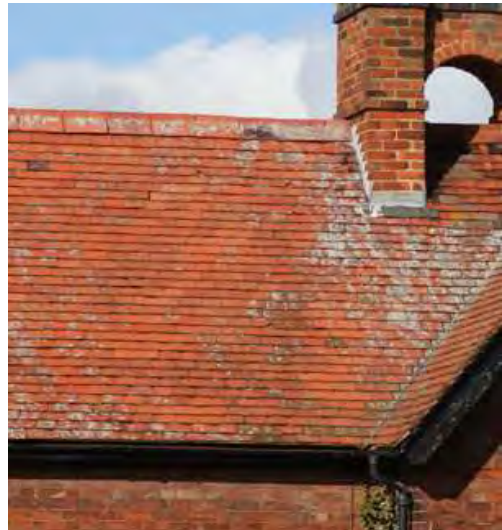
Left - pitched roofs with plain close verges at Plumtree Cottage. This was the most common type of traditional roof.

All of the traditional roofs within the hamlet are pitched and most incorporate a simple detail, where the tiles simply overlap the wall, known as a plain close verge. One of the pitched roofs was rebuilt in the 19<sup>th</sup> century with a pair of exposed rafters finishing the gable. Only Woodhouse Farm, and the gabled dormers, have bargeboards. A fragment of a raised, coped brick gable, a common regional detail, can be seen on one of the outbuildings at Tutholme.

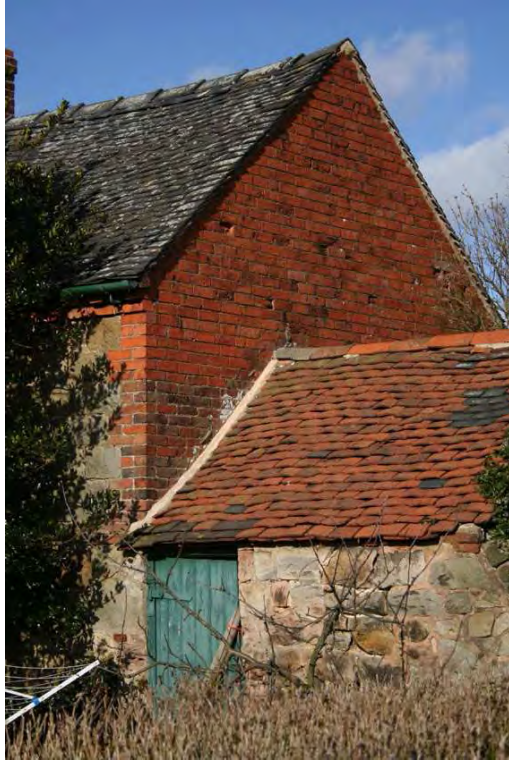
Above - plain close verge and mortared flaunching at Pool Farm.

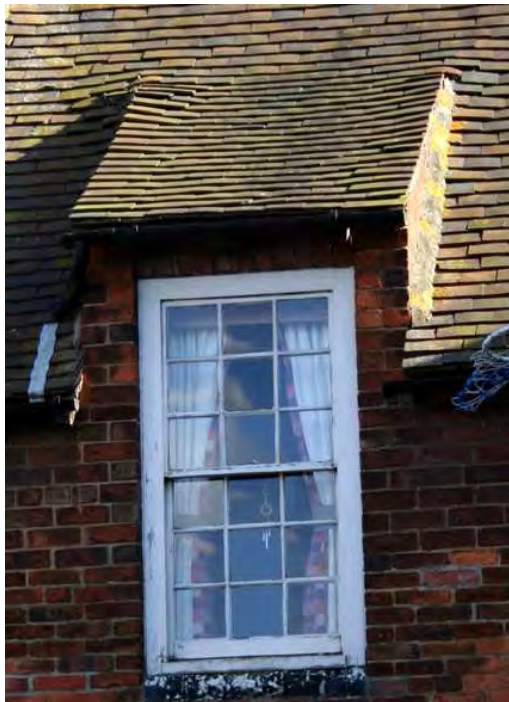
Below - raking dormer window and multi-paned sash at Tutholme. This type of dormer window was added to several Melbourne estate properties in Woodhouses at the end of the C19.

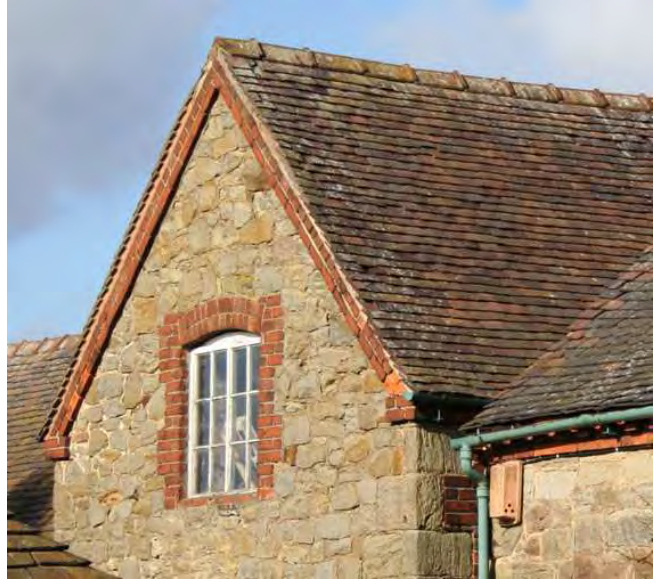
Above - plain corbelled brick verge, eaves and brick quoin window surround, in combination with rubble gritstone walls, at Pool Farm.

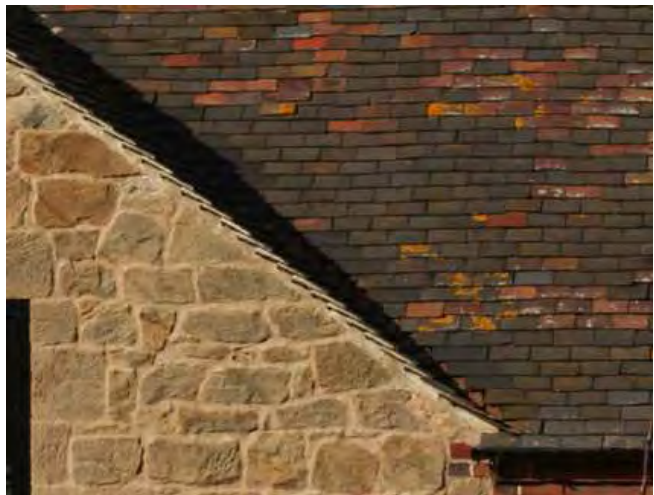
Above - plain close verge at Woodhouses Barn.

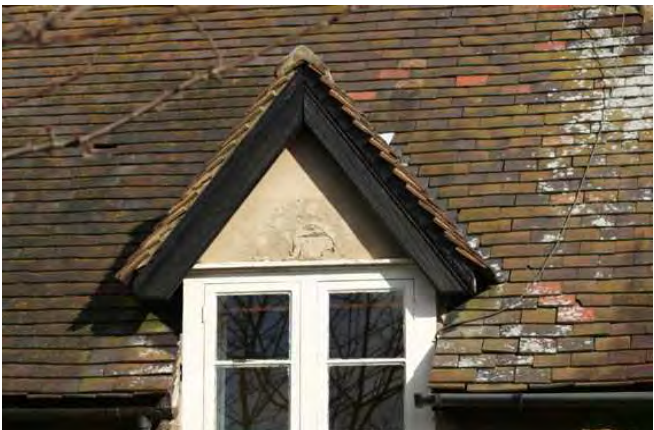
Below - pitched roof with bargeboards and dormer window at Common Farm Cottage.

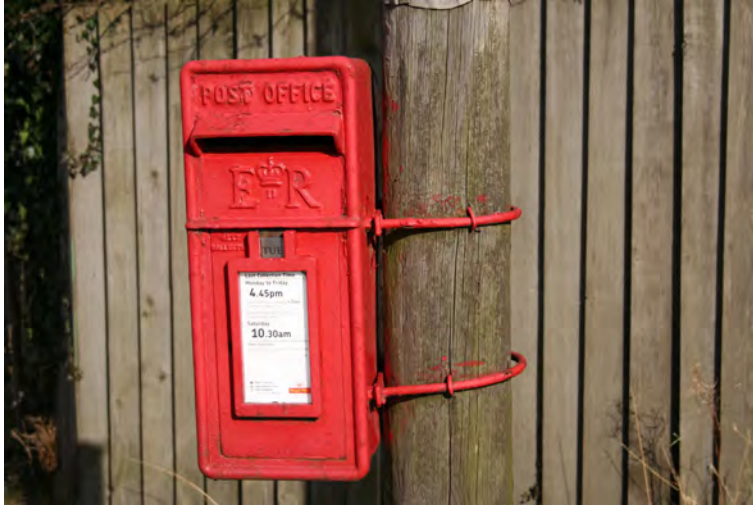
## STREET FURNITURE

Left - Red lamp-post letter box (ER) circa 1960s

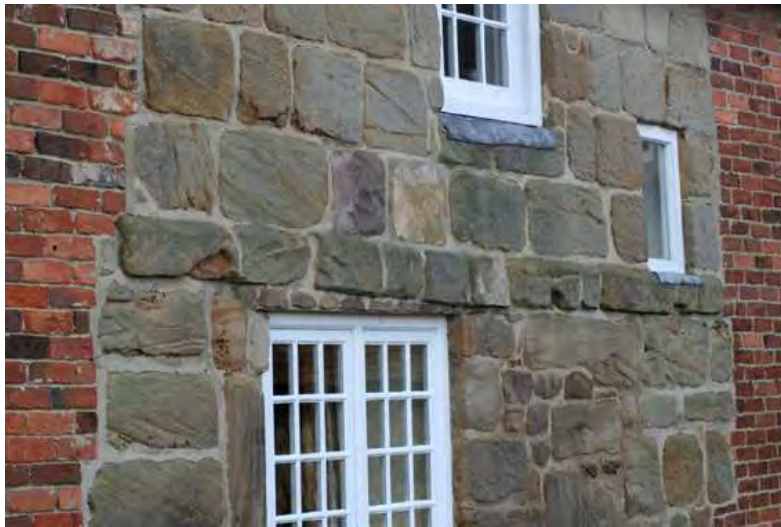
Left - raised, horizontal stone band, set within a coursed gritstone wall (The Malthouse).

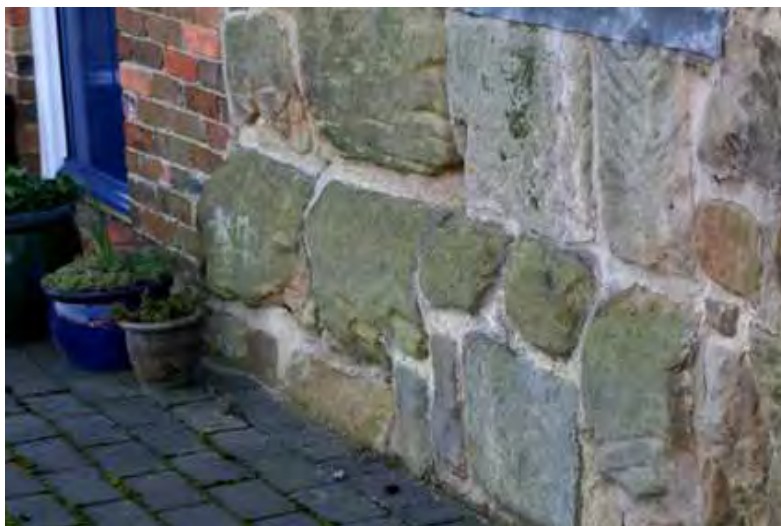
Second left - stone chamfered plinth (The Malthouse).

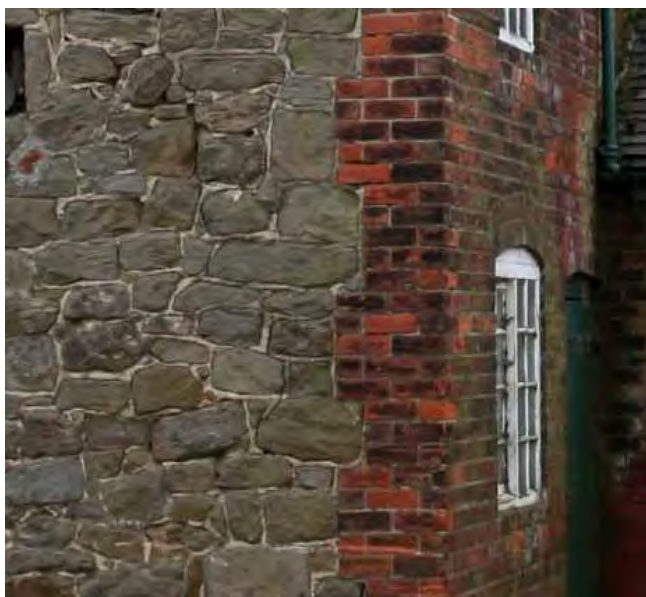
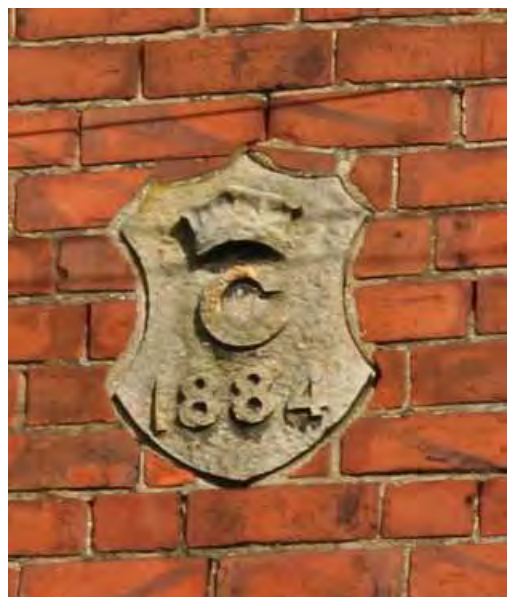
Bottom right - shield, datestone and initial "C" for Earl Cowper, owner of the Melbourne Estate. The coronet represents his title of Earl (Woodhouse Farm).

The only other obvious sign of an estate identity is the presence of the datestone on Woodhouse Farm. Underneath the date 1884 is the initial “C” for Earl Cowper, owner of the Estate, with a coronet representing his title. Similar datestones can be found elsewhere on the estate at Melbourne and Kings Newton.

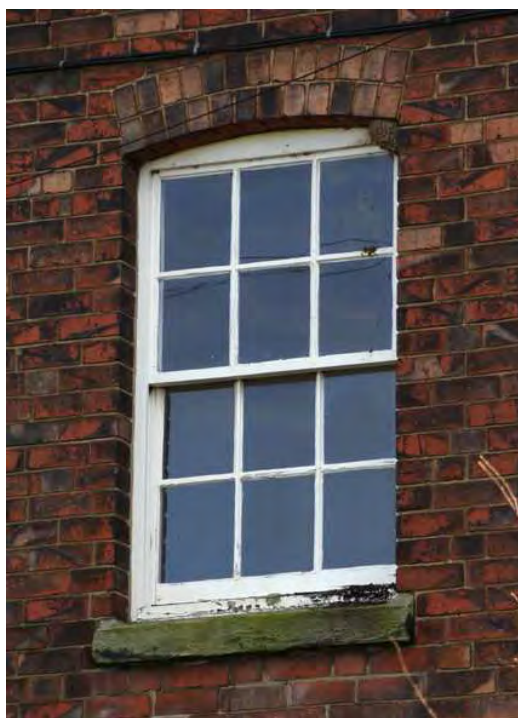
Above - multi-paned horizontally sliding sash window. This pattern is sometimes found on the Melbourne estate properties in the area, but is uncommon (Tutholme).

There are many instances of traditional joinery within the hamlet. Perhaps the oldest surviving window is a small multi-paned horizontal sliding sash. Examples of these can be also found in Melbourne, used on Melbourne estate properties. There are also examples of casement windows recessed within chamfered frames, often associated with estate building. Small-paned sash windows were used when they re-windowed Tutholme and The Malthouse and they were the choice at Woodhouse Farm (1884). Many of the agricultural buildings still retain the original cast-iron and timber “hopper” windows.

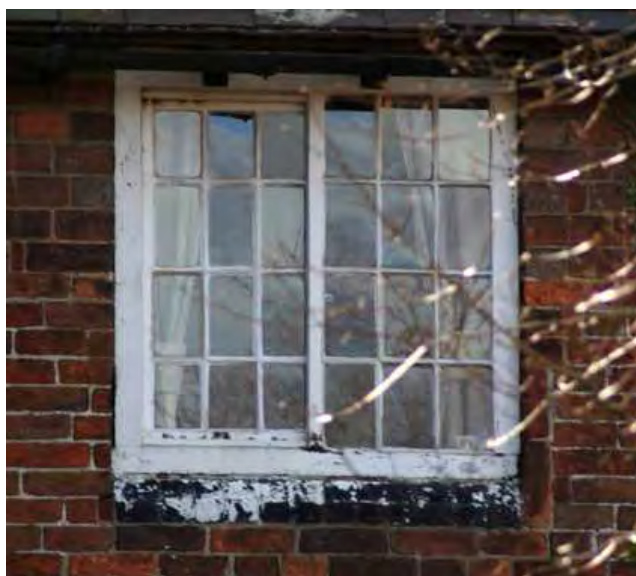
Above - small-paned vertically sliding sash window of 1884 (Woodhouse Farm). During the latter part of the C19 a number of properties were updated with multi-paned sash windows.

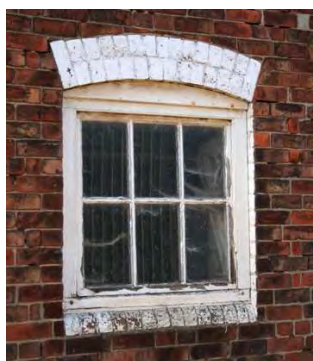
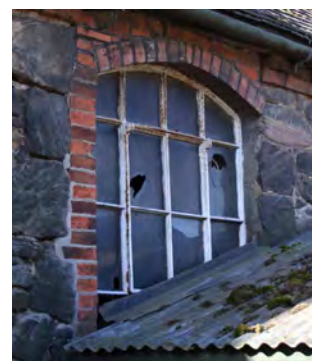
Right - timber hopper at Pool Farm.  
Far right - cast-iron hopper at Pool Farm.

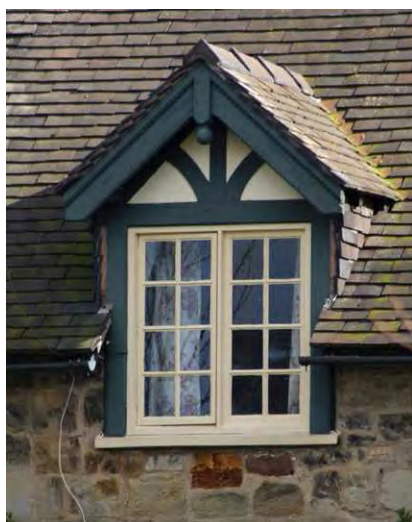
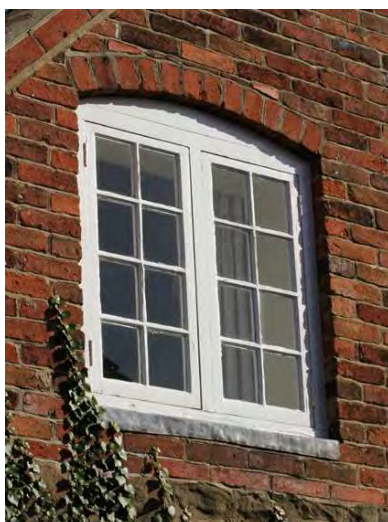
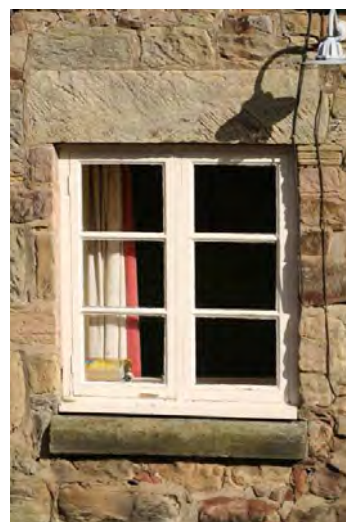
Below left - side-hinged, multi-paned timber casements at Woodhouse Farm Cottage, recessed lights within a chamfered frame. Below centre and right - casements at The Malthouse and Common Farm Cottage.
