Stanton by Bridge *Conservation Area* Character Statement

2013
CONSULTATION DRAFT

**SOUTH DERBYSHIRE
DISTRICT COUNCIL**

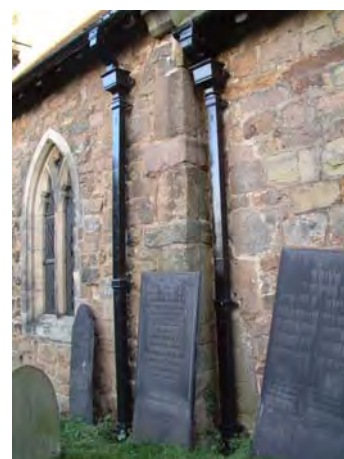
*Church - detail of
'long-and-short' work*

The Church of St. Michael provides physical evidence of Anglo-Saxon occupation, incorporating “long-and-short work”, an early method of inserting quoins in stone walls. There was an old north-south route running from the Trent river crossing to the church, and this may explain why the church is some distance from the present main thoroughfare of the village. This route is partly preserved in a footpath, which runs south from the church to St. Brides, but where it meets the Trent flood plain it has been destroyed by 20th century gravel extraction.

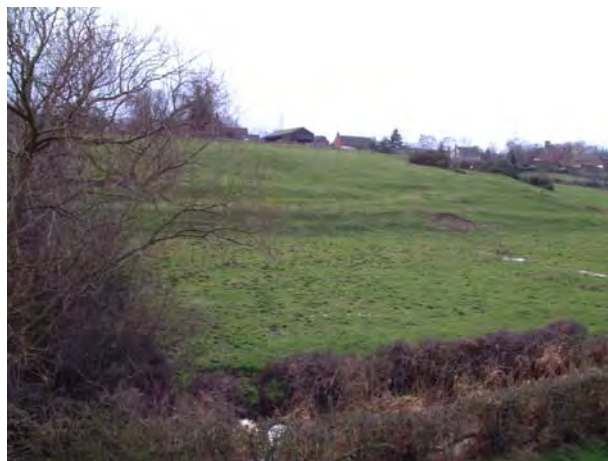
View of earthworks from The Causeway

preserved as a long earthwork boundary bank, visible in low sunlight.

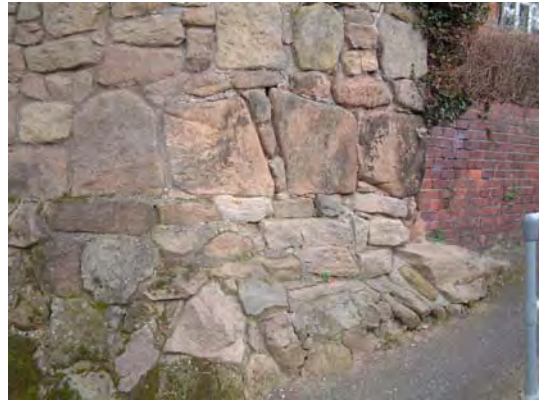
Detail of boundary wall on Ingleby Lane

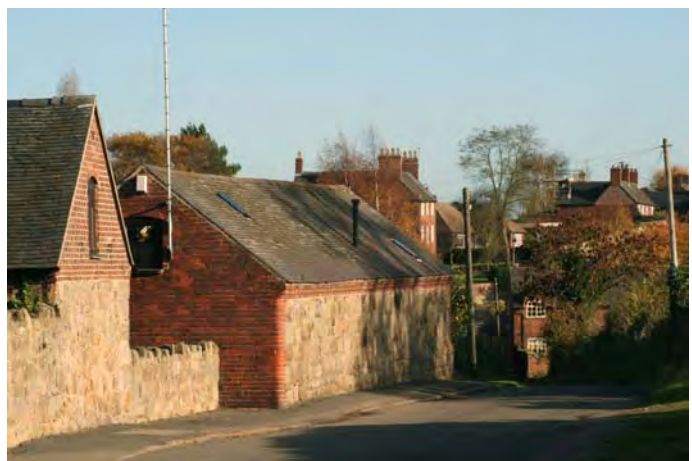
Main Street - rubblestone and brick

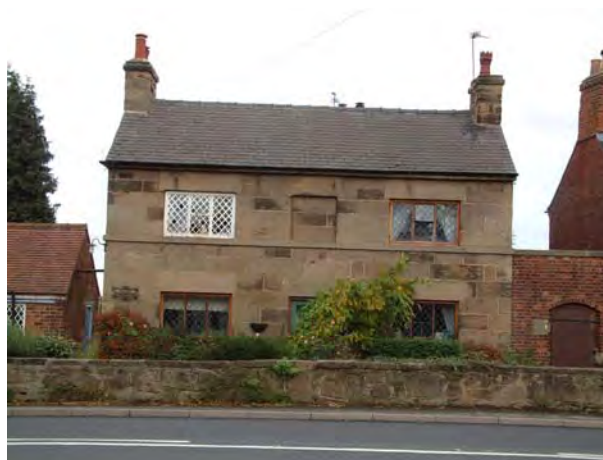
High Standing, Derby Road

Whilst the earliest surviving buildings were built from rubble gritstone, these were displaced by either more refined coursed ashlar or brick, according to the status of the building. With the improvement of transport in the 19th century the range of materials would have increased. The sandstone used at High Standing (circa 1830), for example, was probably acquired from a more northerly part of Derbyshire.

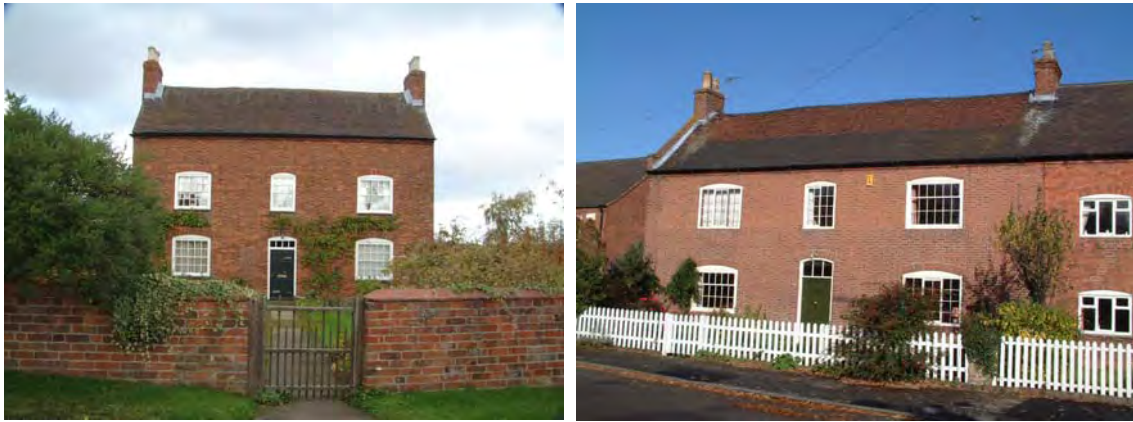
Red clay tiles survive at Poplars Farm (left) and Hollyhocks (right)

canal. This is a noticeable absence, indicative that there was little development in the 19th century (with the odd exception such as High Standing and the Waterworks). Blue clay tiles are extremely durable and from the late 18th century on they tended to replace the local red clay tiles, of which the only surviving examples are at Hollyhocks and Poplars Farmhouse.

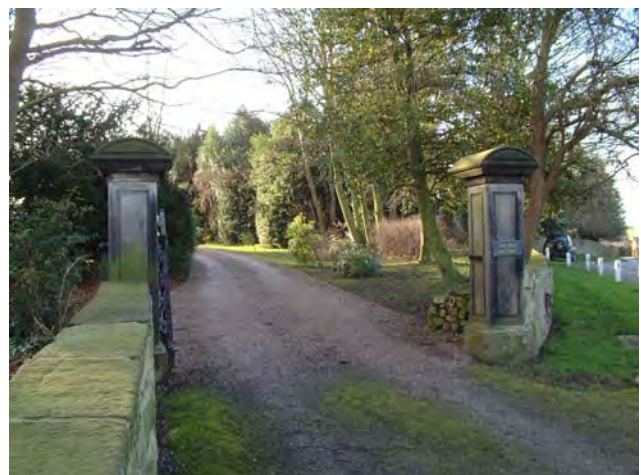
The Old Rectory entrance

There are 4 principal farms in the village. They are very substantial buildings, of 2½ and 3-storeys, illustrating the wealth of their aristocratic owners, but they were nevertheless worked by tenant farmers. The Old Rectory, in contrast, was much grander in design and proportion, with the grandest entrance of all, reflecting the higher status of the Rector. It sits in a mature garden with a large walled kitchen garden and faces the open fields to the east.

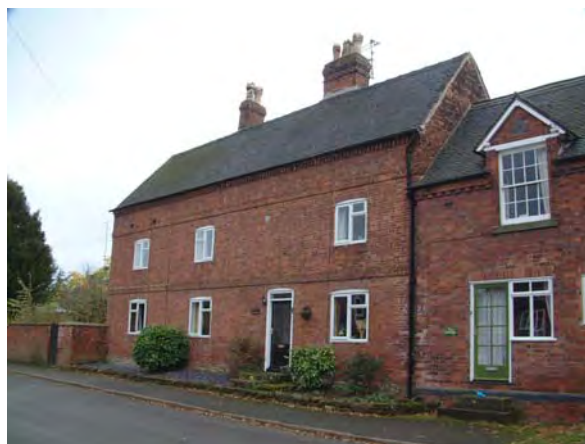
The four main farms were established over a short period between the mid 18th century and early 19th century. Grange Farmhouse (formerly Ivy House Farm – Harpur estate) is the earliest farmhouse – of early to mid 18th century construction, incorporating raised bands of brickwork and a central chimney stack. Manor Farm, Hollies Farm (Burdett estate), and Poplars Farm (Harpur estate) followed shortly afterwards and date from the late 18th to the early 19th century. They also incorporate dentilled brick eaves. The farmsteads were designed around courtyards or “foldyards”, with most of the activities hidden from the road behind long low ranges of buildings.

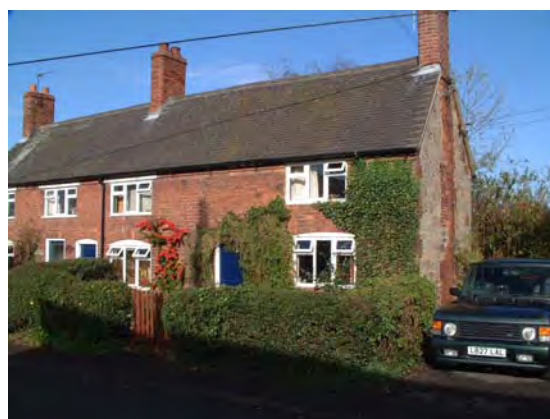
Plumtree Cottages, Ingleby Road

There has been a loss of historic window joinery in the houses in the settlement, and there is a risk that the historic window pattern in buildings that are not listed will be lost. Some segmental brick lintels have been rebuilt in a flat soldier course, indicating the presence of a hidden modern “catnic” lintel (The Grange, Yew Tree Cottage, Ivy Cottage). Plumtree Cottages and Rosedene were both photographed in the early 20th century and this provides evidence for the characteristic local horizontal sliding sash windows to be reinstated at some time in the future.

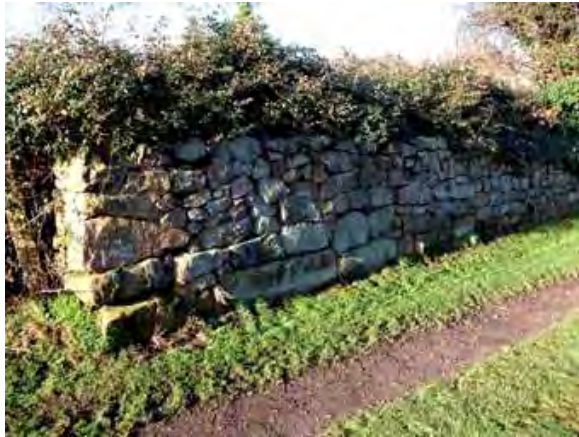
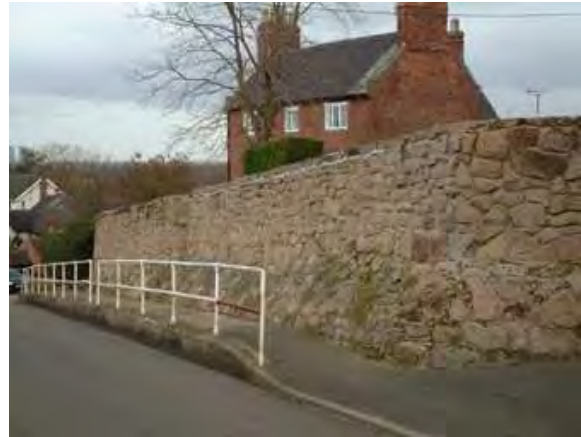
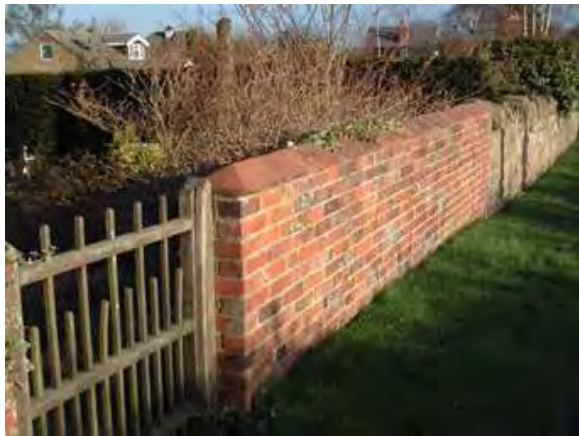
Walls and copings

Stone boundary walls (above, left and right) - pink rubble gritstone incorporating large boulders and the natural outcrops of gritstone within the wall. Copings of squared rubble, laid flat.

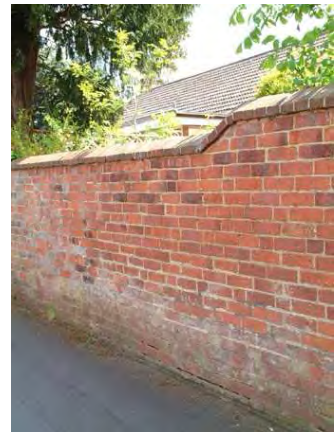
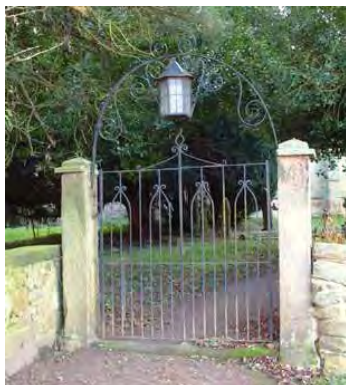
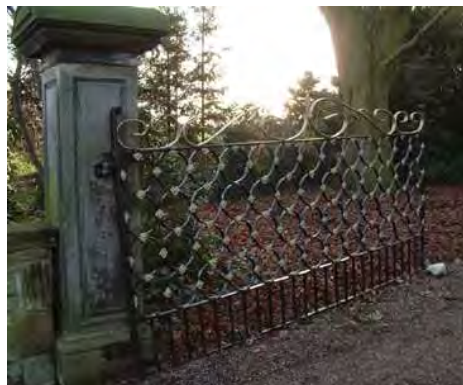
Gates

Brick walls (left and right) in red brick with triangular moulded red clay copings.

Far left - early 20th century wrought iron gates and lantern holder

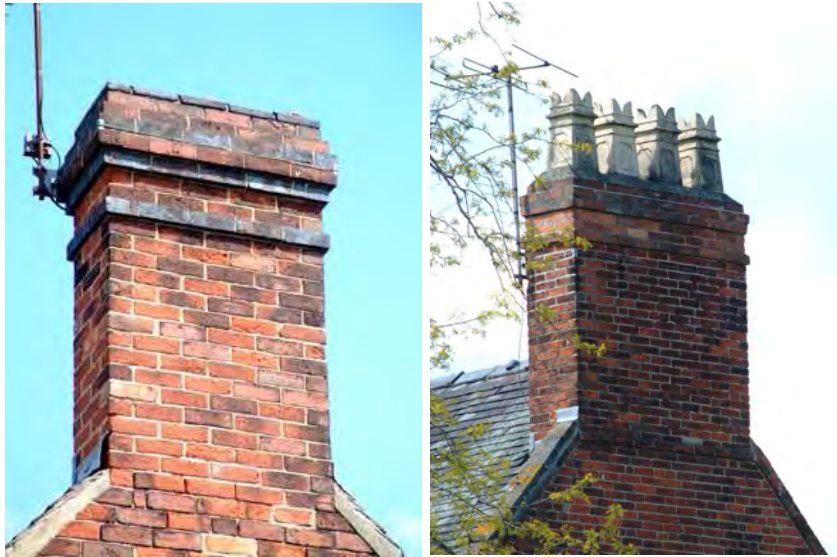
Above - brick chimney stacks with several oversailing courses. The buff square clay pots with the spiked tops were introduced by the Burdett estate at Hollies Farm (above right). Rounded moulded bricks were used by the Harpur-Crewe estate at Plumtree Cottages (right). The same detail occurs in Ticknall.

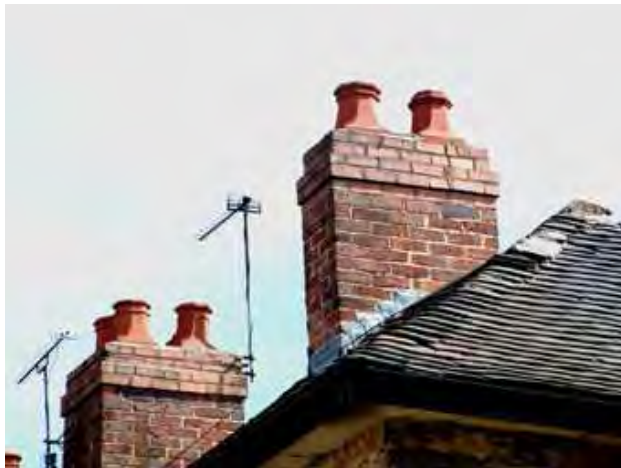
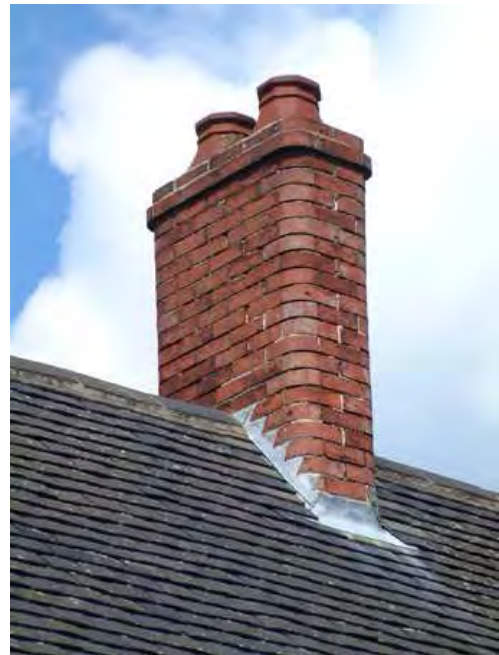
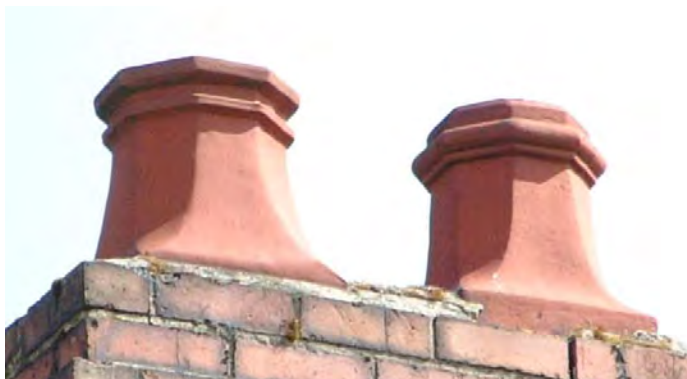
Above - the Harpur-Crewe estate used short red clay pots for Plumtree Cottages (above) and the same pots were used by the Burdett estate for Stone Row (above left and detail left).

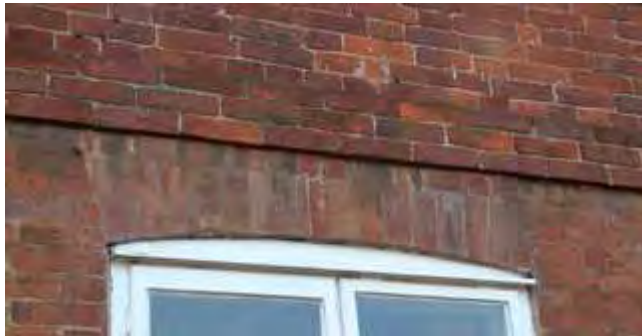
Above - in the 18th century, where wealth permitted in the finer houses, “hand-rubbed” bricks or “gauged” bricks were used. The result was a precise, thinly-jointed, wedge-shaped lintel. These bricks were sandwiched together using lime putty, such as the cambered arch (above).

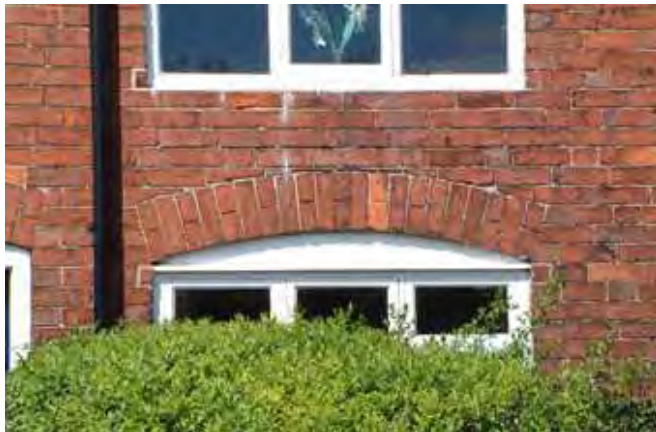
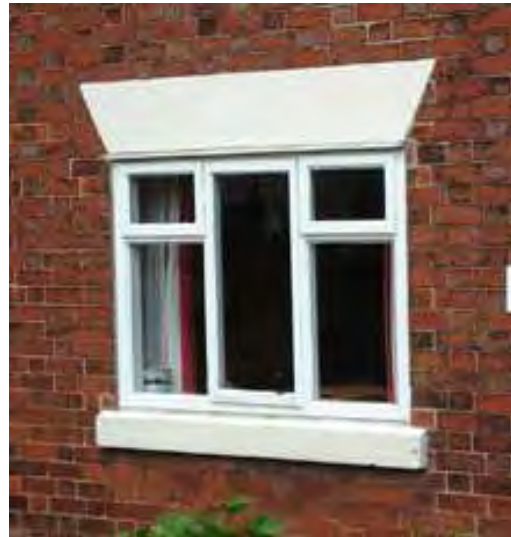
Where economy was important, lintels were simpler in form - a segmental arch formed by a course of “stretcher and header” bricks (below).

By the first half of the 19th century, the use of stone was much more widespread, partly due to improvements in the transportation of heavy goods (by canal and later rail). Wedge-shaped stone lintels echoed the wedge form of the gauged brick lintel (above).

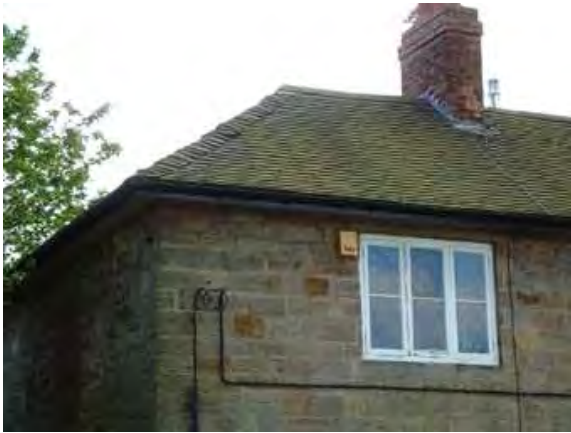
Above left - hipped roof in Staffordshire blue clay tiles with bonnet tiles to the hips

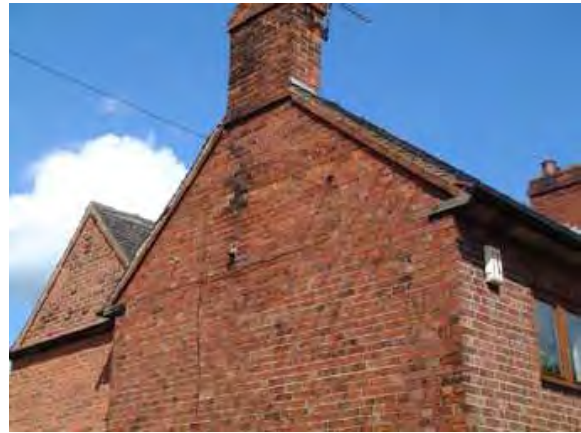
Above right - pitched roof with corbelled brick verge

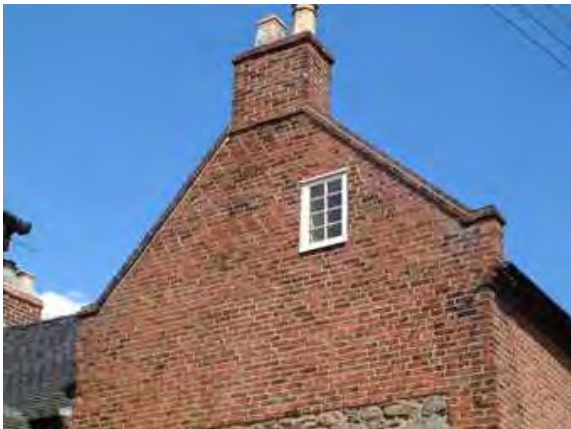
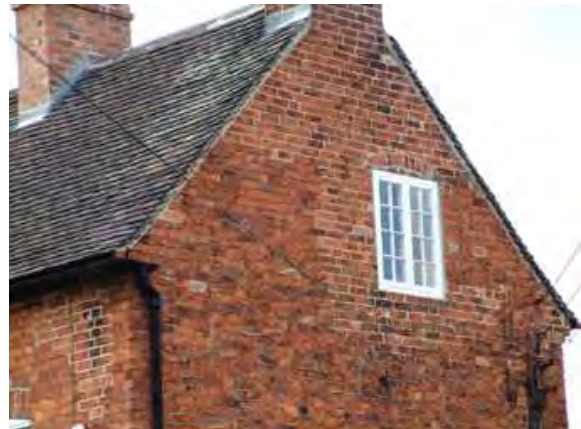
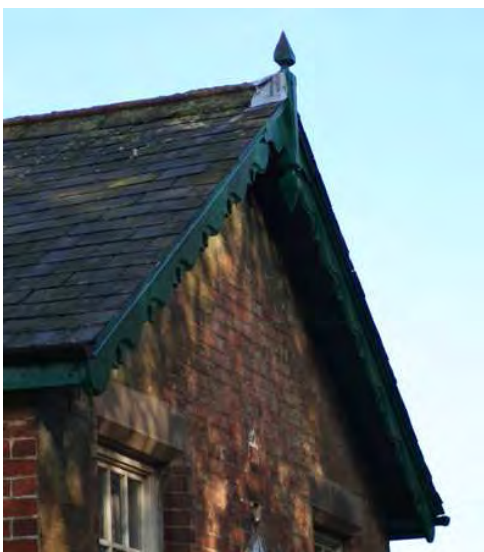
Below left - pitched roof with raised coped brick gable

Left - decorative timber bargeboards

Below right - roof incorporating mixture of old handmade plain red clay tiles and Staffordshire blue clay tiles

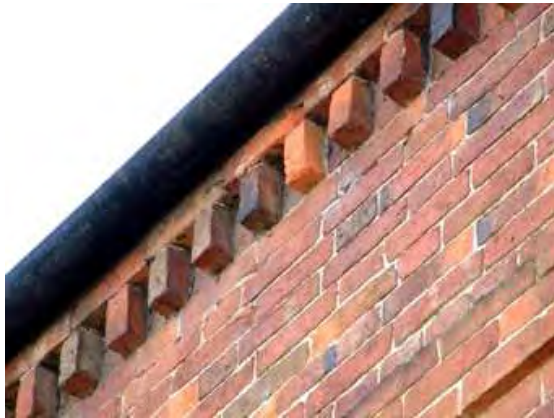
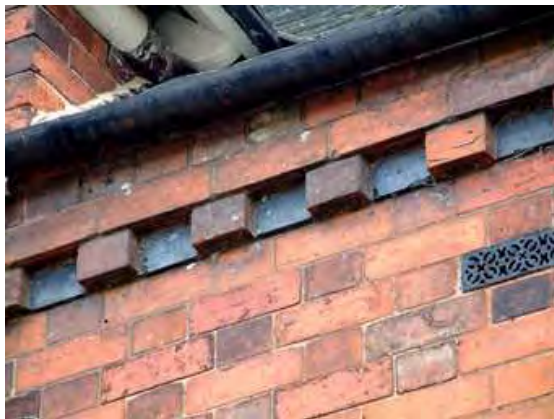
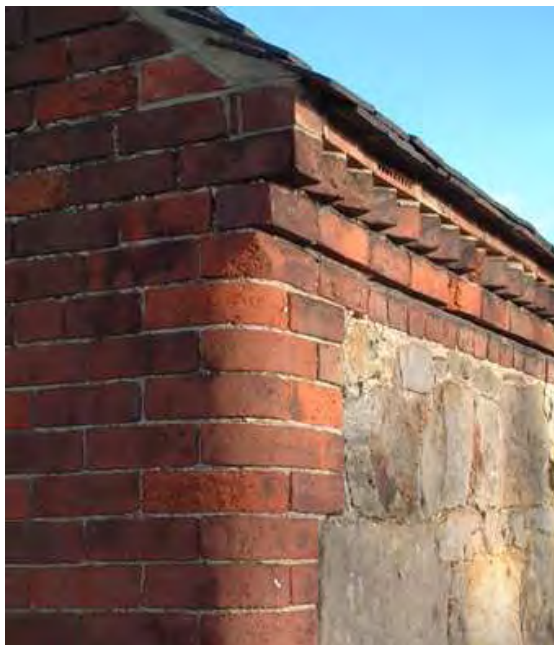
Rounded moulded bricks - used in conjunction with brick chimney stack (right) and corner of agricultural building (above)

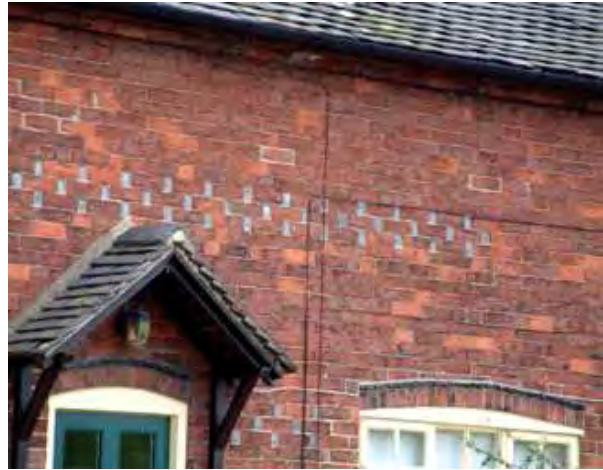
Above and right - the pattern of ventilation holes within brickwork is distinctive. They are survivals from the original use of buildings as hay barns. Most of these slots have been blocked up with slate or blue bricks when the buildings were converted from agricultural uses into dwellings.

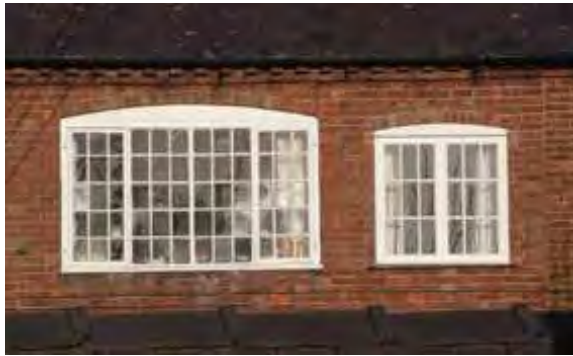
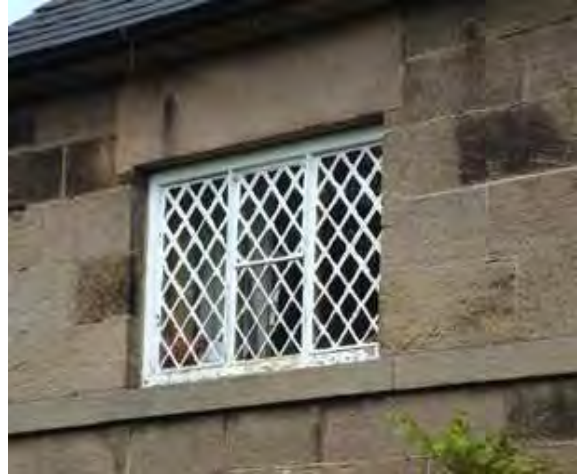
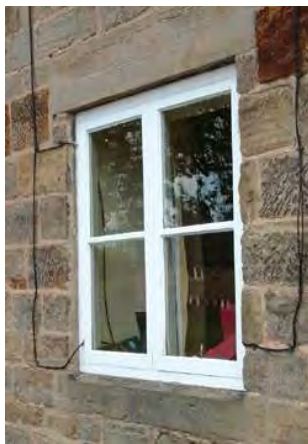
Above left - side-hinged timber casements of multiple panes. These were made with flush fitting opening casements and frames.

Left - casement with single horizontal glazing bar.

Right - side-hinged multi-paned timber casements set within chamfered frame (The Village Hall)

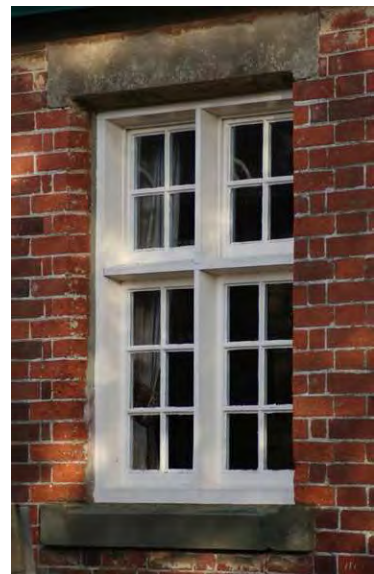
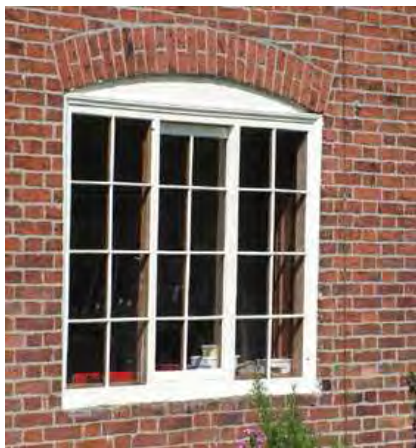
Left and bottom left - horizontally sliding sash windows are a common feature of the Midlands, often reserved for the less important elevations or small vernacular buildings. They are quite common in Stanton.

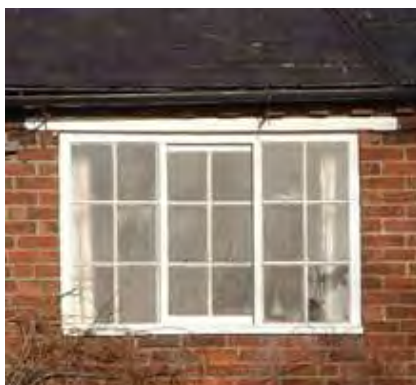
Right - vertically-sliding sash window. Most of the large, formal houses in Georgian England had large sash windows. In the early 19th century it was quite common to still find exposed sash boxes in rural areas (right).

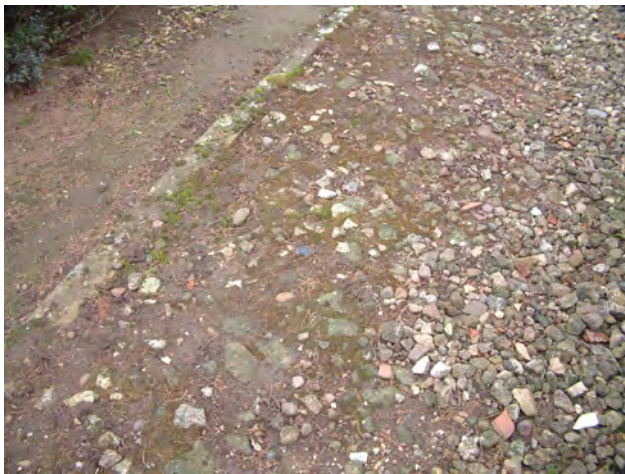
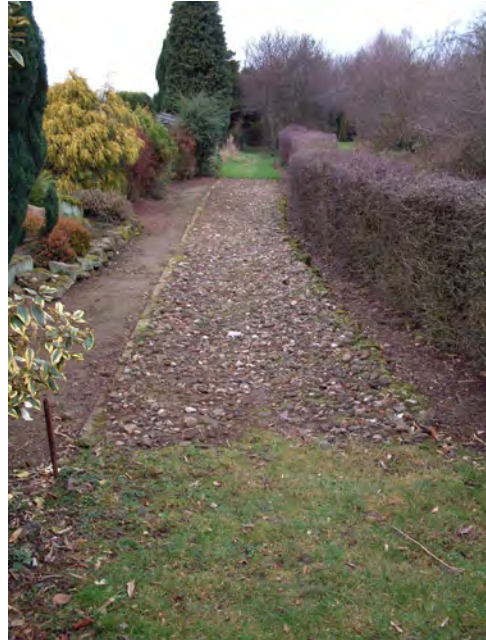
Below: Detail of pitching and gritstone kerb restraint
