Milton *Conservation Area* Character Statement

2013

**SOUTH DERBYSHIRE
DISTRICT COUNCIL**

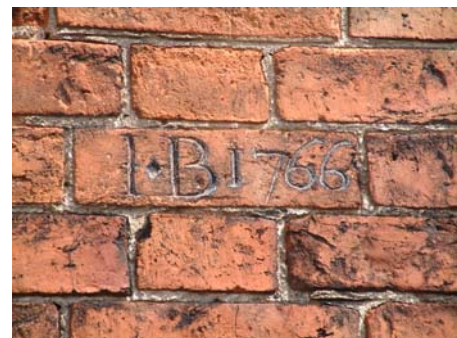
Initialled and dated brick at Brook Farm, built by the Brown family in 1766

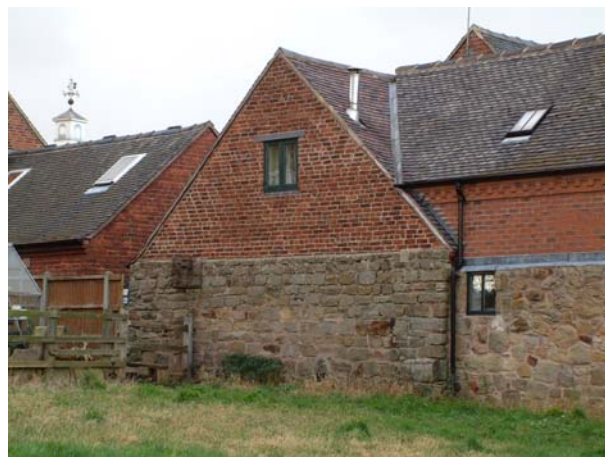
Stone and brick at The Farm

There is physical evidence for earlier buildings having been built in coursed and squared stone, or simply rubblestone, but the examples of this are scarce, most having been replaced during the 19th century with brick buildings. The range of 2½ storey cottages on Main Street (11-15) incorporates a stone plinth, which appears to be original to the late 18th century construction. The same detail appears at Brook Farmhouse and the boundary wall that served its former farmyard. Other buildings that incorporate a stone plinth are generally related to earlier footings of buildings that fronted the road. Lilac Cottage (10 Main Street) is an 18th century brick reconstruction. It has a 17th century plan form and incorporates a stone plinth and section of gable wall, also belonging to its earlier history. Ivy Cottage has footings from an earlier building that was probably set gable-end onto the road and 5 Main Street also incorporates a section of coursed stonework, revealing an earlier building on this site.

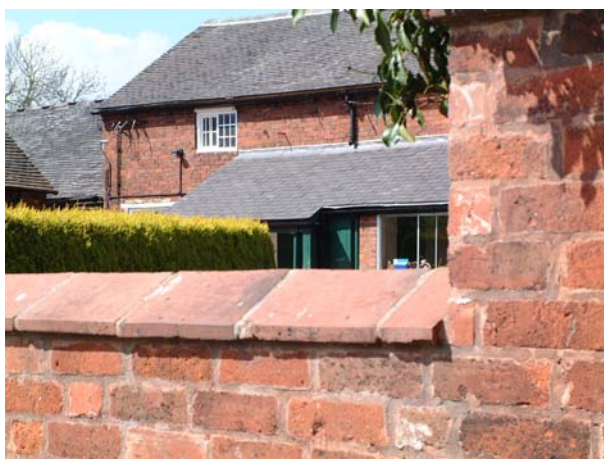
Boundary wall at Common Farm

Although the buildings are largely brick, boundary walls are built from local sandstone or red brick. There are only two instances of the use of railings (The Farm frontage and Kirby Holt).

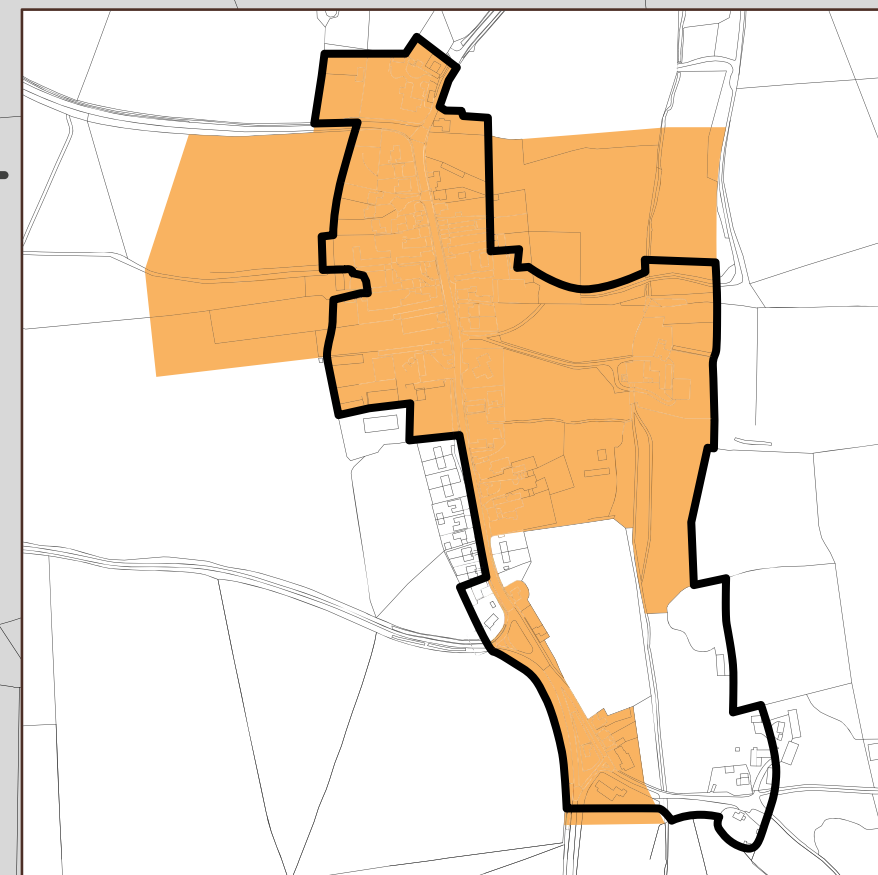
Milton Conservation Area

Designated : 15th July 1971 and
31st January 2013

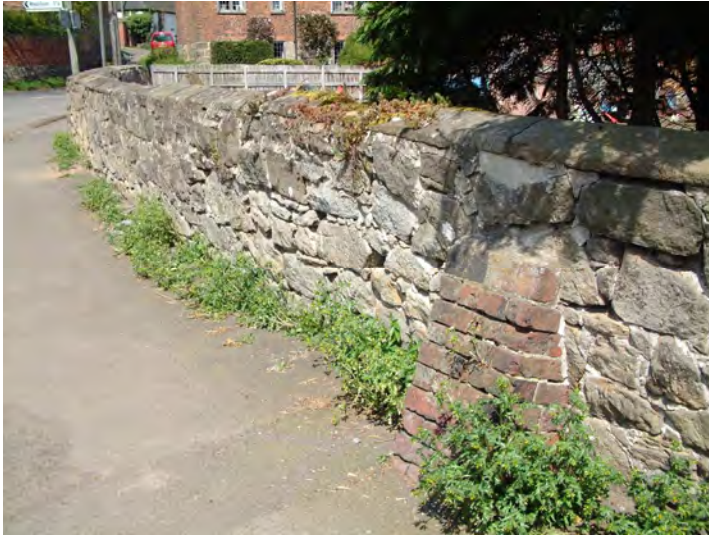
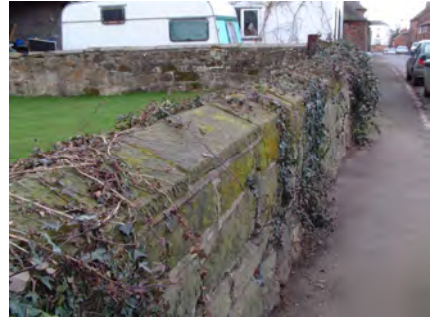
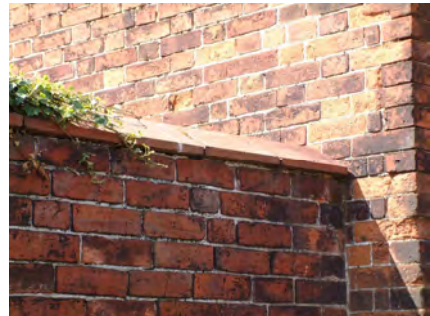
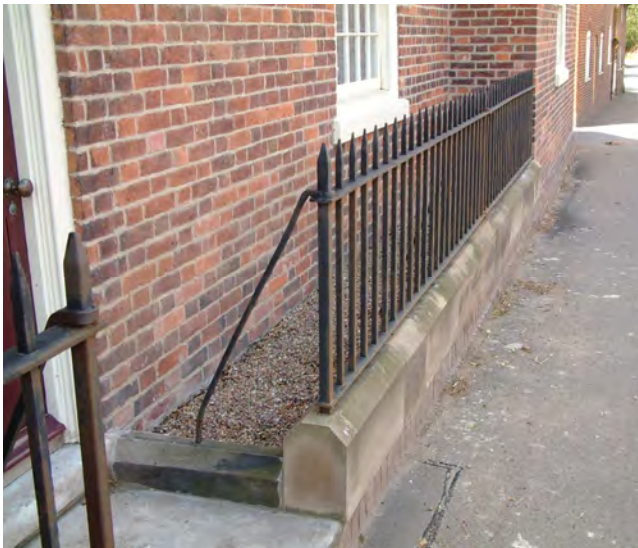
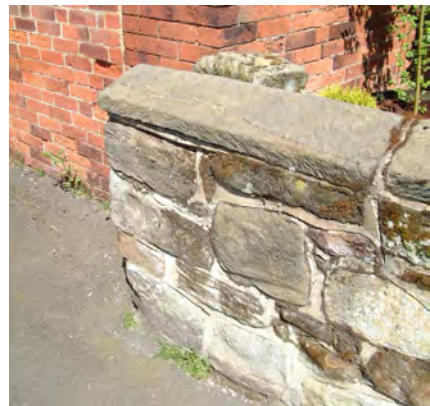
BOUNDARY TREATMENTS

Within Milton boundary walls are predominantly local sandstone, with dressed stone copings, triangular or half-round, more rustic than genteel in character. There are a few instances of brick boundary walls, finished in red clay copings but only two surviving examples of wrought-iron railings set into a stone plinth, of which the example at The Farm (below) has recently been restored.

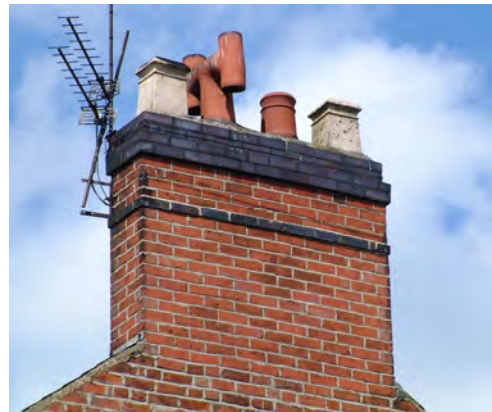
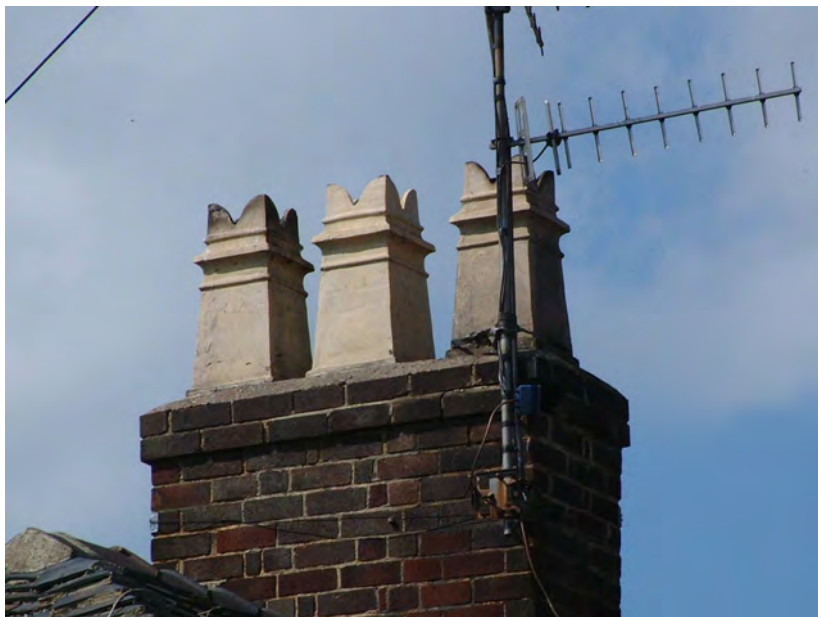
CHIMNEY STACKS AND POTS

Milton has a distinctive roofscape, emphasised by the uniform character of the chimney stacks and pots. Buff-coloured square and square spiked pots are the dominant pattern.

Blue bricks were occasionally used as an oversailing course, where a stronger brick was required (right), but this was generally a late 19th century replacement, carried out for practical reasons, rather than for decorative effect.

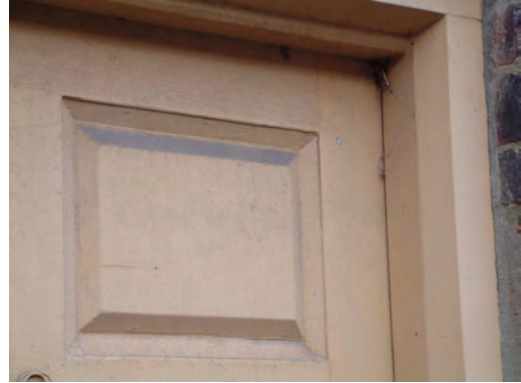
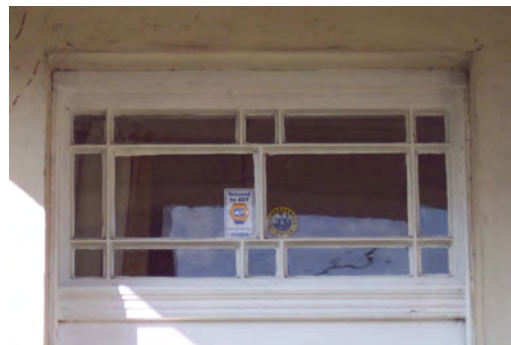
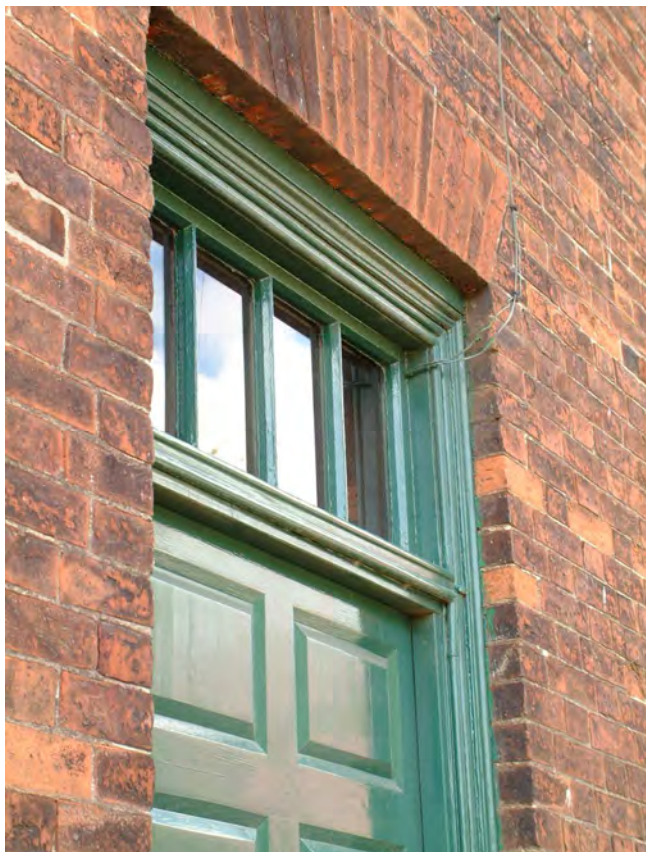
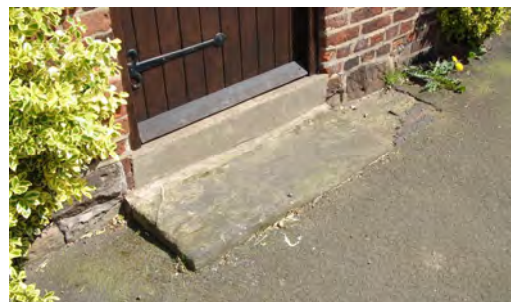
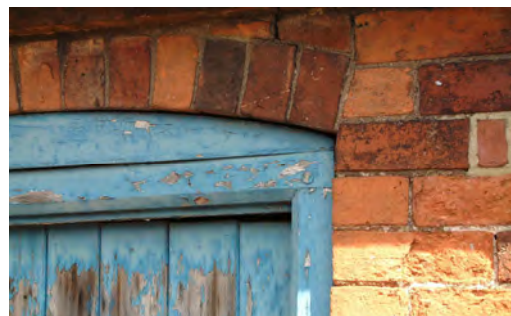
DOORS

Of the few surviving historic doors in Milton, the “double chamfer” 6-panel door is the most common (left, bottom left and detail above). For the smaller cottages, door frames were kept simple with a chamfered and timber pegged construction. Many doors may have been constructed with vertical boards. They usually incorporated a stone threshold. In the early 19th century fanlights were reserved for the better houses (below and bottom left).

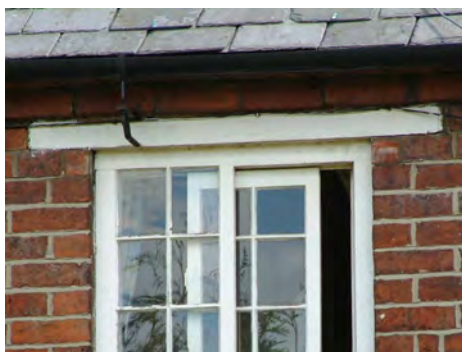
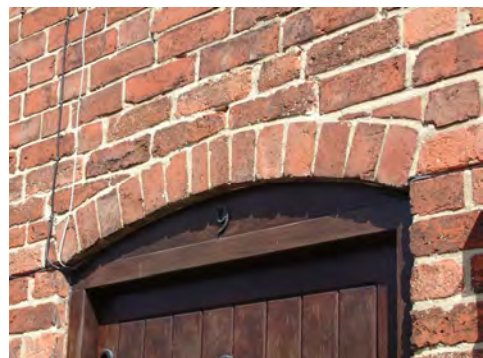
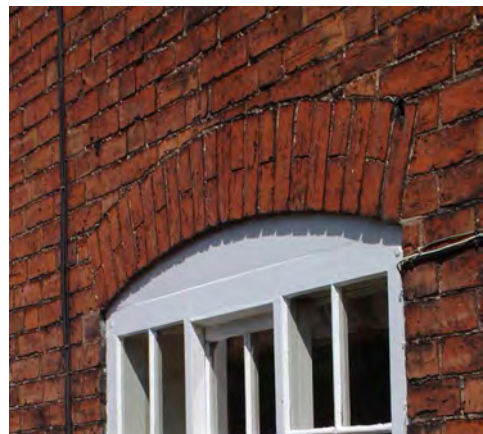
Timber lintels were often used for the first floor window under the eaves (below), where there was insufficient depth for a stone lintel or segmental arch.

Above - segmental arch

The larger properties generally have stone cills (right), whilst the smaller cottages were originally built without proper cills (far right), although tile-creasing and timber cills were sometimes added later.

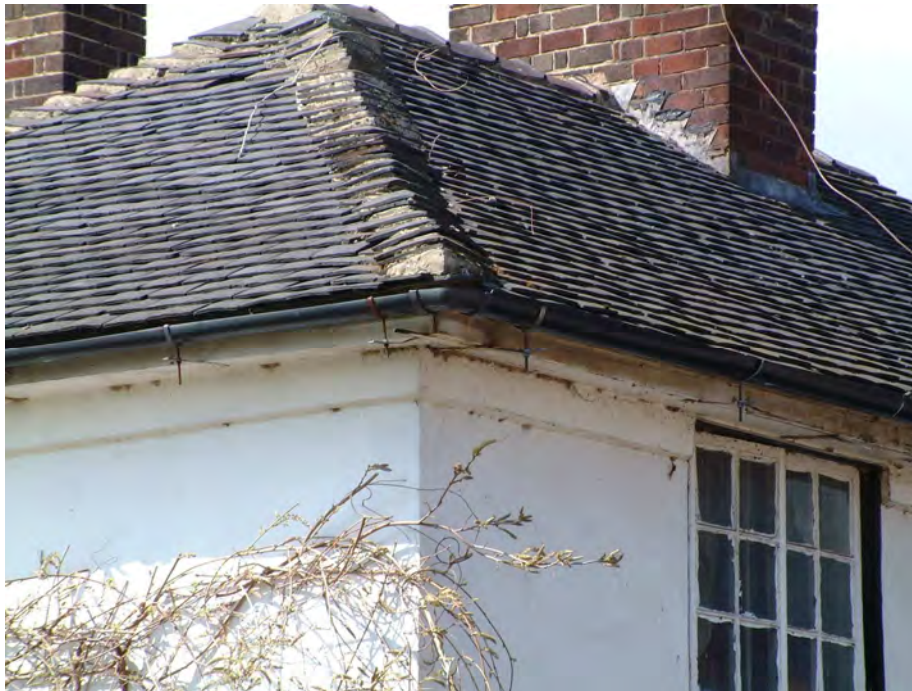
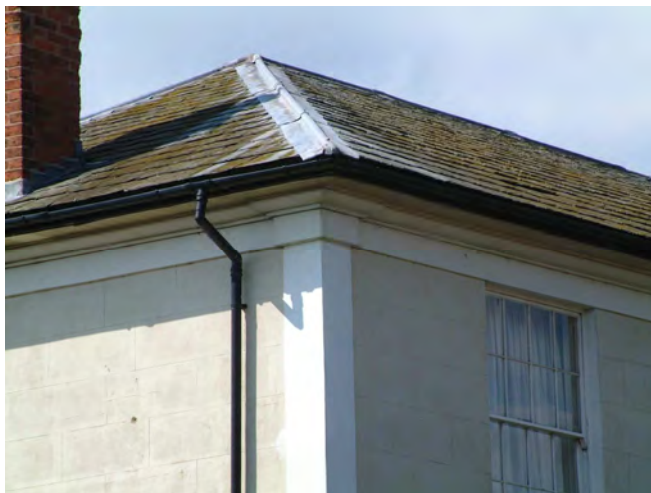
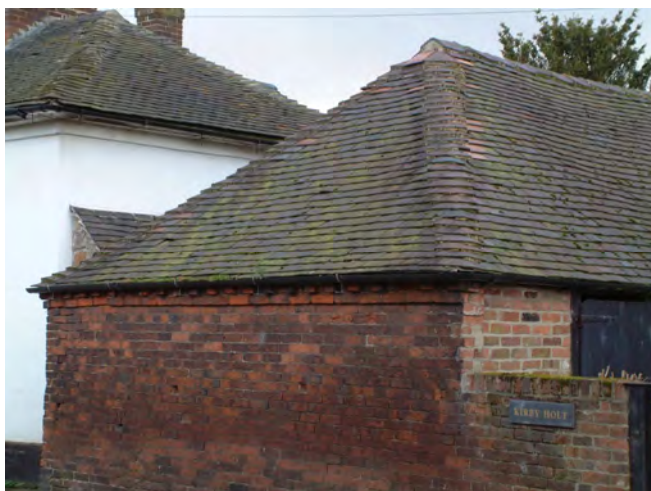
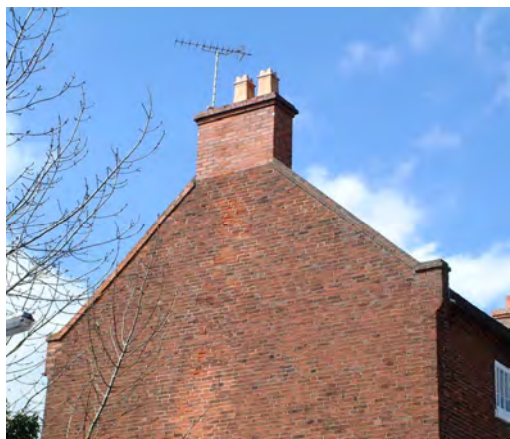
ROOF TYPES AND DETAILS

Hipped roofs are a distinctive feature of Milton (above and left) as are raised coped gables in brick with a brick-on-edge coping (Common Farm - bottom right). These were generally used on the higher status buildings; villas and farmhouses. The most common roof type, used for the majority of small cottages, is the pitched roof with a plain close verge.

Hipped roofs in clay tiles incorporate special clay "bonnet" hip tiles (bottom left). Graduated Burlington slate, used at Kirby Holt (left), has hips cloaked with lead flashings covering timber rolls.

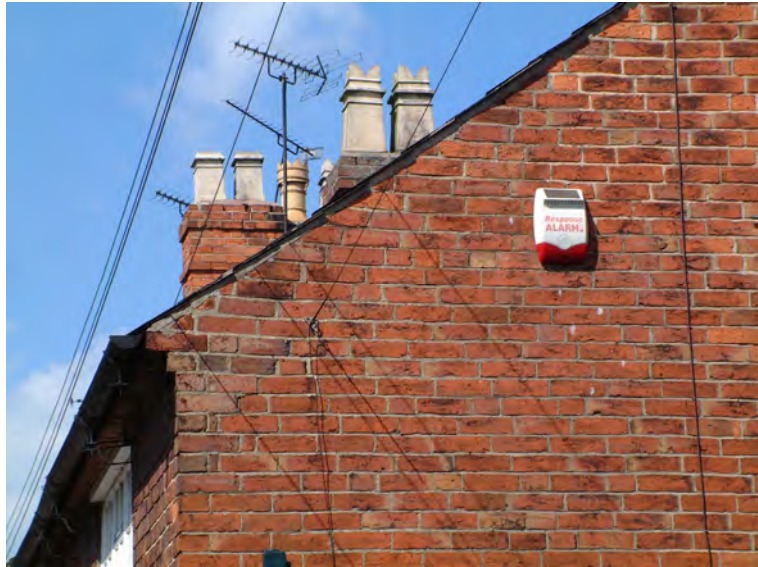
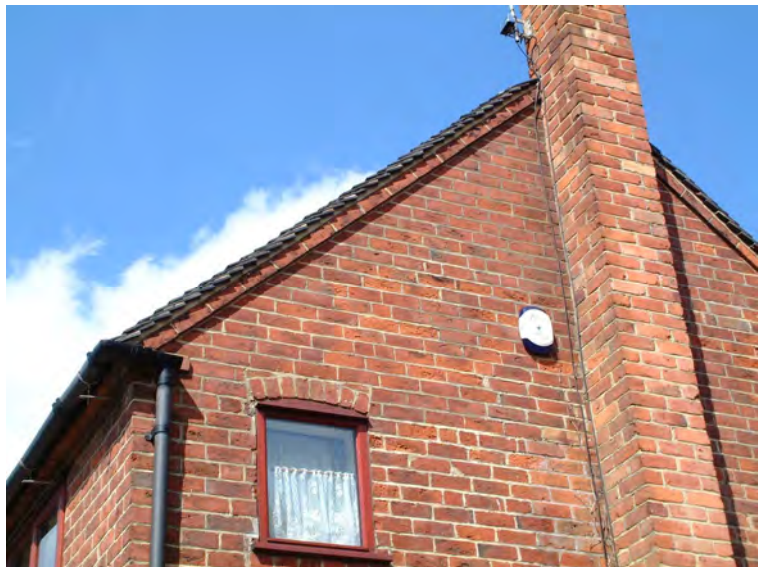
Pitched roof with a plain close verge and corbelled eaves (right), the simplest and most common type of construction.

There is occasionally a corbelled verge, designed to throw rainwater away from the brickwork (below right - No.1 The Hollies).

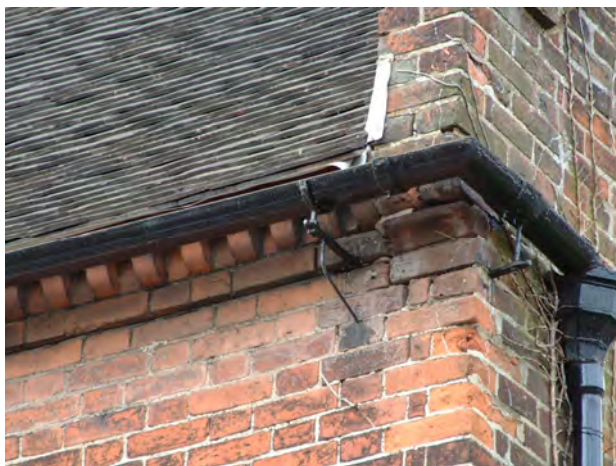
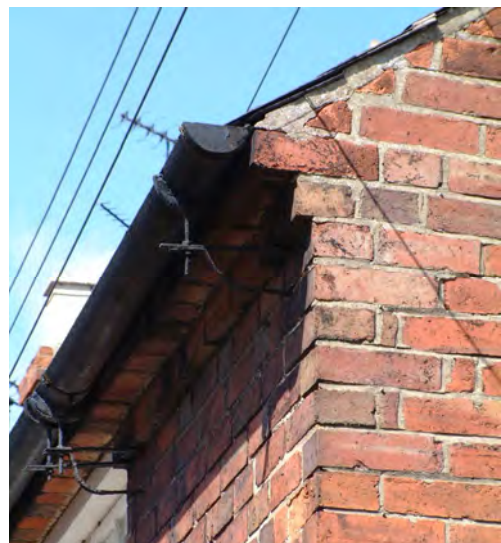
WALLS - BRICKWORK DETAILS

Moulded brickwork at the eaves (above and left). These were specially shaped bricks made in moulds, a refinement of the more common dentilled pattern created with standard bricks. This is common on the larger farmhouses. These are used in combination with a raised coped brick gable.

Many of the traditional cottages have a plain corbelled eaves (right), one of the simplest and most common types of construction.

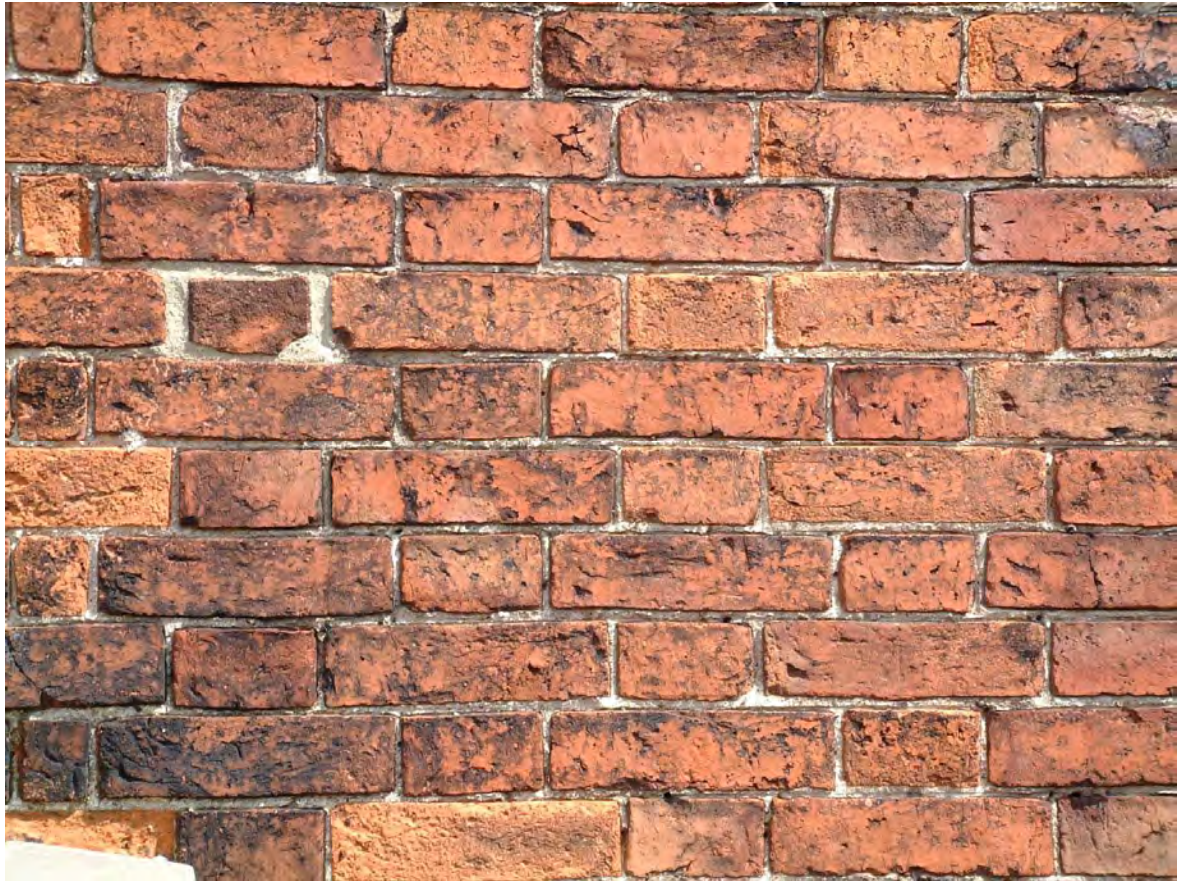
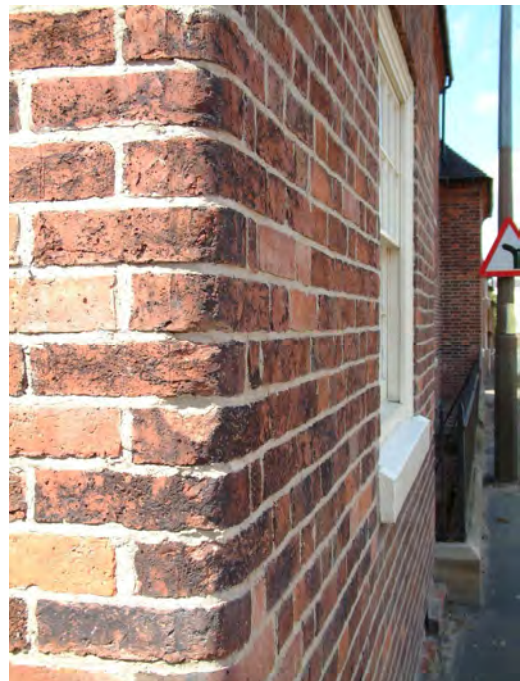
Flemish bond brickwork with penny-struck joint (above) can be found on both the farmhouses and smaller cottages.

The rounded, moulded bricks used to protect corners of buildings from physical damage (The Farm - right) are a local feature of several villages in South Derbyshire.

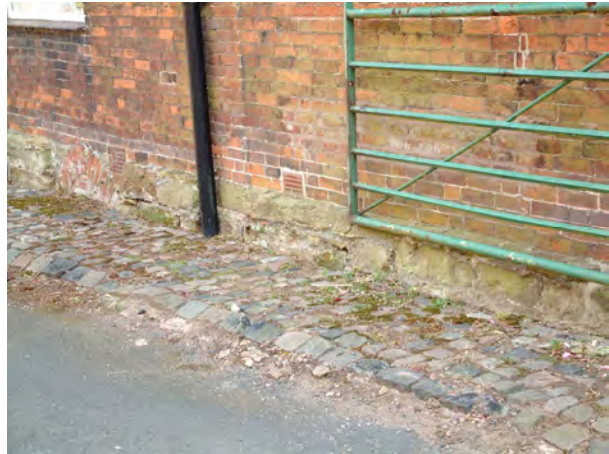
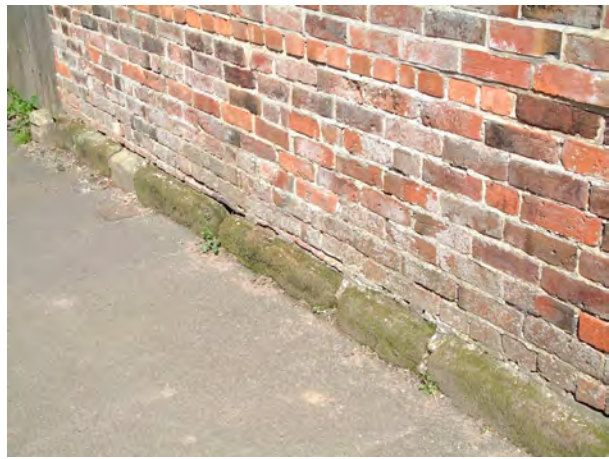
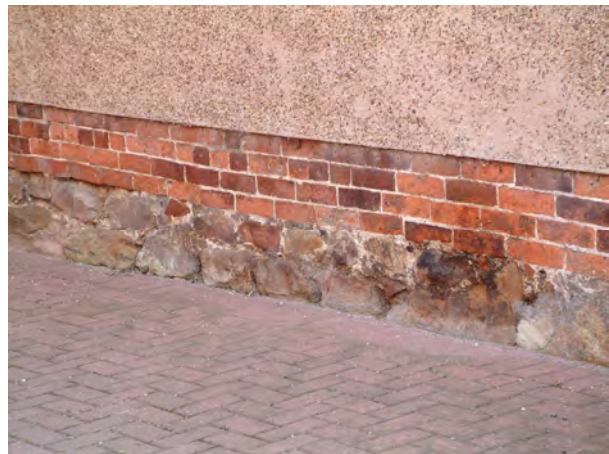
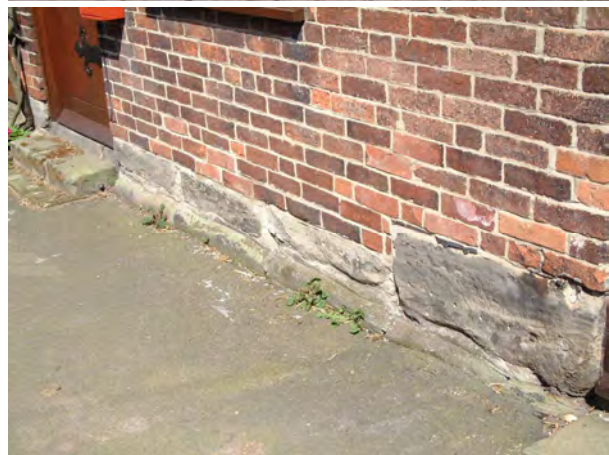
WALLS - Plinths

Milton has a number of brick buildings with a shallow stone plinth. In some cases this represents the rubblestone footings of an earlier building on the same site, but it was also adopted as a base for new walls (roughly coursed examples - right).

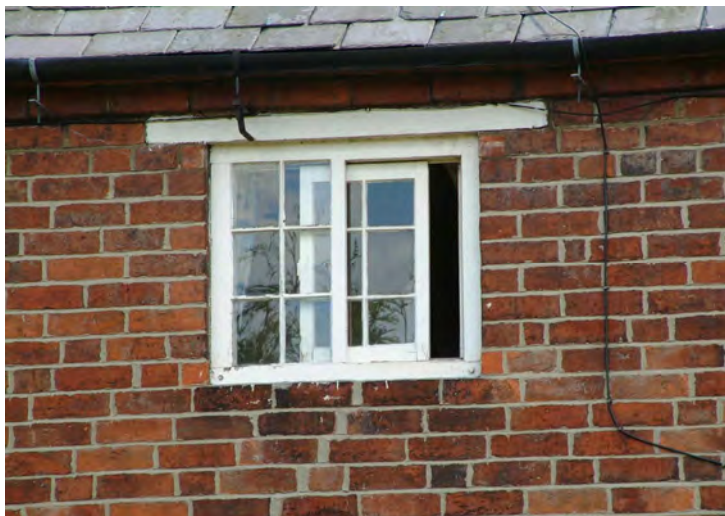
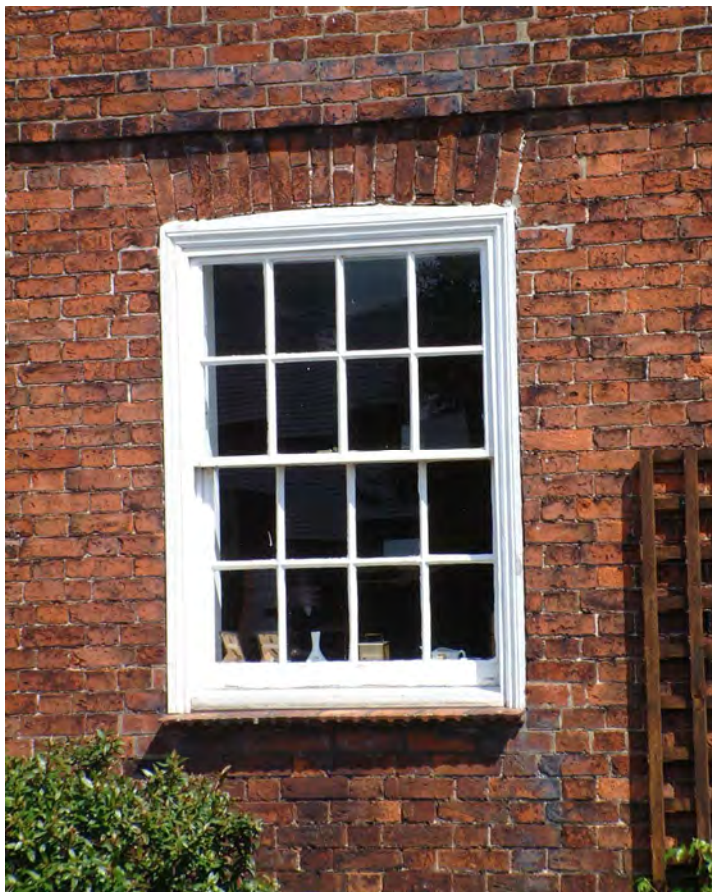
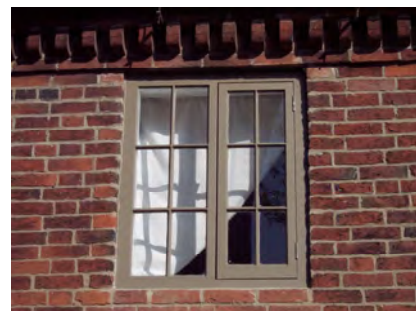
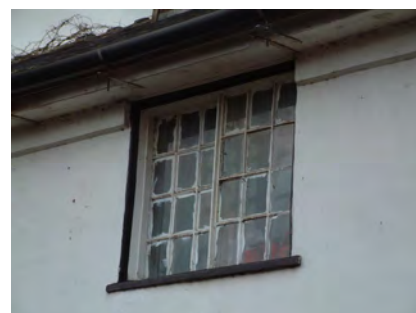
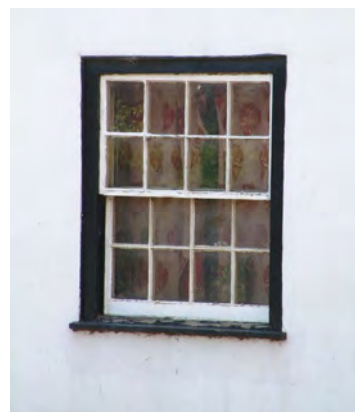
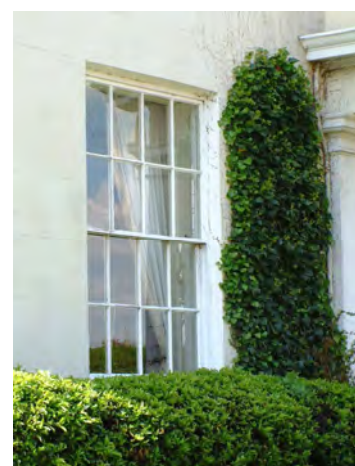
WINDOWS

Within Milton the main historic window types were vertically sliding sashes (below and below right) and timber casement windows, set within chamfered timber frames. There were also occasionally horizontally-sliding sashes, also known as Yorkshire sashes (above and bottom right). There are now few examples left of the once common casements. The example from The Farm (top right) is a recent copy of a traditional style.

Above - horizontally-sliding multi-paned Yorkshire sash

Below - vertically-sliding sash windows (8 over 8 panes)
