Initial Health and Safety Audit

**Conducted for South Derbyshire County Council
Cultural and Community Services**

**The Greenbank Leisure Centre
Etwell Leisure Centre**

**Carried out by Top Lodge Leisure Ltd
January 2022**

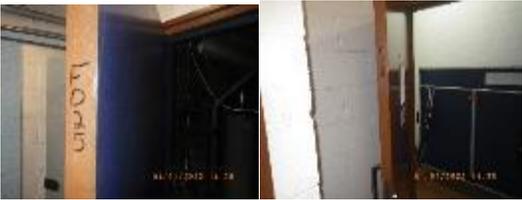
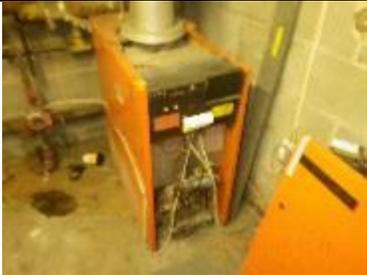
Fire safety	<p>The original fire risk assessment was not available and the review of the assessment that was available showed that none of the actions raised had been closed out. It was not possible to demonstrate closure indicating that the sites have not been brought up to a satisfactory conditions as far as fire safety risk is concerned.</p> <p>There is a fire log book in place at both centres however this is not used to its full potential and only used to record areas including fire extinguisher checks, fire drills and emergency lighting. Issues that have been identified are noted and recorded as being reported to TFM however closure of the issues cannot be demonstrated with some of the same faults being constantly reported.</p> <p>A fire door register is in place however many of the fire doors are inadequate in both buildings and require updating. Some doors are in poor condition and some have had air panels cut into them. The fire door adjacent to the sports hall at Greenbank had had ventilation holes put in that stops the doors from being classed as fire doors.</p>

Fire door with vents cut in. The properties of the fire doors have been defeated.

<p>The fire doors to the studio in the APEX Centre did not close properly.</p> <ul style="list-style-type: none">• An inspection of all fire doors to take place to identify where replacement/remedial actions are required. This could prioritise those that are in the poorest condition and programmed as part of the ongoing maintenance plan. <p>Evacuation drills take place with the Academy at Etwell however although the drills are recorded there is very little information as to how the drill went and whether additional training is required. Similar comments also apply to evacuations carried out at Greenbank.</p> <ul style="list-style-type: none">• Additional information could be added to the Fire Log book identifying any specific issues that may have arisen.• Drills could be made more realistic with scenarios put in place such as blocking a normal evacuation route or placing an object in the zone areas (rooms etc).• Evacuation drills to be carried out to ensure that people with disabilities are able to leave the building safely particularly at the Greenbank Centre. The emergency action plan to be updated to reflect this procedure. <p>A certificate of fire conformity for the fire extinguishers at Etwell was issued by CLK Fire and Safety Compliance Ltd on 24th May 2021.</p> <p>Servicing of extinguishers at Greenbank had been carried out by TFM. Records were not able to be accessed. Certification had been granted by TFM despite two extinguishers being recorded as not being passed.</p> <p>The lift doors at the top and bottom of the stairs at the Greenbank Centre did not have any warning notices on them regarding the use of lifts during fire.</p> <ul style="list-style-type: none">• Evacuation procedures to be reviewed to ensure that the safe evacuation of people with disabilities is identified and procedures put in place and documented.
