Repton *Conservation Area* Character Statement

2010
CONSULTATION DRAFT

**SOUTH DERBYSHIRE
DISTRICT COUNCIL**

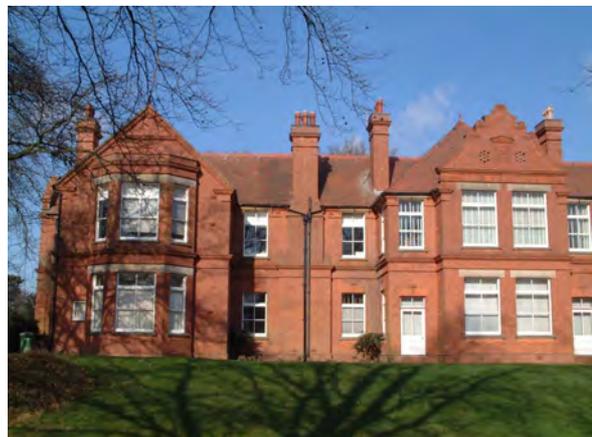
Repton Music School

Sanatorium of 1892) stand out as a major landmark on the main approach. As the road bends to the south, the frontage of the Music School is revealed with its heavily articulated bay windows, and its complex roofline incorporating Dutch gables and multiple chimney stacks, silhouetted against the sky but softened by large mature limes in the foreground.

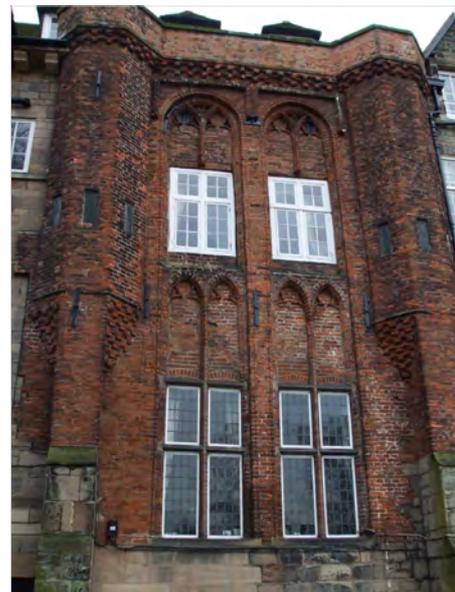
Prior Overton's Tower

Although brick only became popular and relatively commonplace during the 18th century, Repton can boast one of the earliest examples of decorative brickwork in the country, in Prior Overton's tower. However, there are few examples of brickwork used in Repton between ca.1438 and the early 18th century (except perhaps the brick walls within the grounds of The Hall). In this intervening period the main materials used in Repton were

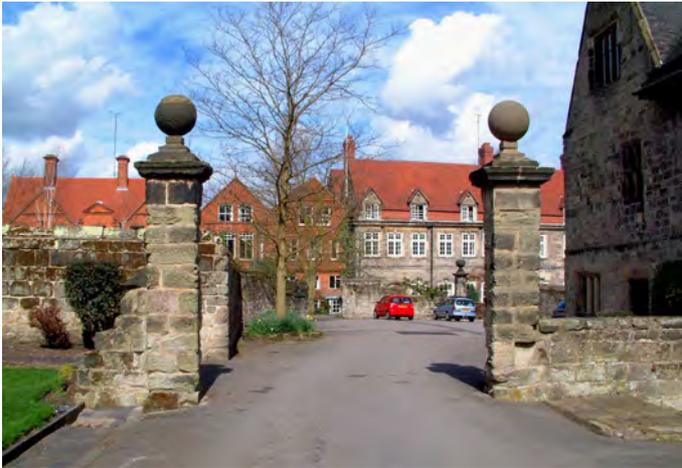
The Hall as viewed from The Priory

result of a lawsuit between the governors of the school and the Thacker family. The space was originally enclosed to the south by the gateway, which formed part of a gatehouse, which would have typically contained a single room on either side, by the churchyard wall to the west and the main Priory buildings to the east. To the north further ranges of monastic buildings are likely to have enclosed the space. This is now a courtyard used for car parking and has a large concave wall defining the northern boundary, and incorporating 2 large modern openings, in addition to the 17th century gateway to The Hall. The walls step down to frame the gatepiers and a view of The Hall.

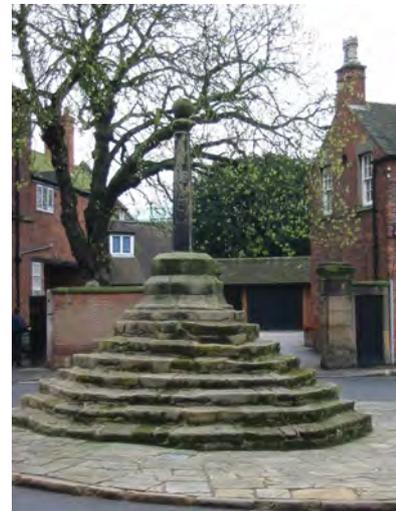
The market cross sits on a multi-faceted base, which is medieval in origin and presumed to be on its original site. This and an area of modern stone paving surrounding the cross form a central circular traffic island.

The market cross

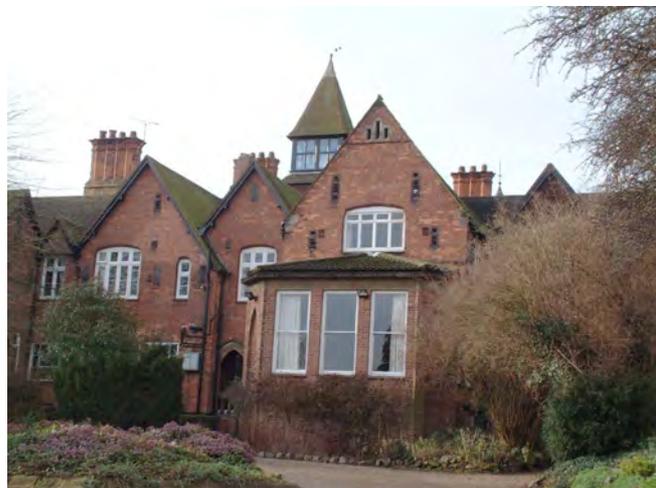
The Priory and Brook House stand out within the street because of their size. They were large 2 and 3-storey purpose-built school accommodation buildings. The Priory (still in use by the school) is the more interesting of these buildings, built in a Gothic Revival style and incorporating many unusual details – Gothic traceried windows, star-shaped chimney stacks and lantern with spire. It was designed in the style of Victorian architects such as Butterfield, to look irregular, as though it had evolved and had its own history, and to

incorporate a picturesque skyline. In contrast, Brook House (now private flats) is plainer, built as a straightforward block, the main elaboration being in the use of half-gabled dormers and the choice of polychromatic details for mouldings, such as buff terracotta for the corbelled eaves and verge and a band of sawtooth moulding, and alternating blocks of coloured ashlar around the entrance door.

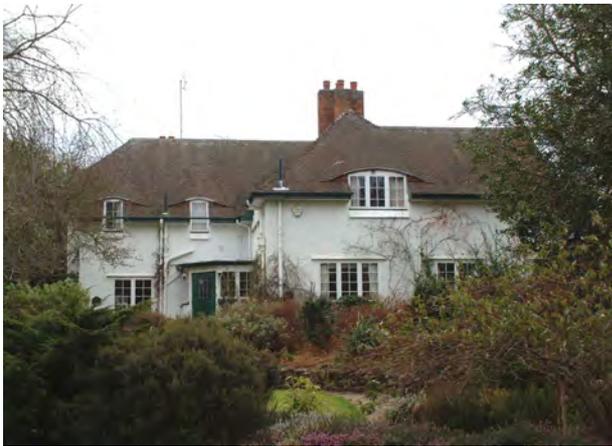
31 Burton Road

The use of render can be found on early 20th century buildings – e.g. numbers 20-36 The Pastures, 31 Burton Road, 11 The Cross, 22-24 Burton Road. This is found as pebbledash or “wet-dash” textured finish, and was a common Arts and Crafts finish at this time, as it was thought to represent a national vernacular tradition. Historically render in Repton was finished smooth using lime and occasionally lined-out to create the impression of ashlar. The instances of original 19th century render surviving are few, most having been replaced in recent years. There are patches of “wet-dash” render still surviving high up on the Old Priory buildings. Smooth lime render has occasionally been replaced in “wet-dash” or pebbledash.

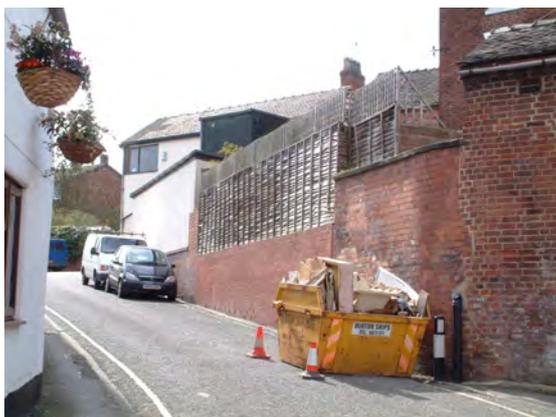
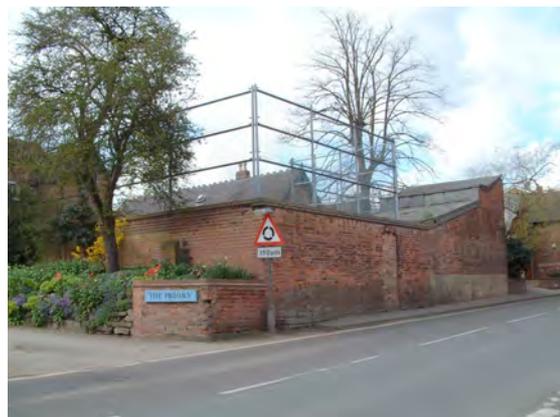
There is a widespread use of high-level netting and chain-link fencing associated with school premises, designed to prevent balls from escaping the school grounds. This appears to be a

perennial problem (with no easy solution) as an early 20th century photograph of the school precinct wall and cricket ground shows. The following sections of raised high-level chain-link fencing within school grounds have a negative effect on the surrounding streetscape:

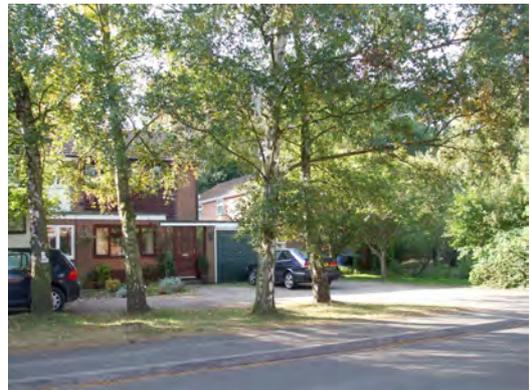
Brook End development

- in front of 20-24 Brook End. Because Brook End has such well-defined boundary walls, the complete loss of enclosure in this one location is very noticeable. Late 19th century photographic evidence suggests that this row replaced a large 17th century house, built directly onto the road frontage.

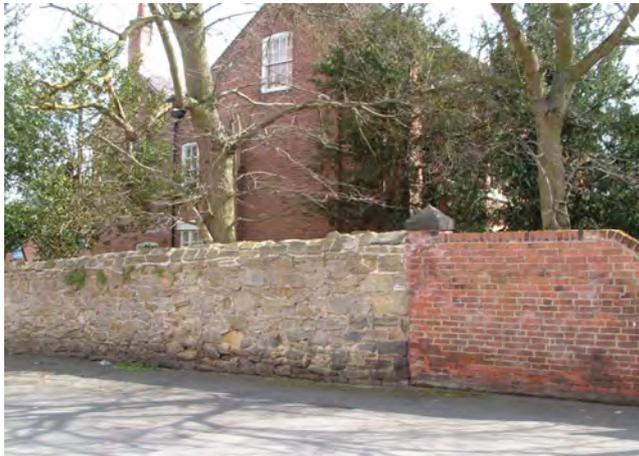
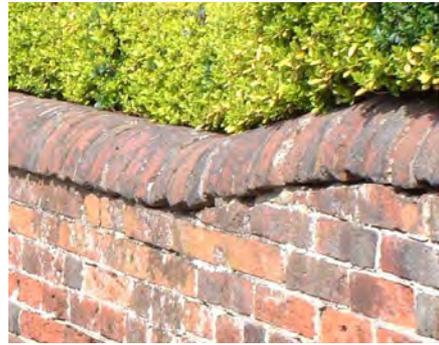
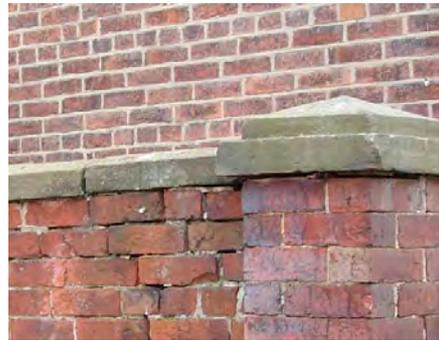
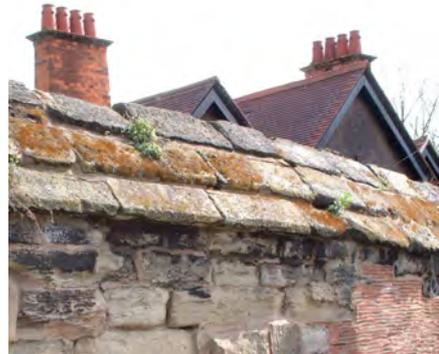
Walls and copings

The earliest walls within the village are built from local stone, the best examples being the large blocks of stone used for the Priory precinct walls, which have wedge-shaped stone copings (right), but there are instances where rubble sandstone survives, usually on the side passages, sometimes freestanding & sometimes used for the footings of a later 18th or 19th century wall (right).

Many walls retain original copings of shaped “dressed” stone, tooled by a stonemason to a fine surface finish, or moulded red clay. Brick on edge copings are also found, but historically they are only used in subordinate locations. Unfortunately, shaped brick copings have often been replaced inappropriately with brick on edge as a cheaper expedient.

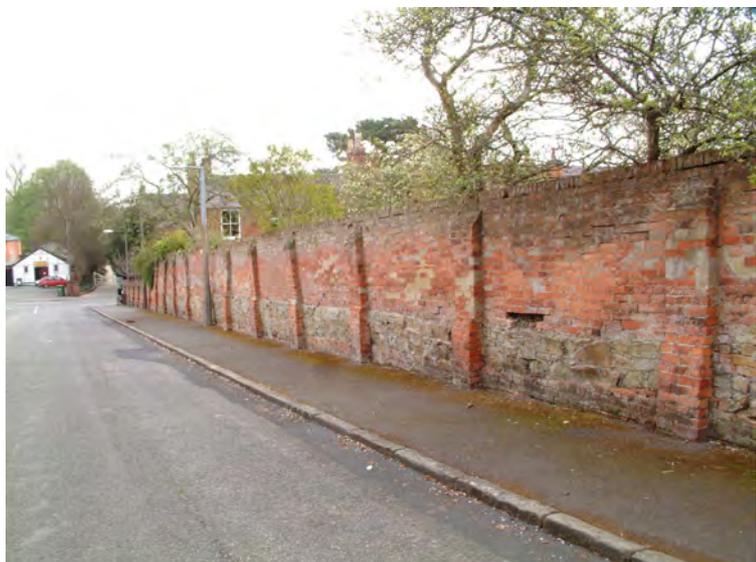
Most of the boundary walls serving domestic properties within Repton are built from red brick, with a sparing use of headers to form the bonding pattern. The example on the right is a late 19th century wall to The Priory, using English Garden Wall bond brickwork and red clay copings on an earlier wall.

The original dressed stone copings survive on the example below, although the railings which were fixed to the stone coping at The Old Manse (1 Main Street) have been removed.

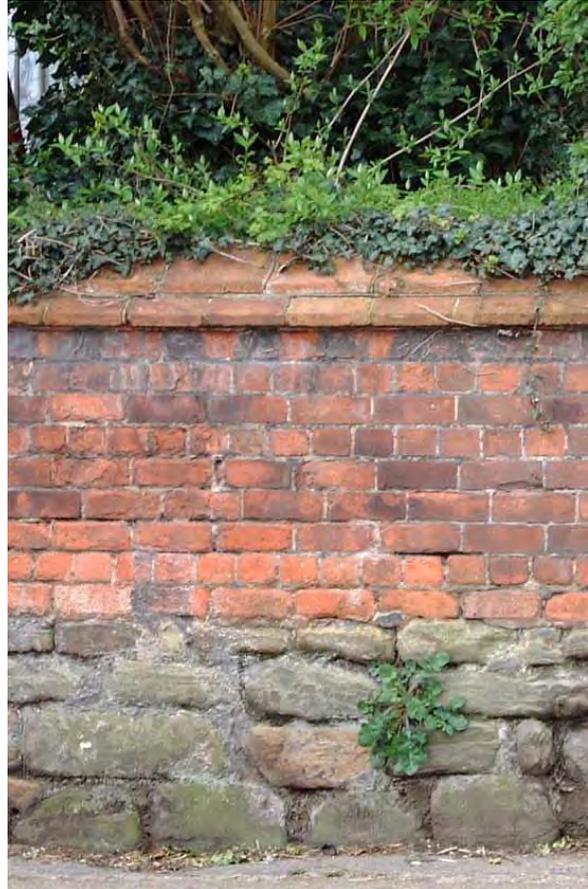
Brick wall and stone coping at Holly Bank, Main Street (below)

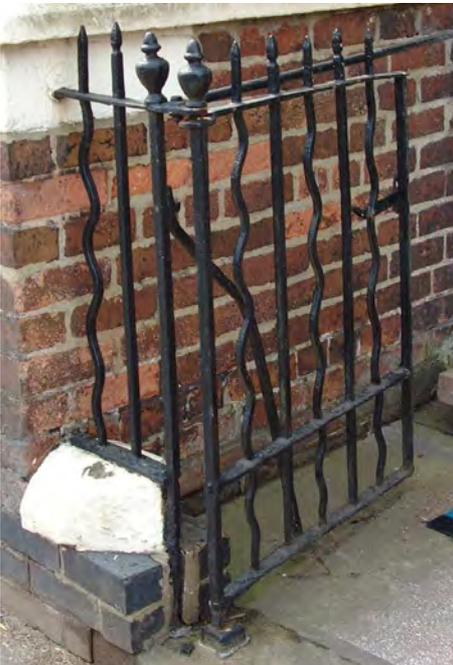
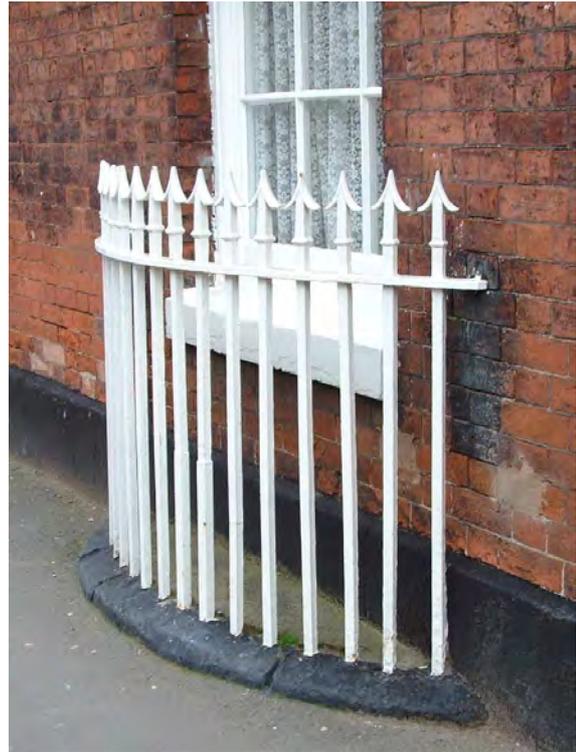
Repton once had many frontages embellished with a fine set of railings. These range from the late 18th century slender, square-section, wrought-iron railings, with each vertical bar fixed into an ashlar stone plinth (right - in front of No. 3 High Street), to the 20th century steel railings at the school entrance to The Queen's Walk by the Four Hundred Walk (not illustrated).

Many of the smallest terraced cottages along High Street and Main Street had sets of railings, with an identical pattern adopted for each row.

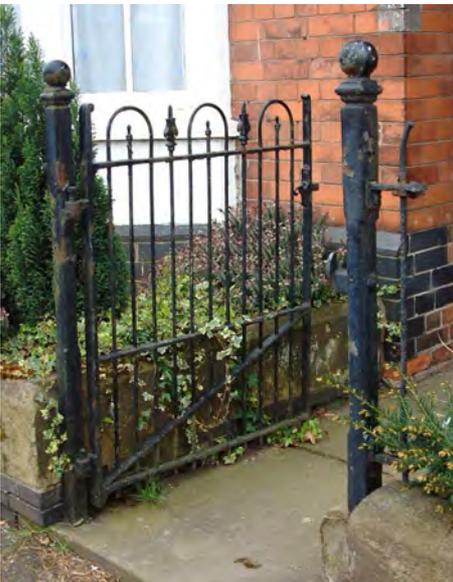
Although most of the railings have been removed, many gates were retained and these incorporate cast-iron posts with ball tops and urns and railings with hoops, spear-tops, buds and spikes. These provide detailed evidence of the former appearance of the railings.

The examples at 92 & 72 High Street (left) combine both cast and wrought iron

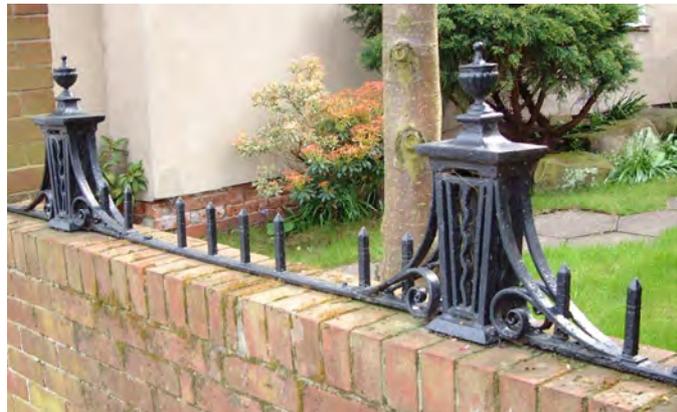
Art nouveau ironwork at 13 Burton Road (below).

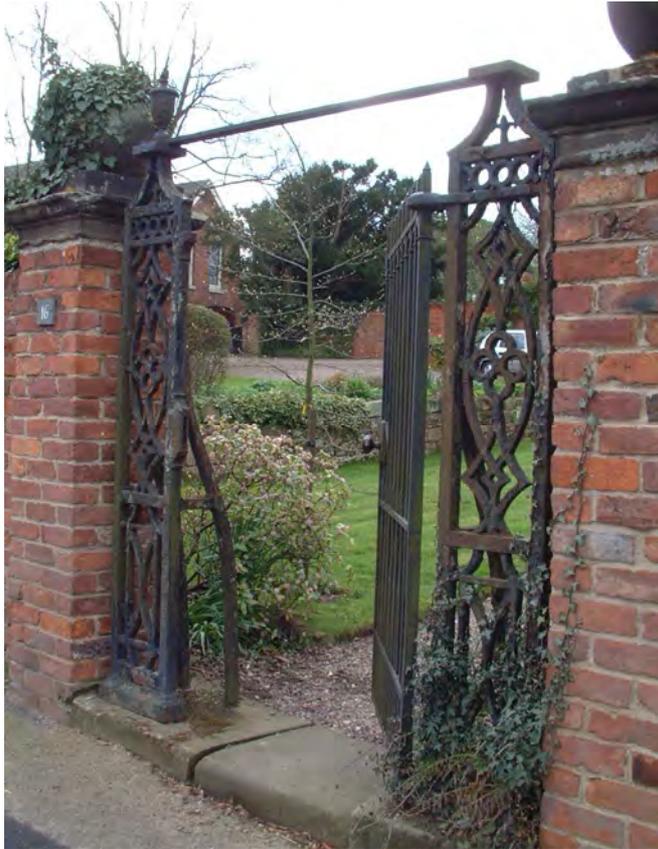
The cast-iron gateway at The Grange on Main Street (left) illustrates the early use of cast-iron at the turn of the 19th century.

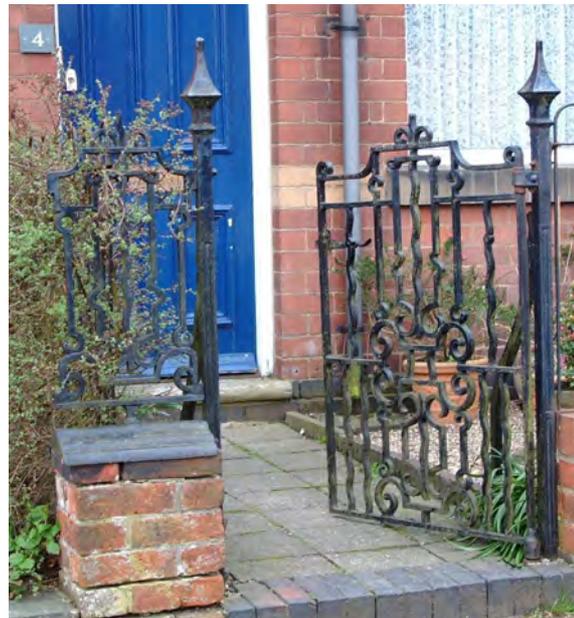
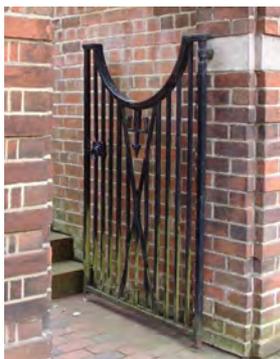
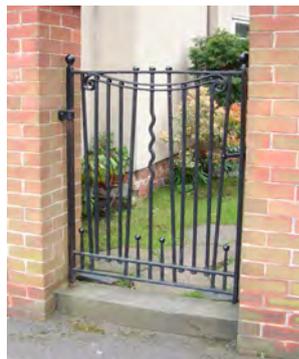
However, a revolt against factory production & industrialisation, epitomised by the Arts & Crafts movement, meant that from the early 20th century there was a return to the use of hand-made wrought-iron, exemplified in Repton at properties such as New House (below left) and 13-17 Burton Road (below right).

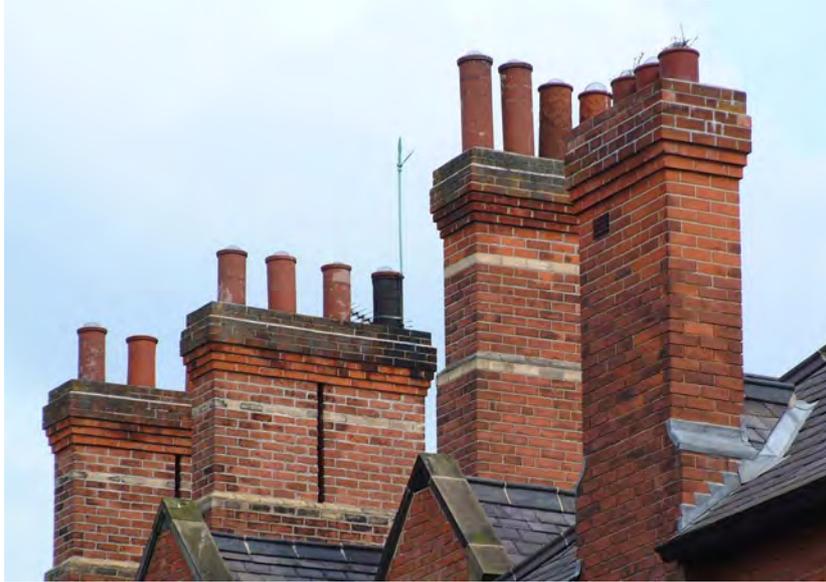
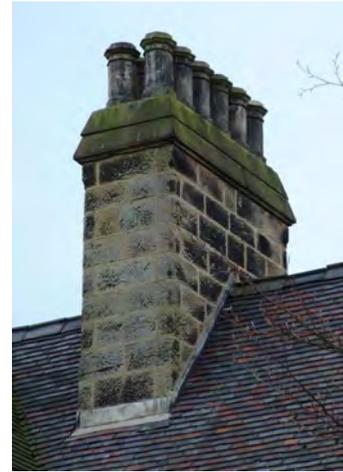
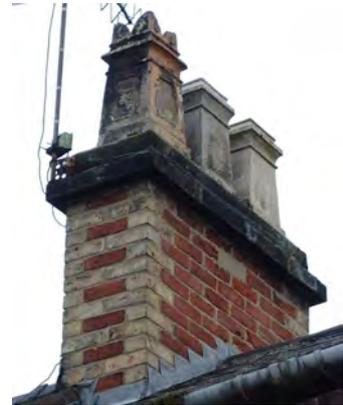
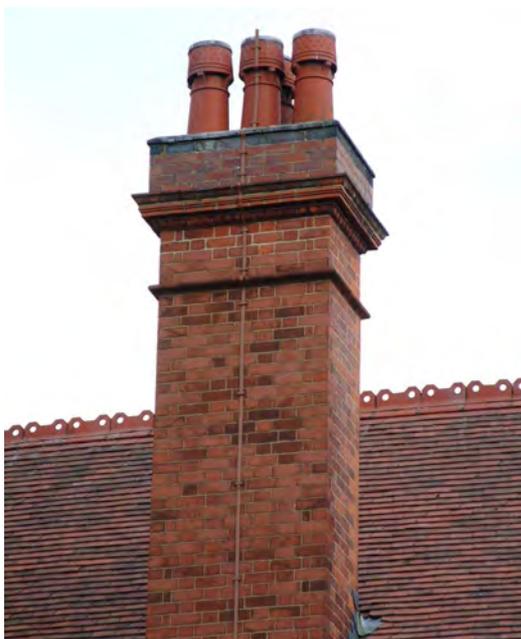
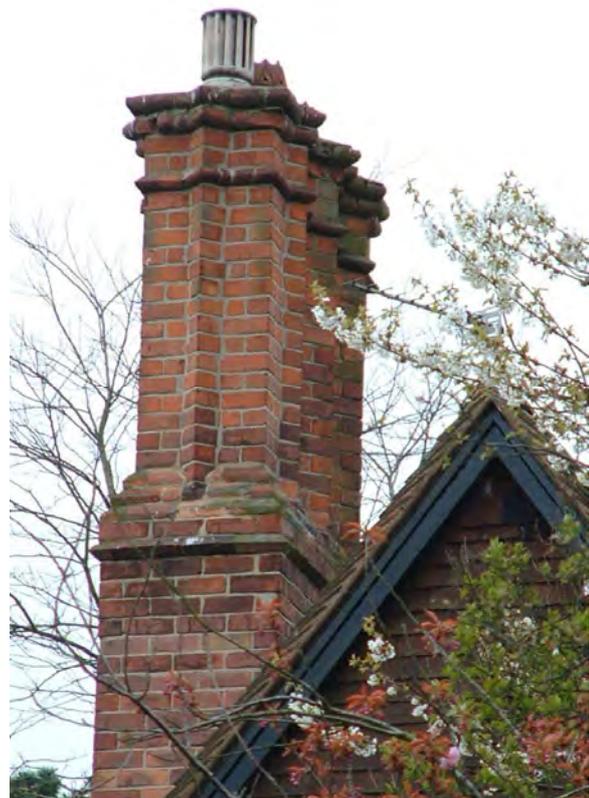
CHIMNEY STACKS AND POTS

The large number of late 19th century school buildings in Repton has led to an abundance of statuesque chimney stacks, some of unusual form, such as the star-shaped cluster of flues at The Priory (bottom right) and the stone stacks that emulate the Priory precinct walls, at The Orchard (top right). Plainer stacks also have a strong presence - Brook House (above) and the Music School (below), incorporating bands of moulded red or yellow bricks.

The small domestic chimneys were also occasionally quite inventive, such as those incorporating a yellow brick to form quoins (above right).

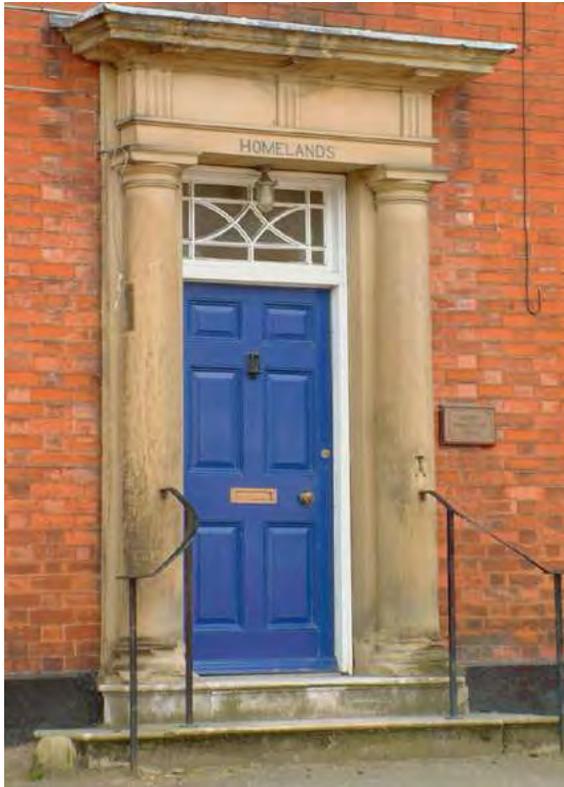
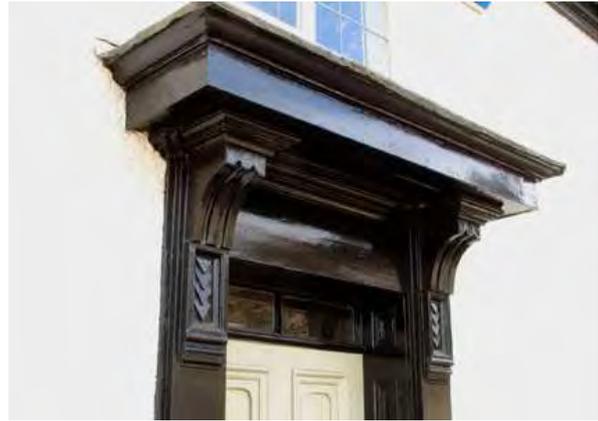
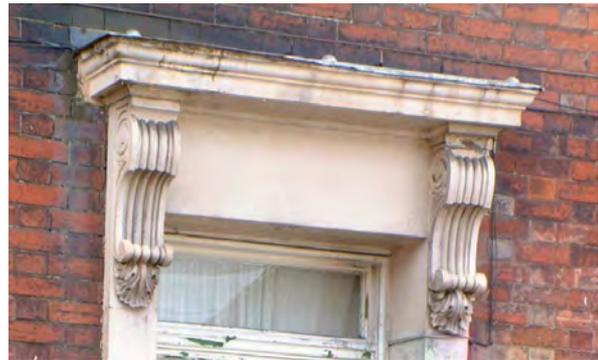
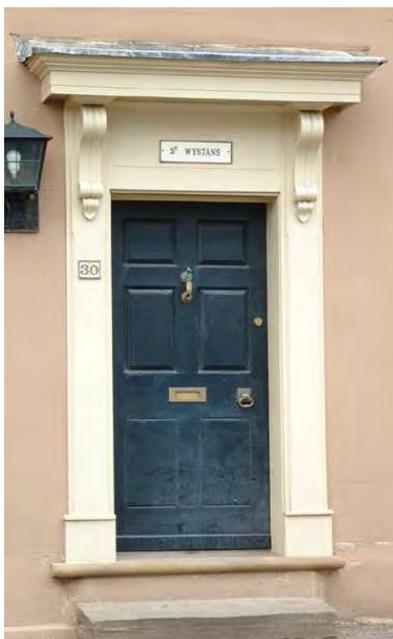
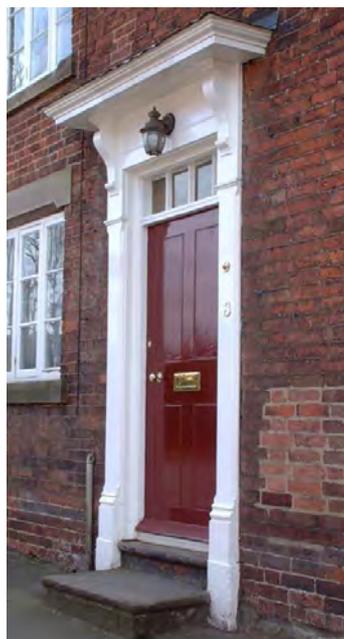
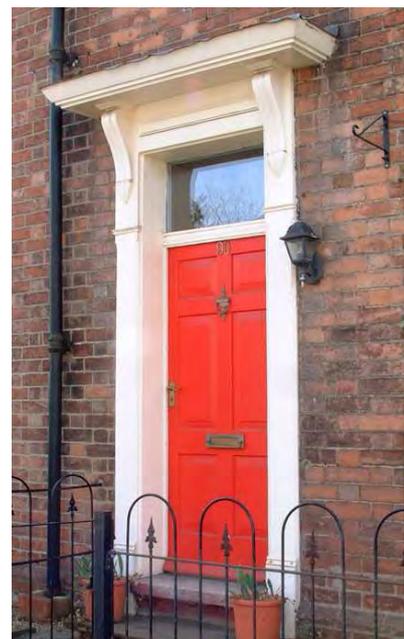
DOORS - Doorcases

Above - elaborate doorcases of the High Victorian era.

Above left - a complete classical Doric stone doorcase at 76 High Street, incorporating a full “entablature” and engaged Doric columns. During the 19th century the classical doorcase was adapted in timber and often simplified incorporating narrow, plain, square pilasters and decorative “console brackets” supporting the cornice (above and below).

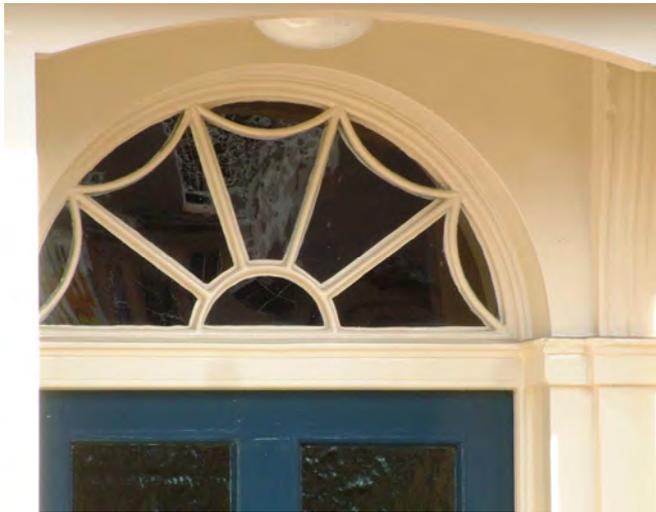
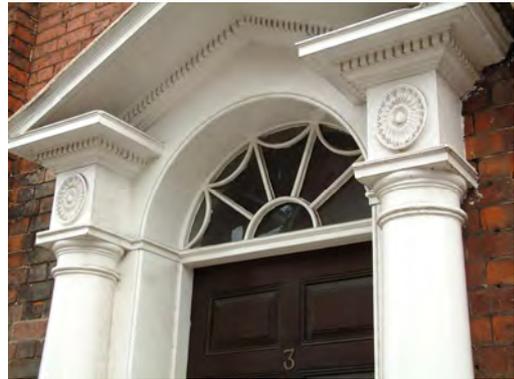
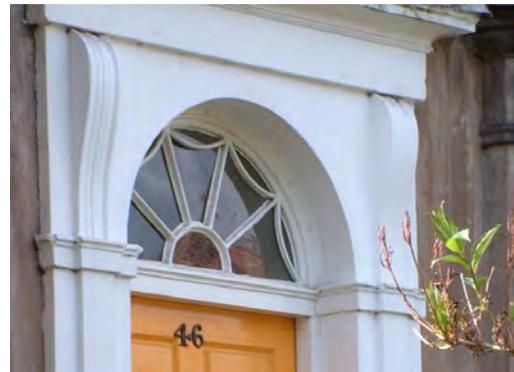
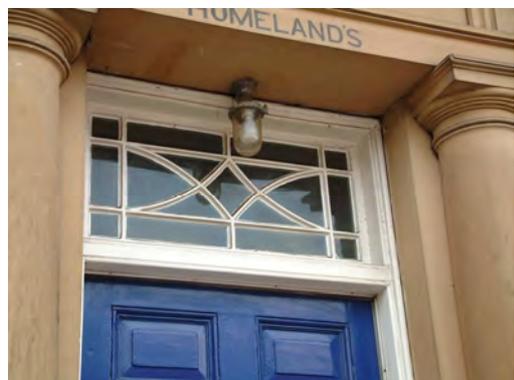
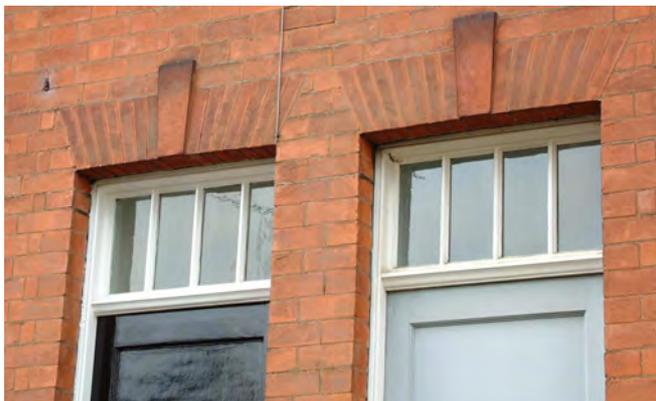
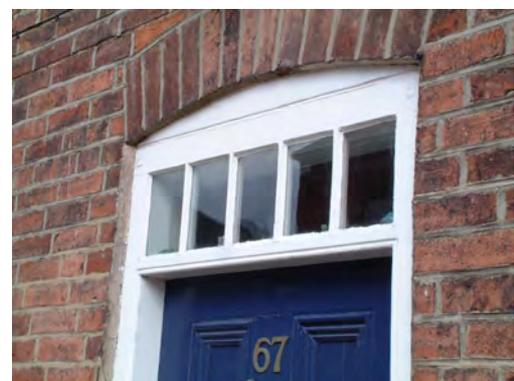
DOORS - Fanlights and Overlights

Fanlights were used to light a hallway, which was often otherwise unlit, and became common when house plans changed to incorporate a central hallway with a staircase in the Georgian period. Until then, doors generally opened onto a small lobby or directly into a room and there was no need for the additional light source.

Fanlights were positioned above the door, retaining the solid joinery of the door, and it was only in the mid to late 19th century that glass was inserted into the door itself.

Most of the earliest fanlights in Repton are semi-circular (or "lunette"), echoing the designs of Robert Adam, and incorporating a sunburst (top right - 3 & 46 High Street). An alternative was the rectangular overlight (76 High Street - right). Later overlights were much plainer (as used at 50-54 High Street, below, & 67 High Street, right) and tended to be rectangular and sub-divided by narrow vertical glazing bars.

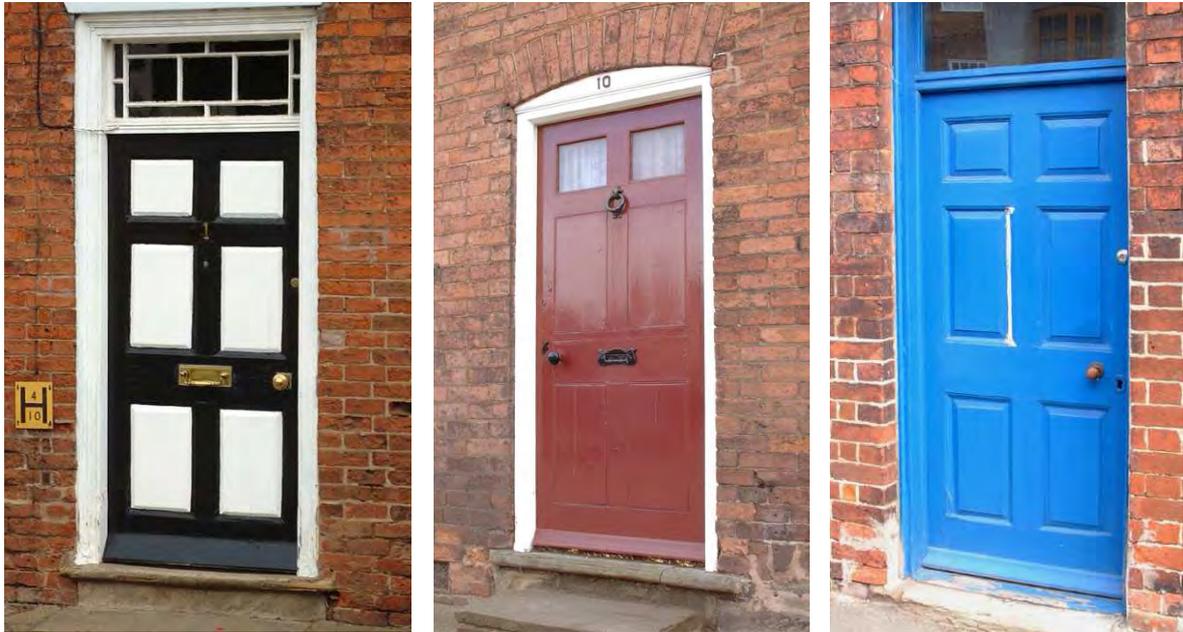
Above - Georgian six-panel doors at Brook End, High Street and Main Street. From left; (1) six-panel door with “double-chamfer” panels, (2) six-panel door with bead mouldings, (3) six-panel “raised & fielded” door

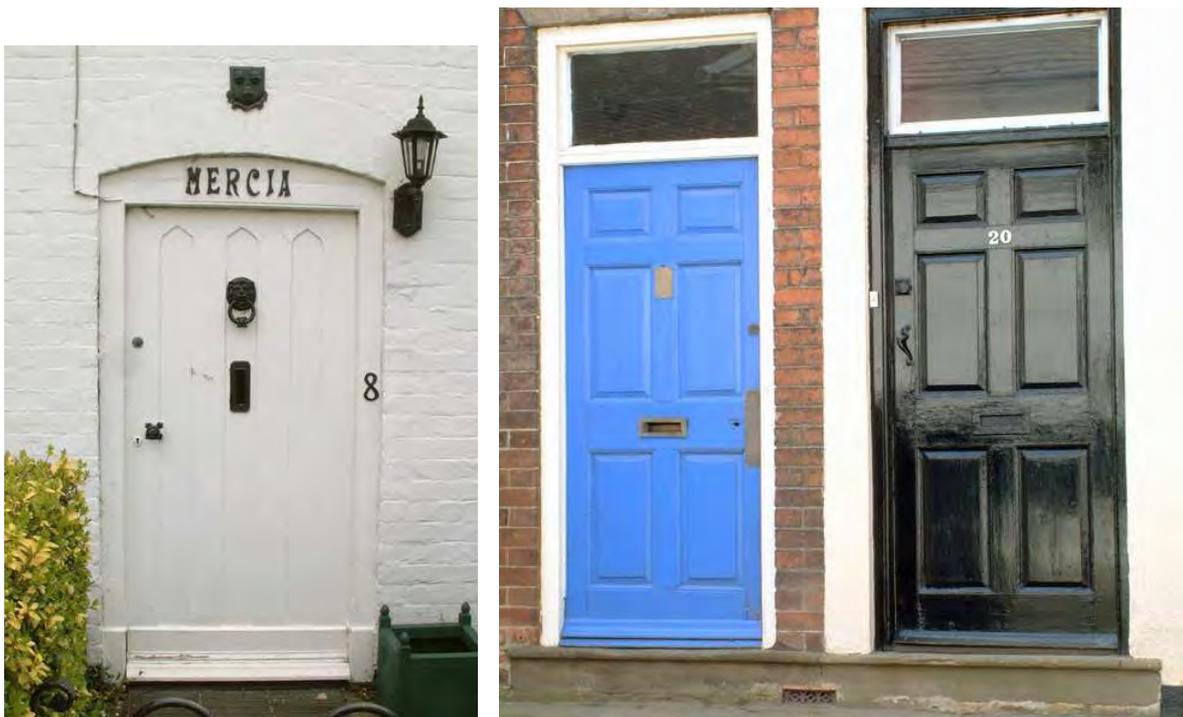
Below left - boarded door with pointed arched top rail in the gothic style. This style was commonly adopted by the Harpur estate in the early 19th century. Below right - pair of six-panel doors with “raised and fielded” panels (18-20 High Street). It is extremely rare to find original doors of this early 19th century pattern, particularly when designed as a pair.

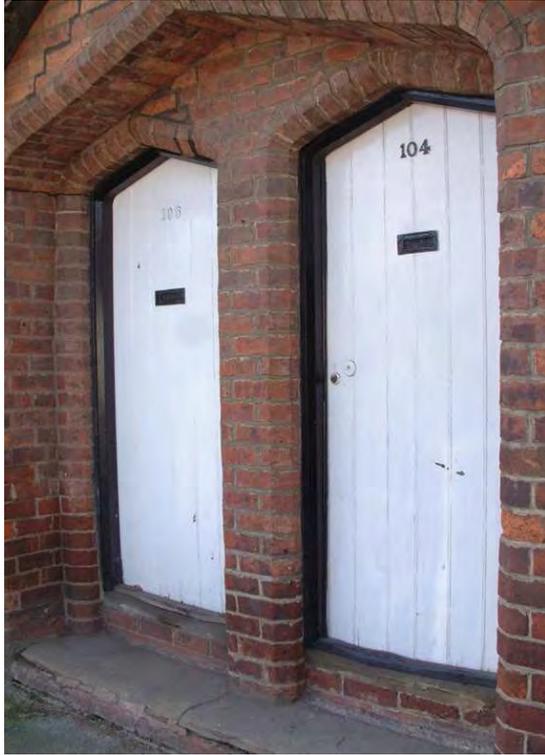
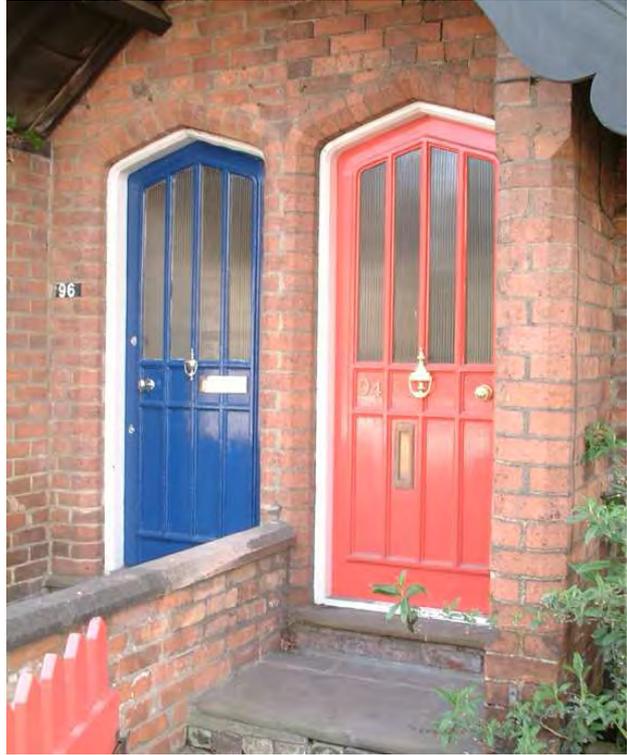
Above left - pair of fully boarded 19th century doors, a style appropriate for Gothic style cottages (104-106 High Street). Above right - pair of 19th century boarded and framed doors with applied fillets (94-96 High Street). This style was also adopted for its Gothic characteristics.

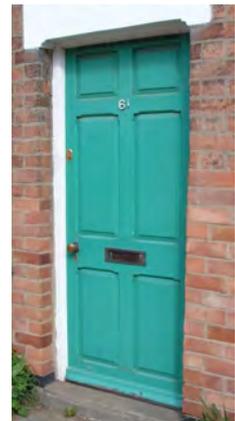
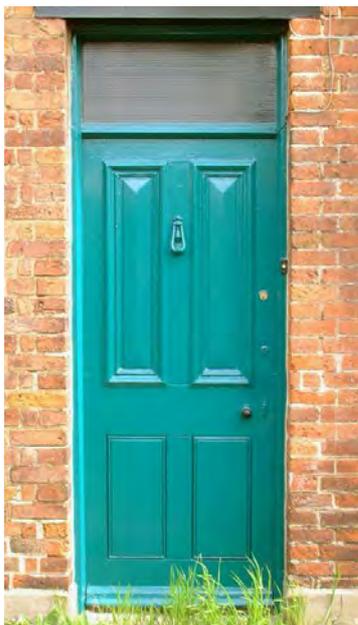
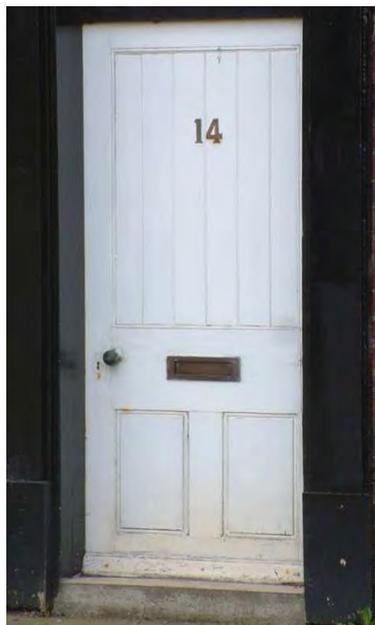
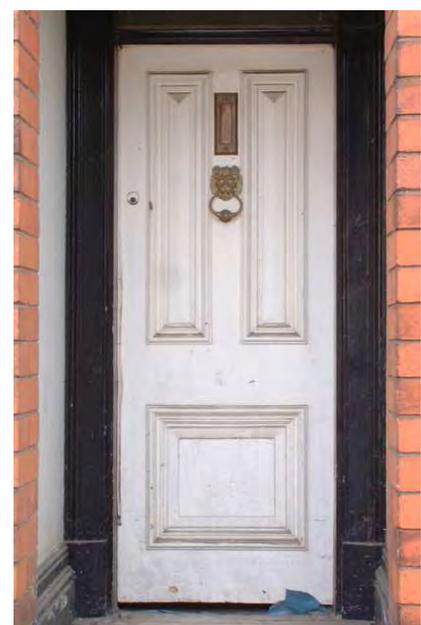
Right - late 19th century six-panel door with “chamfer-stop” mouldings.

Below - 19th century Victorian panelled doors. From left; (1) Four-panel with bead mouldings to bottom panels and raised panels above, with “bolection” mouldings, (2) Panelled former shop door with bead mouldings. The glazed panel has been boarded over. (3) Three-panel with heavy “bolection” mouldings.

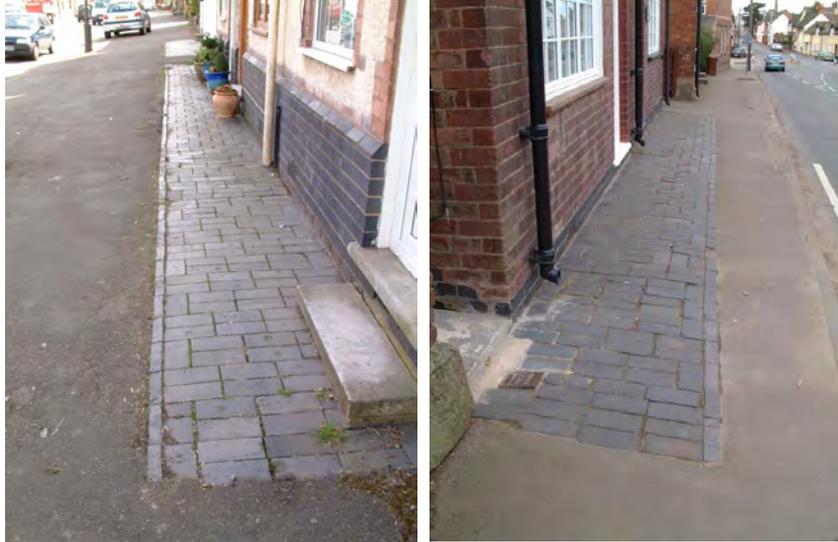
Band of blue clay bricks, approximately 1 metre wide laid as an apron in front of buildings, in a bond of paired bricks.

Apron in front of 68 High Street (grid ref. N 430, 568 / E 326, 672)

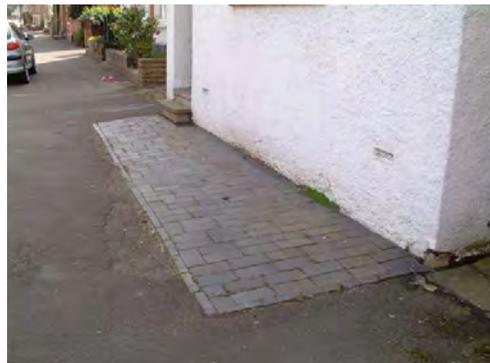
Apron in front of 12-14 Main Street (grid ref. N 430, 709 / E 326, 483)

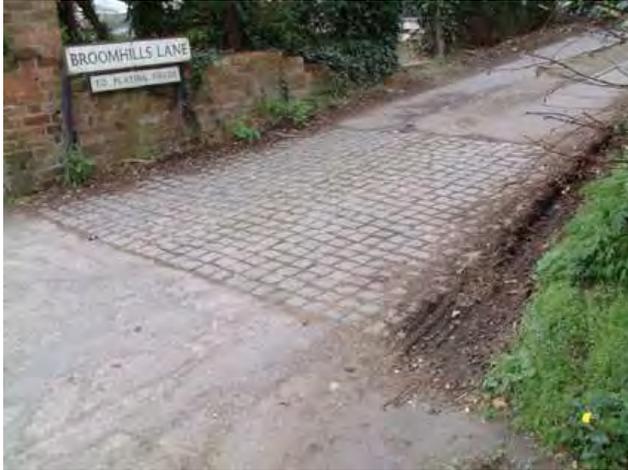
Left - Squared setts. Although this is a traditional material, it was probably laid recently.

Location:
Vehicle crossover at bottom of Broomhills Lane, off Main Street
(grid ref. N 430, 730 / E 326, 443)

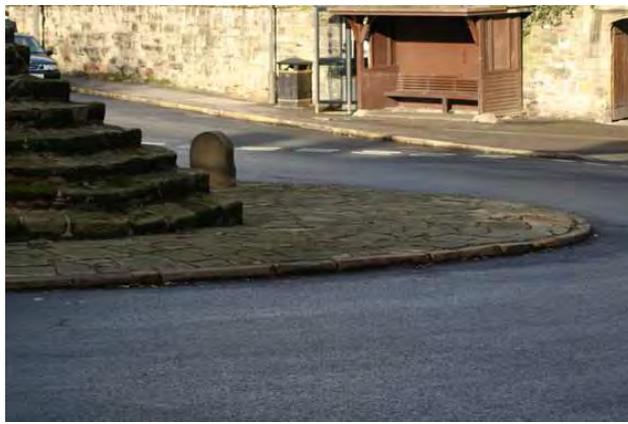
Left - Paving flags (crazy paving)

Location:
Surrounding the base of the market cross and the triangle
(grid ref. N 430, 371 / E 327, 016)

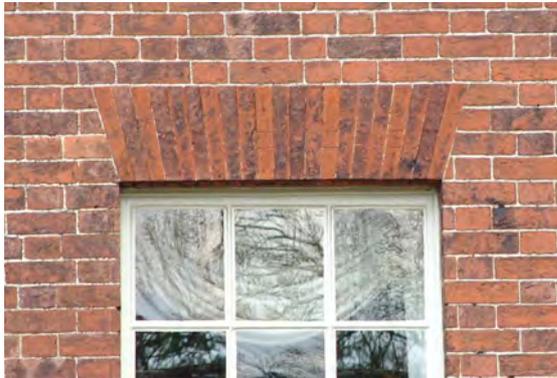
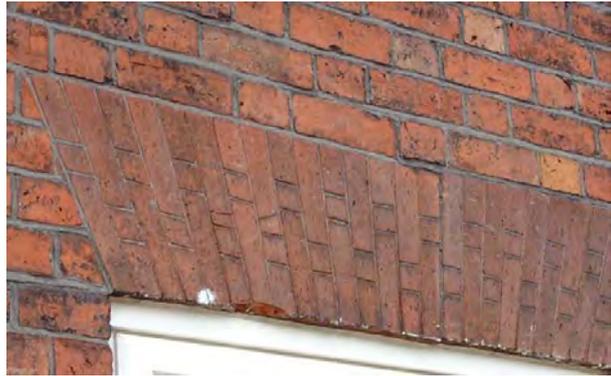
LINTELS & CILLS

In the 18th century, where wealth permitted in the finer houses, “hand-rubbed” bricks or “gauged” bricks were used. The result was a precise, thinly-jointed, wedge-shaped lintel. Originally, the brickwork joints (including false joints) were picked out in a fine white lime mortar or “putty”, which in most cases has weathered away (left and above). The example at 50 High Street (below) is an early 20th century copy.

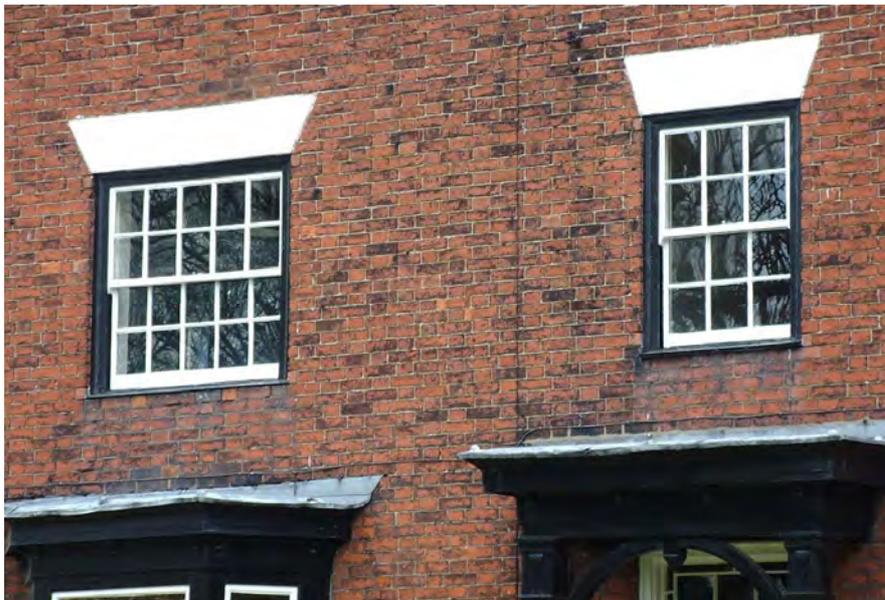
Brook Farm (above), with exposed sash boxes and wedge lintels. There are hints that the lintels are formed with render over original segmental arches, and that the sashes are a later alteration, replacing original casement windows.

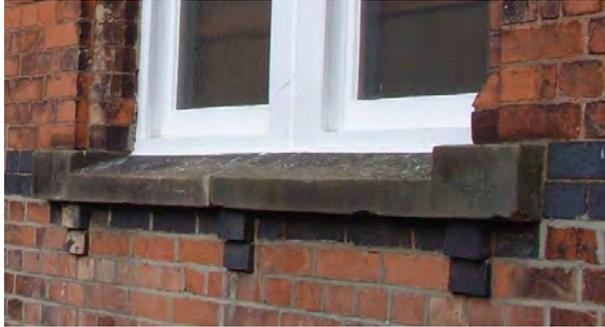
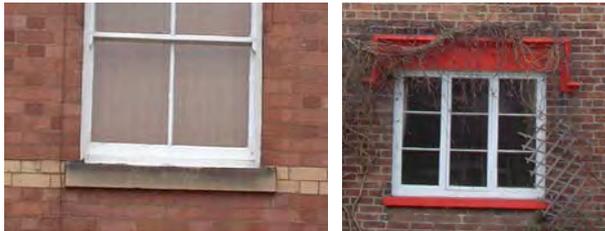
Stone cills (above) were common in the mid-late 19th century, although many are now painted.

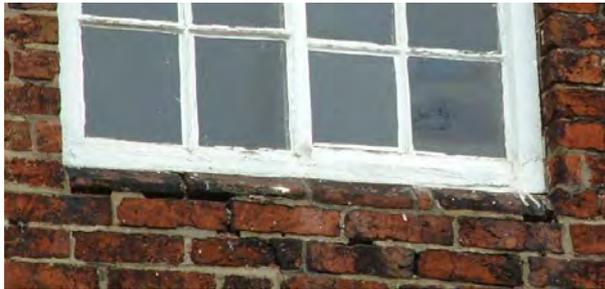
Above - where there was no cill, as with many of the smaller cottages and the less important elevations of the town houses, the window joinery was positioned close to the face of the wall. In the example above handmade bricks were moulded to create a weathering.

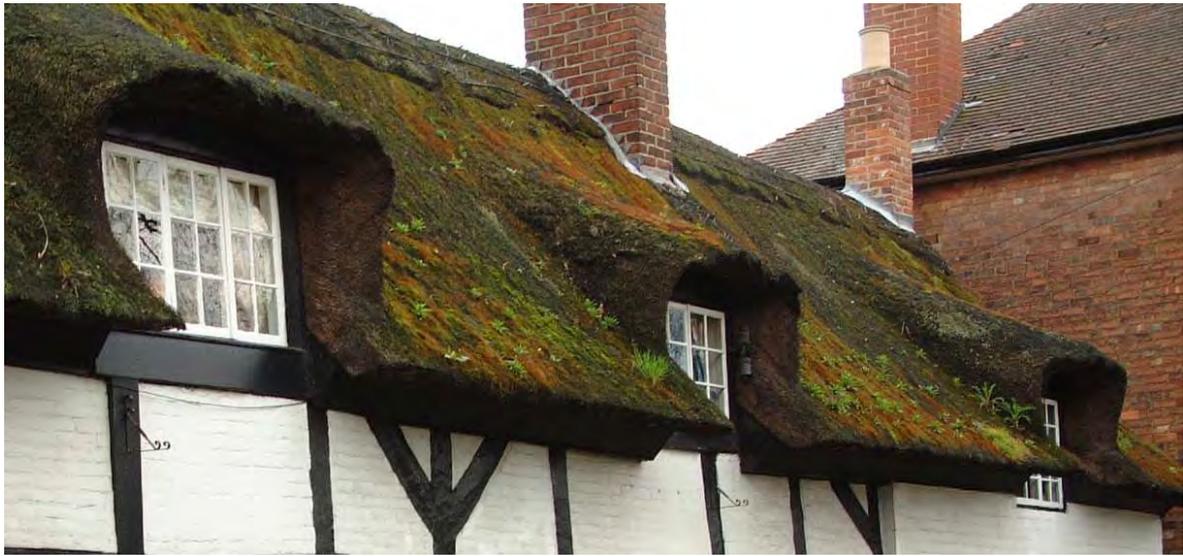
(Above) Thatched roof at 5 Willington Road.

(Below) A “laced valley” at 34 High Street. The detail can also be found at “Danesgate” on Well Lane.

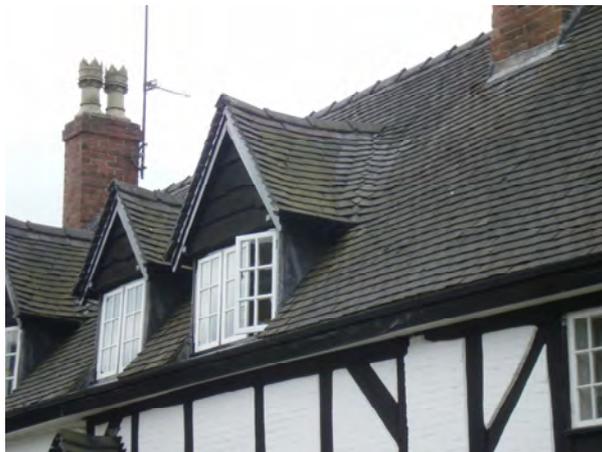
Decorative and plain bargeboards (right), incorporating timber finials. Scalloped and fretted bargeboards were used to create a picturesque Gothic character and interesting shadows. Bargeboards are found in combination with half-timbered gables. (bottom right).

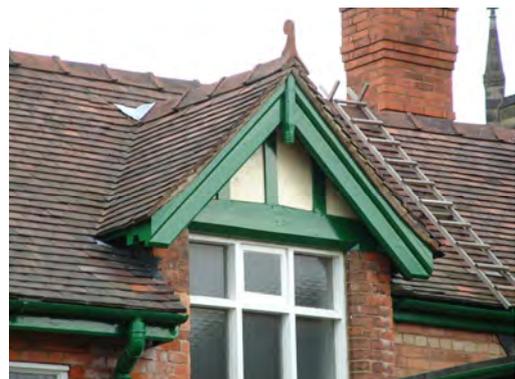
Left - pitched roof with corbelled brick verge

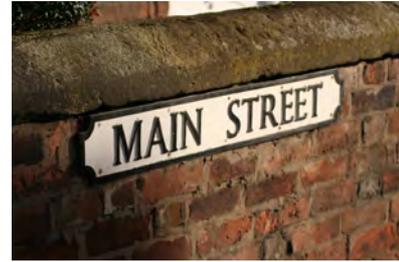
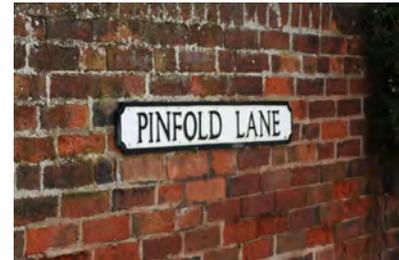
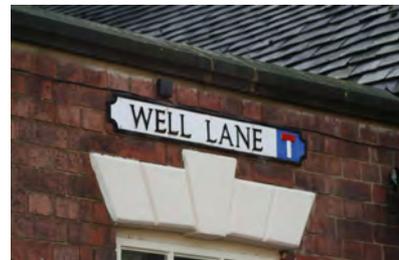
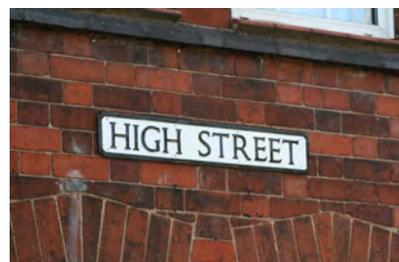
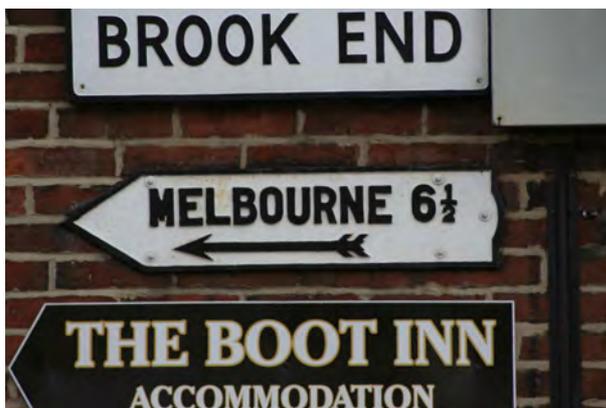
Left and below - Cast iron or cast aluminium street name plaque with raised letters and mitred corners (all reproduction)

“High Street” (pictured right), located on front elevation of 110 High Street at junction with Well Lane. (grid ref. N 430, 690 / E 326, 549)

“High Street”, located on boundary wall of 95 High Street at junction with Pinfold Lane. (grid ref. N 430, 662 / E 326, 539)

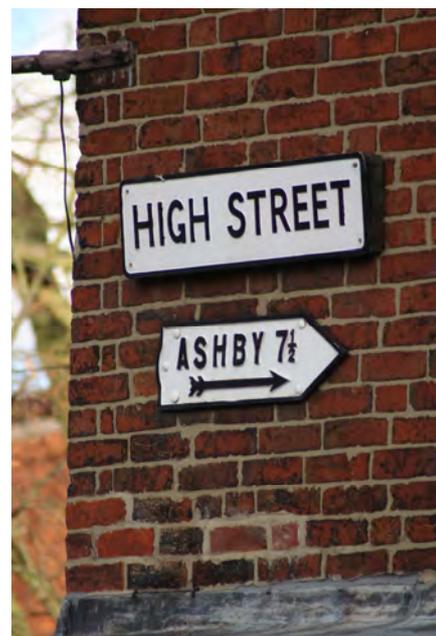
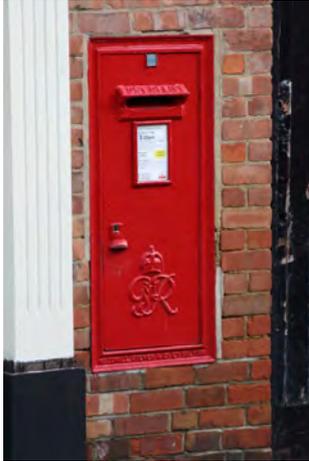
Above and bottom right - Arrow-shaped cast iron directional sign, with raised letters, arrow and mileage.

Gable end of 1 High Street. Sign says MELBOURNE 6 1/2 miles (grid ref. N430, 388 / E 327, 020)

Front elevation of 1 High Street. Sign says ASHBY 7 1/2 miles (grid ref. N430, 387 / E 327, 016)
