Repton *Conservation Area* Character Statement

2010
CONSULTATION DRAFT

**SOUTH DERBYSHIRE
DISTRICT COUNCIL**

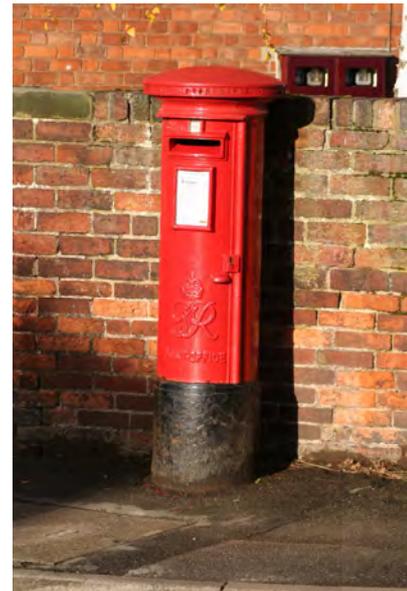
Left - GR letter box fixed within wall.
Location:
Wall of Post Office, 3 High Street
(grid ref. N 430, 403 / E 326, 992)

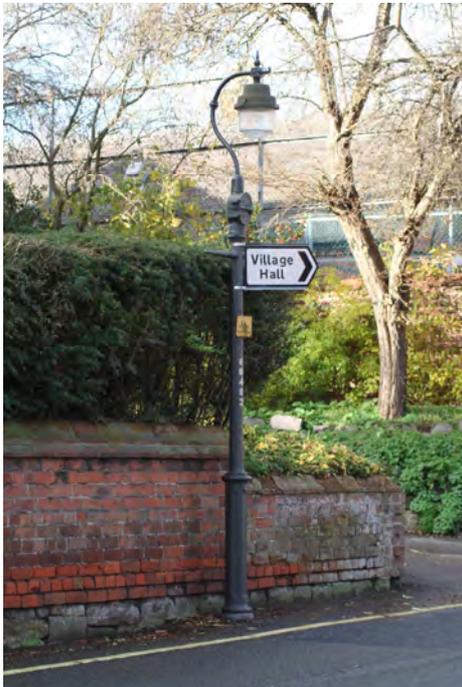
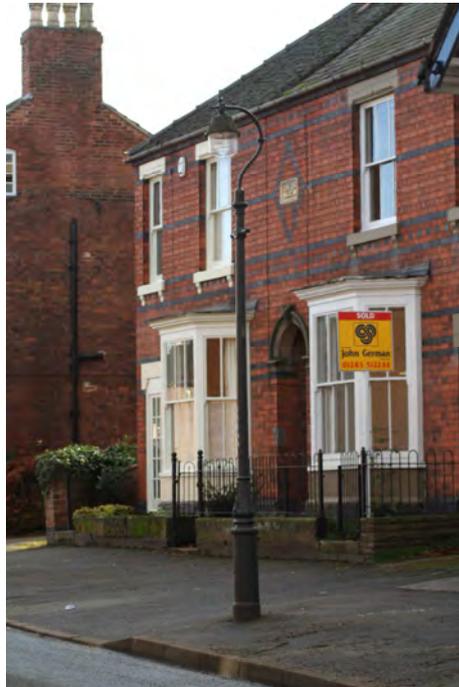
Right - GR Pillar Box.
Location:
Junction of Pinfold Lane and High Street
(grid ref. N 430, 695 / E 326, 546)

Above - Cast iron lighting columns

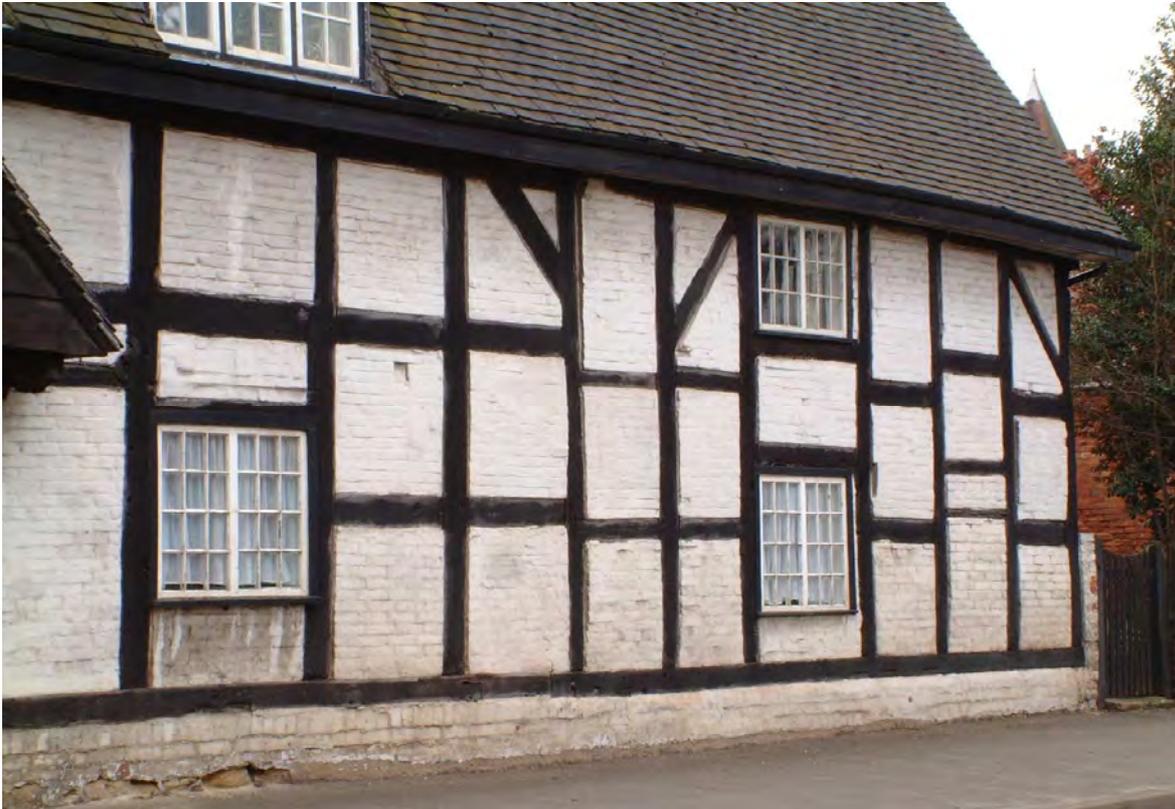
Timber-frame

Up until the 18th century, the principal building materials for the smaller houses were timber, with panels of wattle-and-daub. The type of timber-frame used in Repton is known as small box-framing - a combination of posts and short horizontal rails. There are examples along High Street, Burton Road and Willington Road. The wattle and daub was often replaced with bricks, a practice known as “nogging” (above - 34 High Street), here painted white.

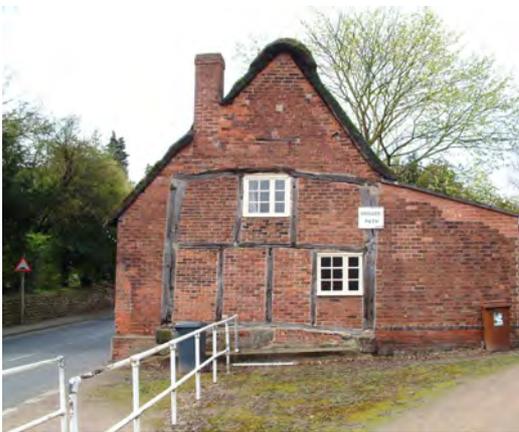
Left - fragments of box frame can still be seen in the gable end of 10 Burton Road. In this case the wattle and daub panels were replaced in unpainted red brick.

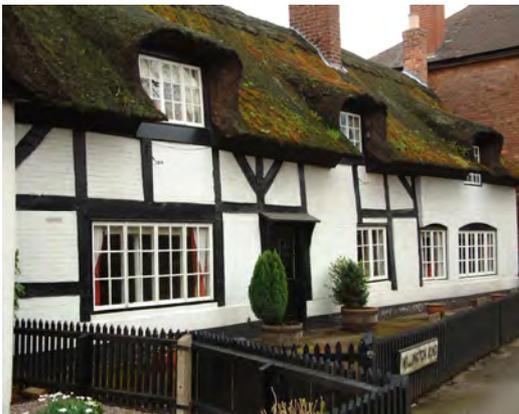
Braces are used in the construction, near the corners, and at the junction of internal partitions, to stiffen the structure, as at 5 Willington Road (bottom).

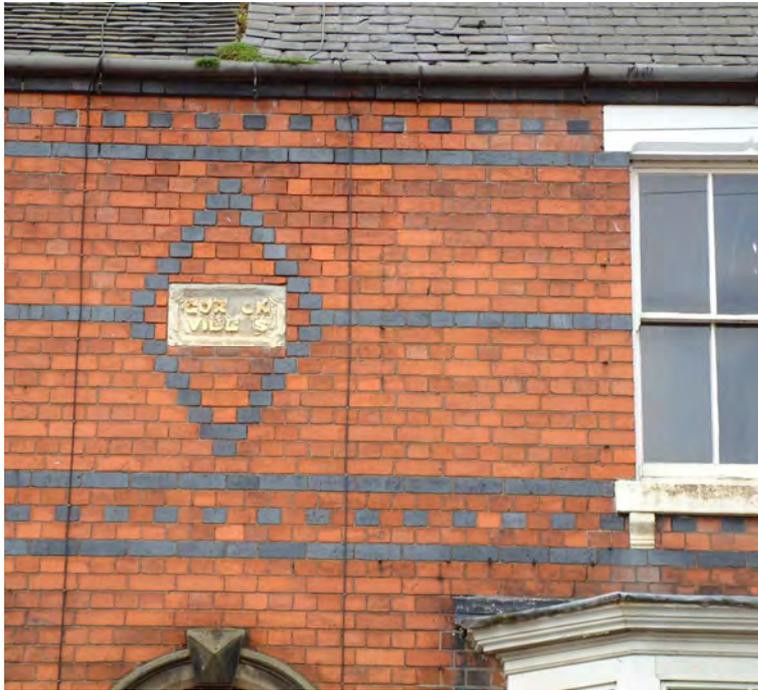
Polychromatic brickwork using blue bricks (above), and occasionally buff, was used in the second half of the 19th century in Repton. At 8-10 Well Lane (above right) a simplistic diaper pattern on the gable end with hood moulds in blue brick, echoing Tudor brickwork, distinguishes the building above the ordinary.

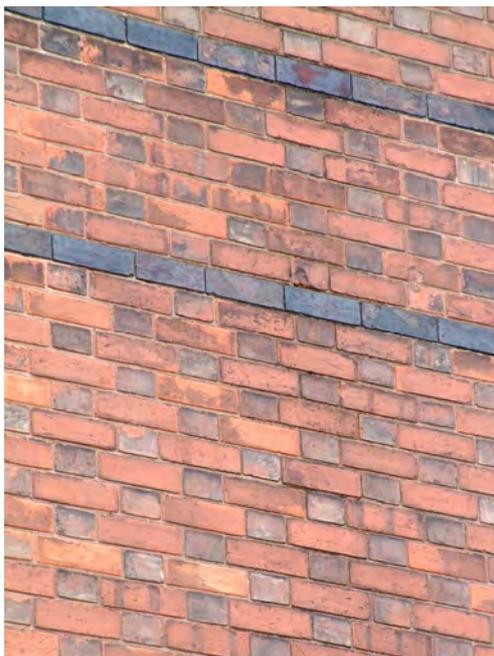
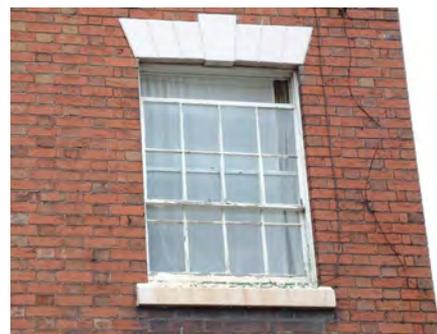
Below - Flemish bond brickwork was extensively used in the 18th and 19th centuries. It could be used to decorative effect by incorporating coloured “headers” picked out in a subtle contrasting shade (here, blue and pink).

There are several types of decorative brick eaves. The earliest used brick corbelled out in a “dentilled” or “sawtooth” pattern (right), and sometimes combined half-round cast-iron gutters on metal brackets, fixed to the brickwork.

In the 19th century the eaves became even more decorative, some with shaped or moulded brick “modillions” in blue or buff coloured bricks (bottom right). This created a distinctive decorative eaves line. In most cases, gutters were of cast-iron ogee form and had a square base which sat on top of the projecting eaves, avoiding the need for any visible brackets (bottom). The gutter profile thus became an integral part of the architecture of the building.

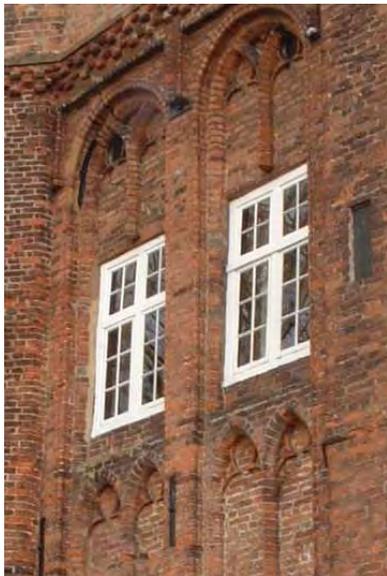
The earliest use of decorative brickwork in Repton was at Prior Overton’s tower c1438 (above), but another 17th century example of “sawtooth” brickwork can be found at The Priory (below).

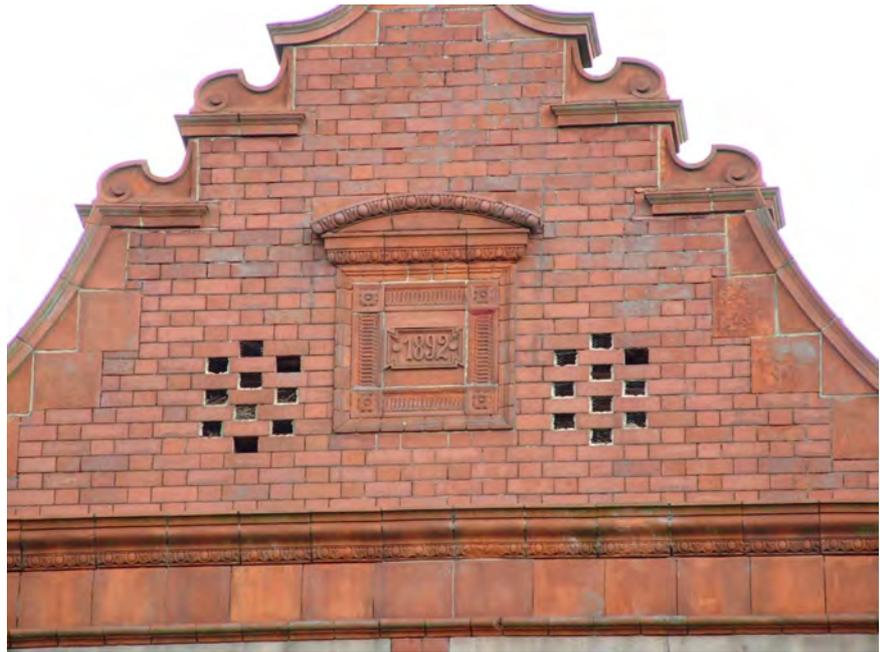
Terracotta is used on a number of the more imposing school buildings in the late 19th century, but the most decorative elements are often reserved for high level details such as the Dutch gable end (above) at the former Sanatorium and the pediment and gables (below) at School House.

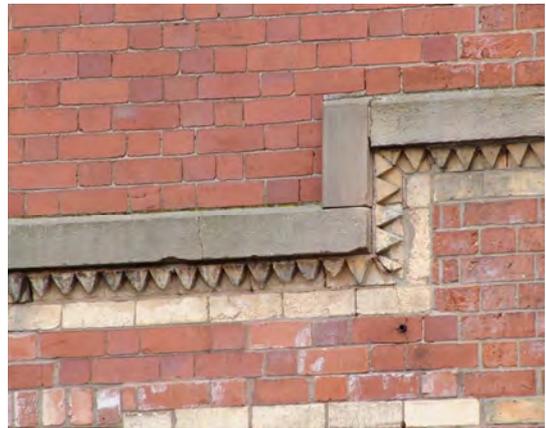
Buff-coloured brick is occasionally used for decorative bands such as that at Brook House (right), which reflects the earlier “sawtooth” pattern found on brick eaves and on Gothic buildings.

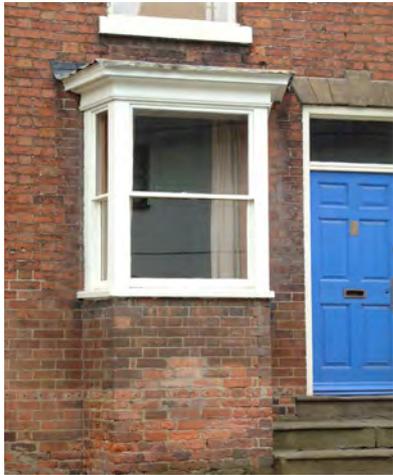
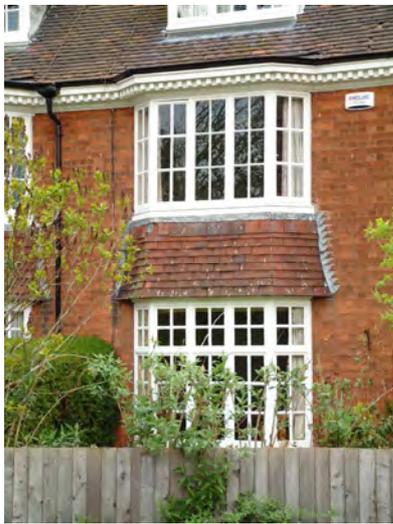
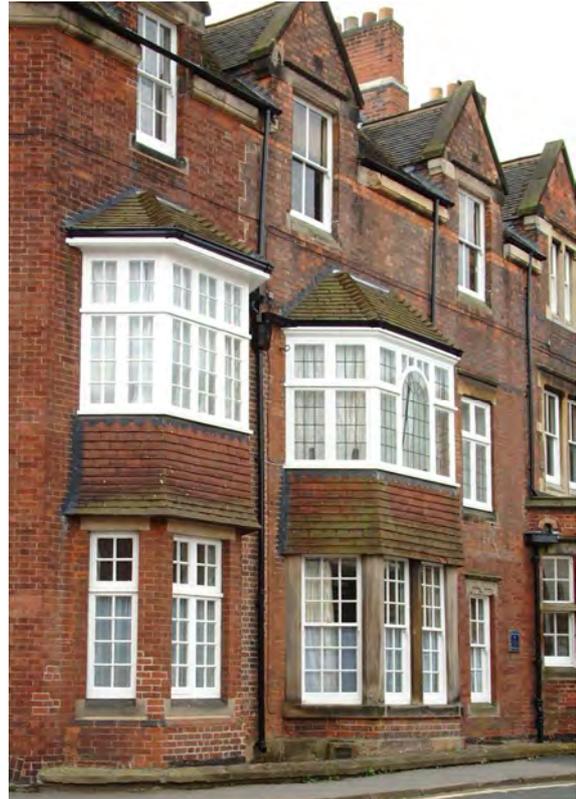
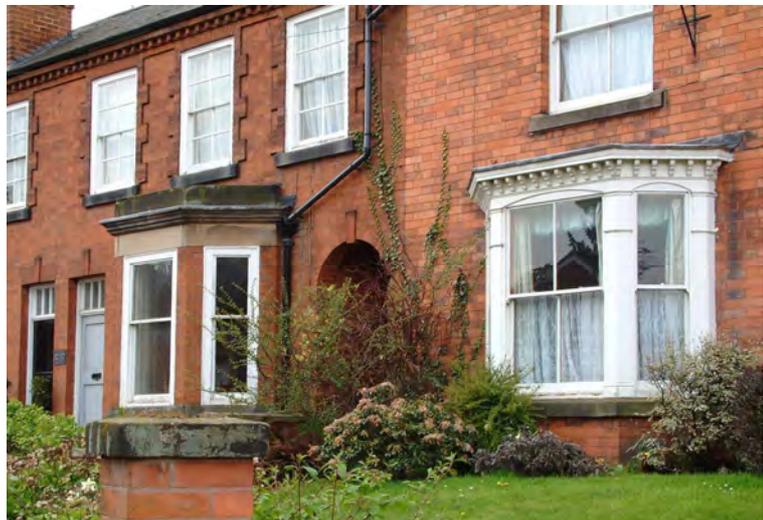
WINDOWS - Bay windows

Bay windows are a distinctive feature within Repton. They start to appear in the mid 19th century with a ground floor bay window (top left), which was introduced to add more light into the main living room and made the most of the large panes of plate glass made available following the abolition of tax on glass in 1845. They were often added to 18th century buildings to update them.

During the Edwardian period (left and above) bay windows were often full-height through both floors, as in a national style called Queen Anne Revival; the contrast between the red brickwork and white painted joinery was an important element. By this time, panes of glass were being made smaller in timber or lead to emulate the older styles.

Bays continued to feature into the late 19th and early 20th centuries.

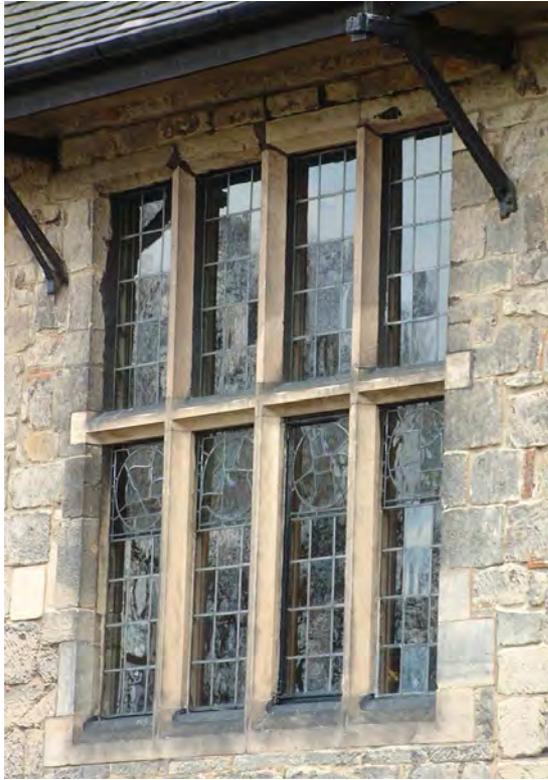
Above - The Old Priory - mullioned windows with stained and painted glass. The leaded lights are fixed directly into the stonework and held in place with "saddle bars".

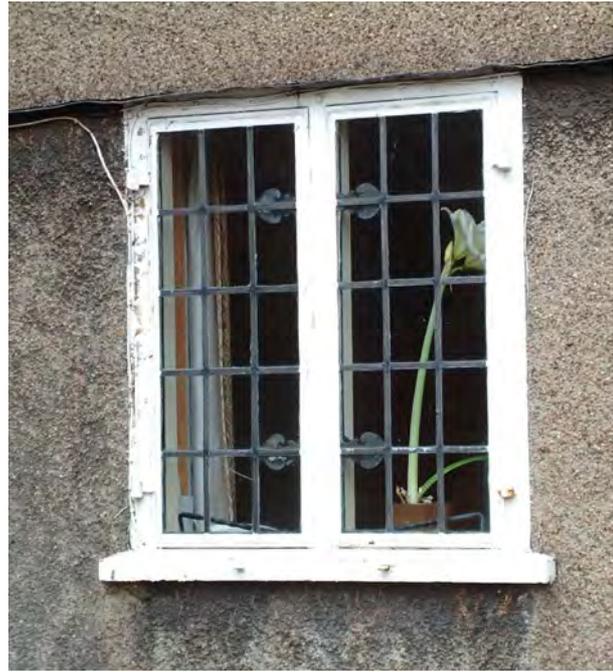
The first windows were made with glass "quarries" (square or diamond-shaped pieces of glass), separated by lead "comes". The lozenge shape evolved as a result of the process of making crown glass. By the 18th century, glass quarries were usually rectangular in shape (as at The Old Priory - left).

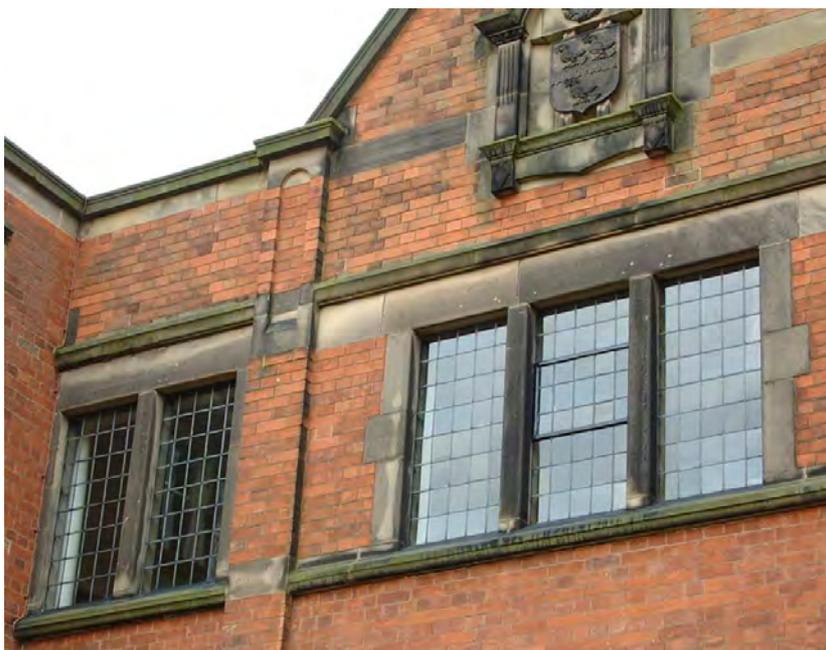
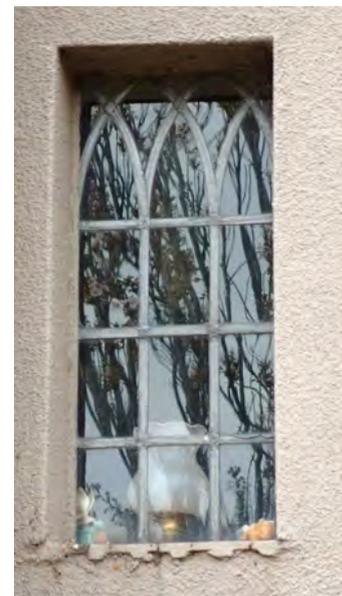
Leaded-light windows enjoyed a revival under the Arts and Crafts movement, examples of which can be seen at 11 The Cross (above) and 20-36 The Pastures (below right) and were used in various locations at the school (below left).

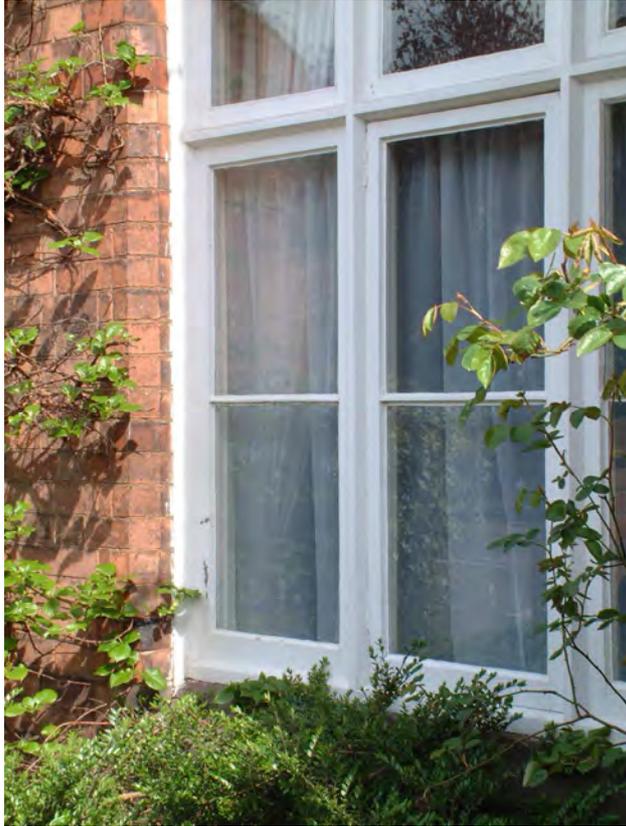
Windows with hinged opening lights are known as casements. Early opening lights were generally of wrought or cast iron and were often designed to carry leaded lights. By the late 18th century timber opening lights with glazing bars were becoming more common and sometimes replaced the earlier metal ones.

A number of the traditional timber casements are recessed within a timber frame, which has shaped mullions. This style is associated with several of the local estates. The casements themselves can be simple, with perhaps one horizontal glazing bar (as at Chapel House - left, 37 High Street) or multi-paned (as at 67 High Street - below).

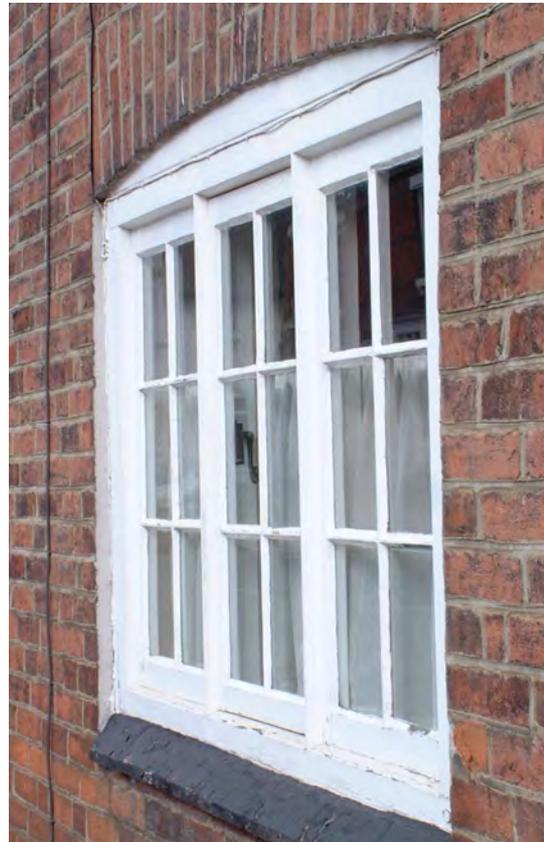
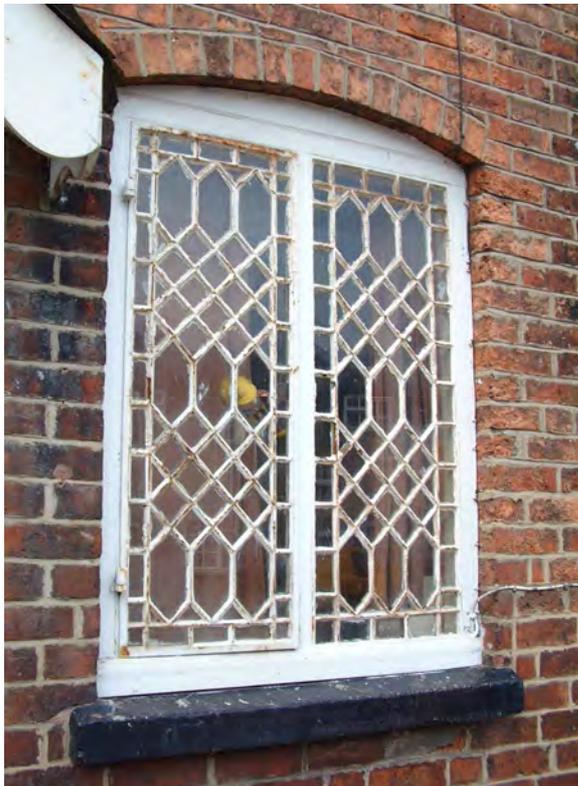
The cast-iron casements at 100-104 High Street (left) were designed in a gothic style to mimic the leaded-light quarries of traditional leaded-light windows, but in the 19th century, by using cast-iron, they could be made more cheaply by mass production. They differ in appearance from their leaded predecessors, because the glazing bars in a cast iron window were usually painted

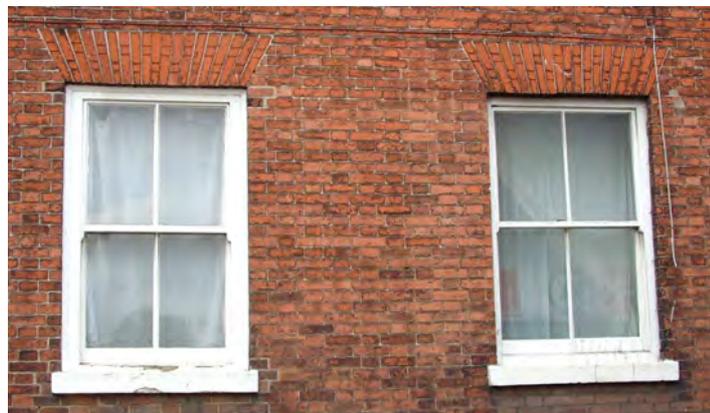
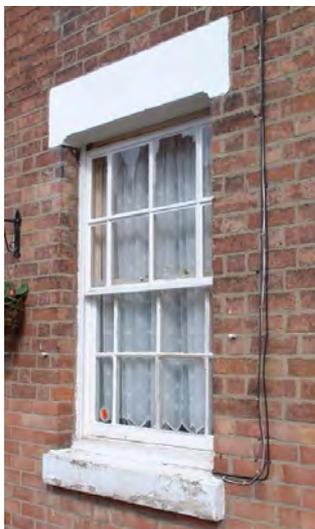
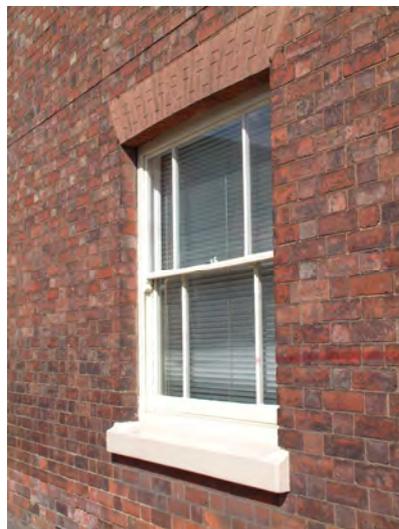
The windows at 4 High Street (below) are late 19th century replacements, with horns, of earlier sashes.

There are many examples of sash windows in Repton. At 1 Main Street (above) the multi-paned sashes of the first half of the 19th century survive. A variation on the vertical sliding sash with margin lights was used at 57-61 High Street (below left).

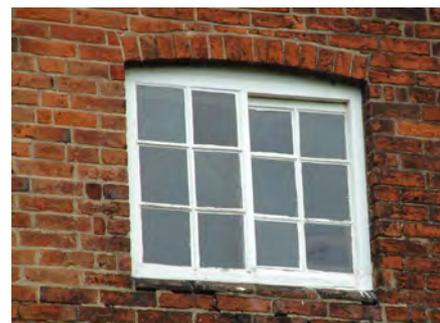
Horizontally sliding sash windows are a common feature of the Midlands, often reserved for the less important elevations, as at Brook Farm (below).

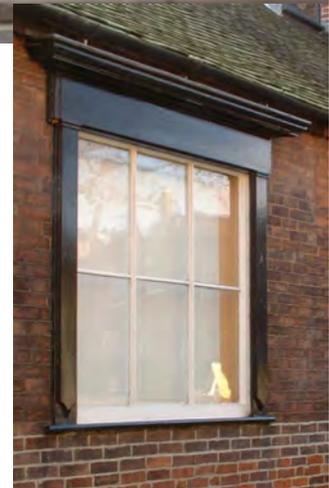
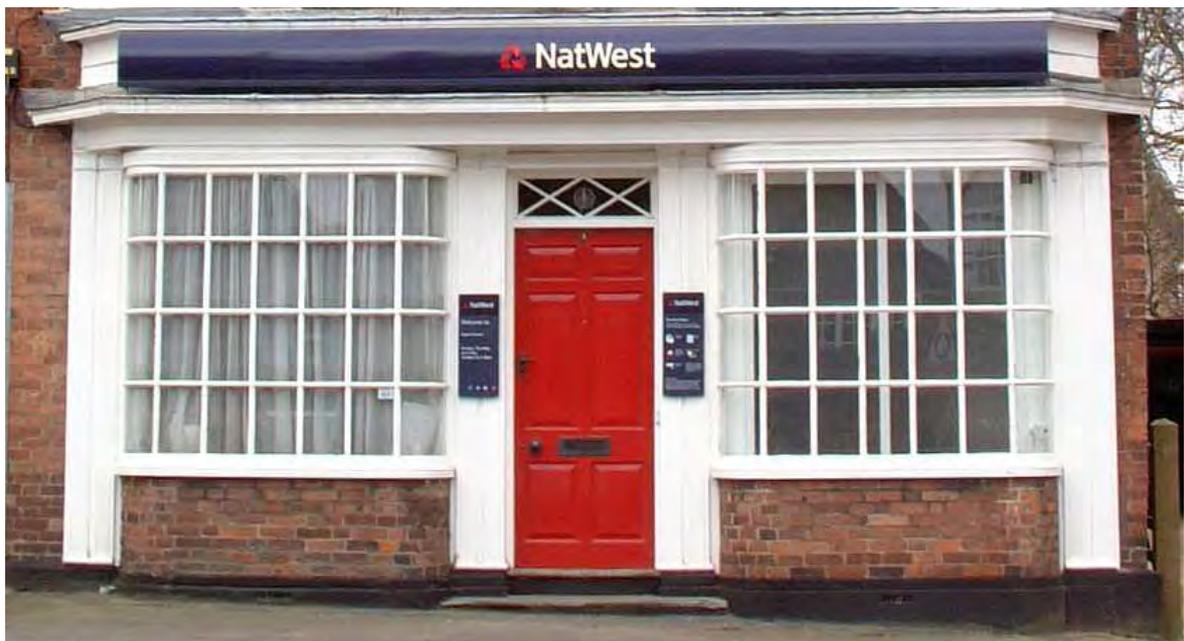
Those few original shopfronts surviving in Repton have unusual designs. The shopfront at No. 1 High Street (above) incorporates rather grand brick pilasters with carved stone capitals and a dressed ashlar plinth and a recessed shop doorway with miniature matching column. The shop window at the rear of the property, facing Brook End (right), is more low key and typical of traditional mid 19th century shopfronts with simple narrow timber pilasters, narrow fascia and cornice. The shopfront at 5 The Cross (below) is also quite grand and probably dates from the early 20th century. It is a “Queen Anne” style interpretation of a Georgian shopfront incorporating shallow, bow-fronted windows.

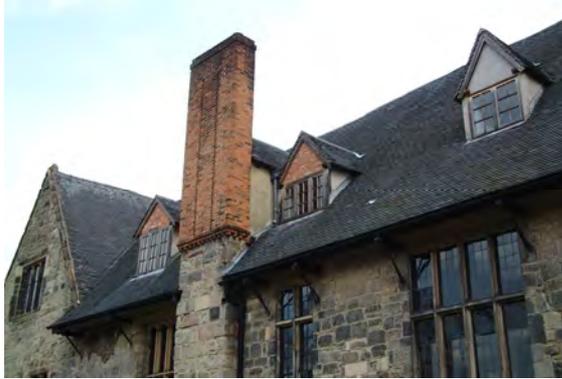
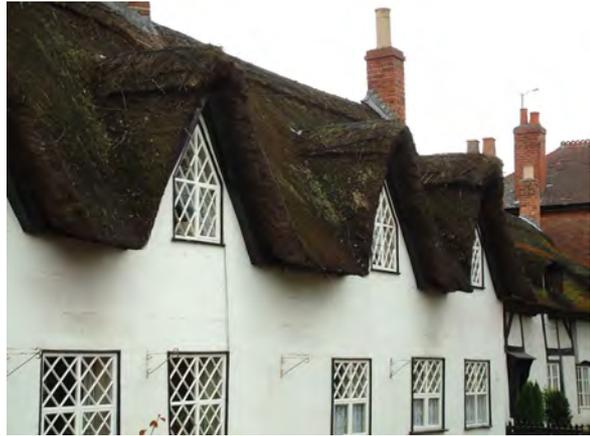
WINDOWS - Dormer windows

Dormer windows at The Old Priory (top left), are a later adaptation to the original building. A number of school buildings were built with half or full dormers during the second half of the 19th century (left - The Old Mitre and The Orchard). Dormers were also added to The Hall (left bottom).

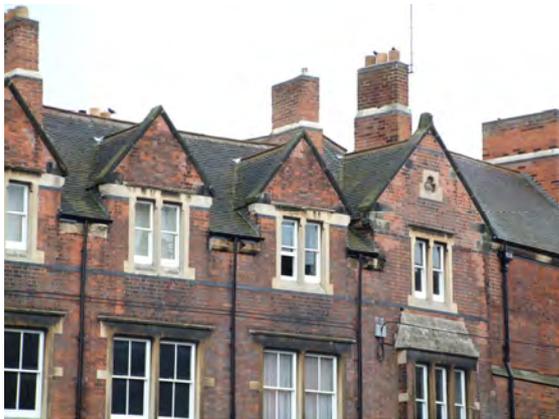
The pointed dormer windows at 1-3 Willington road (above) are early 19th century modifications, incorporated when the lattice windows were added to create a picturesque, Gothic appearance.

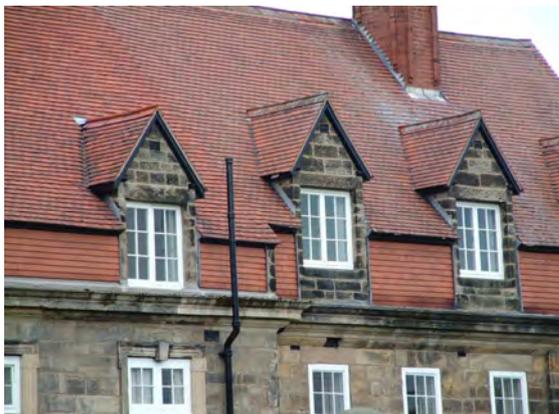
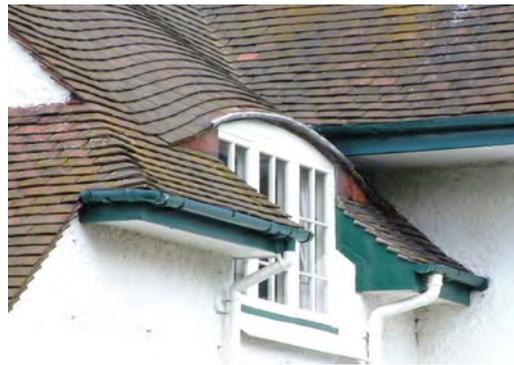
Eyebrow dormers were incorporated into Arts & Crafts houses as a reinterpretation of a national vernacular tradition - 31 Burton Road and Mitre Cottage, Mitre Drive (below).
